Aviation Investigation Final Report

Location:	Marana, Arizona	Accident Number:	WPR21LA145
Date & Time:	March 28, 2021, 14:28 Local	Registration:	N644SR
Aircraft:	CIRRUS DESIGN CORP SR22	Aircraft Damage:	Substantial
Defining Event:	Loss of engine power (total)	Injuries:	2 None
Flight Conducted Under:	Part 91: General aviation - Personal

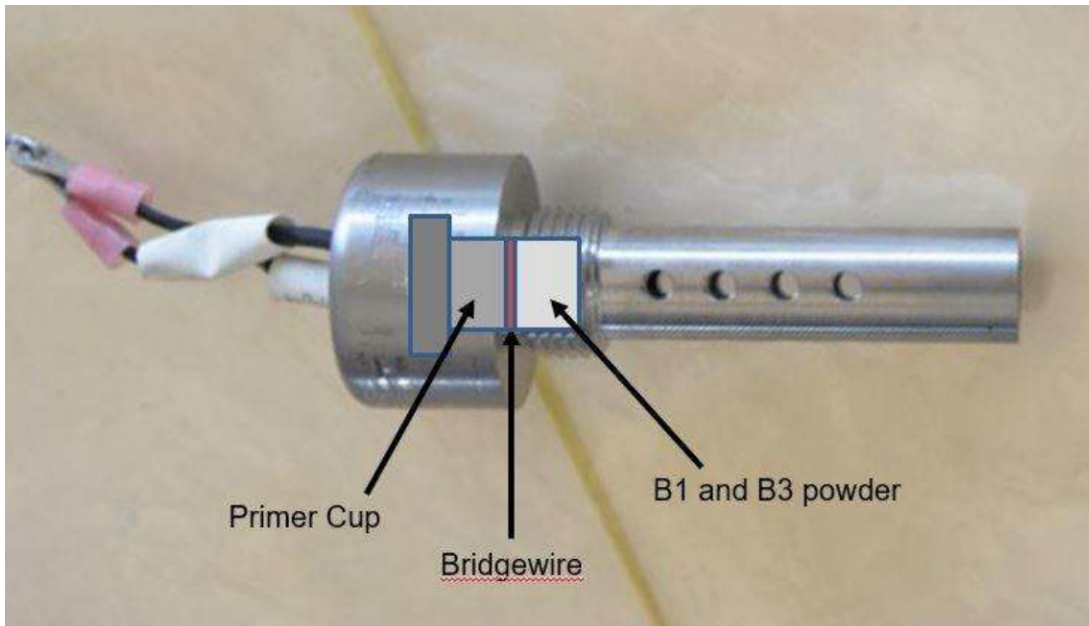
Figure 3. CAPS Igniter Assembly (Exemplar), courtesy Cirrus Aircraft

The squib utilizes an internal bridge wire that heats up and ignites a primer charge, a Boron-Barium Chromate mixture (B1), within the squib. Activation of the B1 then ignites the output charge (B3) which subsequently ignites the BKNO_3 pellets. The flame from the burning pellets exits the igniter through holes drilled in its sides and ignites the rocket propellant grains.
