# Aviation Investigation Final Report

<b>Location:</b>	LeRoy, Kansas	<b>Accident Number:</b>	CEN21LA187
<b>Date &amp; Time:</b>	April 9, 2021, 10:12 Local	<b>Registration:</b>	N421PB
<b>Aircraft:</b>	Eurocopter EC120	<b>Aircraft Damage:</b>	Substantial
<b>Defining Event:</b>	Fuel starvation	<b>Injuries:</b>	2 None
<b>Flight Conducted Under:</b>	Part 91: General aviation - Personal

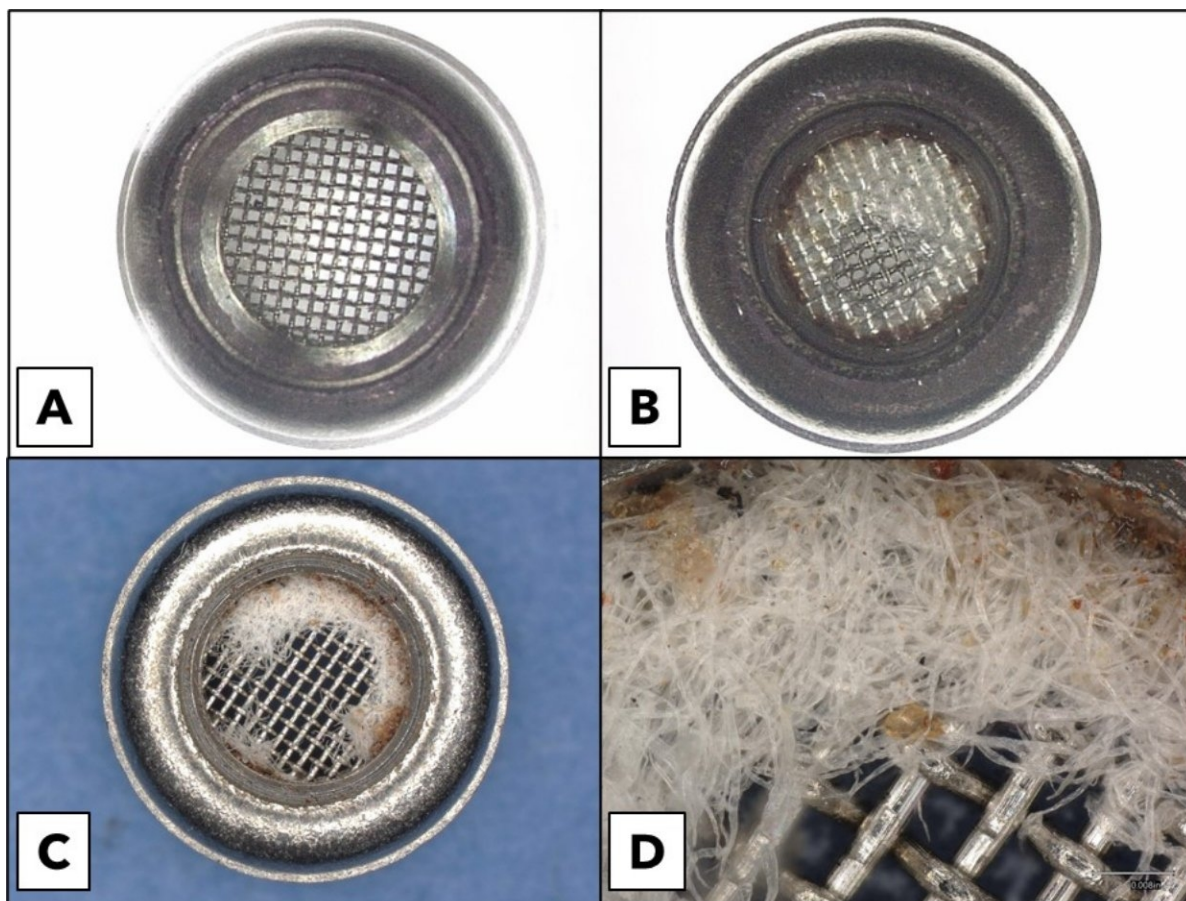
Based on the known information, the cellulose contamination found in the fuel injector manifold filter was likely introduced during associated fuel system maintenance at an undetermined date. The contaminated fuel injection manifold filter restricted fuel flow to the gas generator, which resulted in the partial loss of engine power during the flight. Additionally, the pilot likely delayed entering an autorotation after the partial loss of engine power, which resulted in insufficient main rotor speed and an excessive descent rate at touchdown.

When bench tested, the left fuel injection manifold flowed within the design limits with an average flow of 21.3 liters/hour (limits  $21.2 \pm 0.8$  liters/hour) and max deviation of 0.6 liters/hour (limits = 1.6 liters/hour). When bench tested, the right fuel injection manifold flowed significantly less than the design limits with an average flow of 4.3 liters/hour. The right fuel injection manifold houses a filter at the entrance to the manifold that protects both right and left injection manifolds where they connect inline to the adjusted valve. The original filter was removed, a new filter installed, and the right fuel injection manifold tested within the design limits with an average flow of 20.9 liters/hour and max deviation of 1.0 liters/hour. A microscope examination revealed contamination that obscured about 75% of the filter screen, as shown in figure 1.

The fuel injection manifold filter was sent to the National Transportation Safety Board Materials Laboratory for additional examination using Fourier Transform Infrared (FTIR) spectrometry. The FTIR spectrum for the unknown sample had signatures consistent with cellulose. Cellulose is found in natural plant fibers like paper and cotton. The spectra of known samples of white paper and white cotton were also compared to the unknown sample and exhibited strong matches.

**Figure 1** – (A) Exemplar fuel injection manifold filter; (B) Accident fuel injection manifold filter, wet; (C) Accident fuel injection manifold filter, dry; (D) Filter contamination at 200X magnification
