Aviation Investigation Final Report

Location:	Brownsville, Tennessee	Accident Number:	ERA21FA189
Date & Time:	April 20, 2021, 20:52 Local	Registration:	N4303G
Aircraft:	Piper PA-28RT-201T	Aircraft Damage:	Destroyed
Defining Event:	VFR encounter with IMC	Injuries:	2 Fatal
Flight Conducted Under:	Part 91: General aviation - Personal

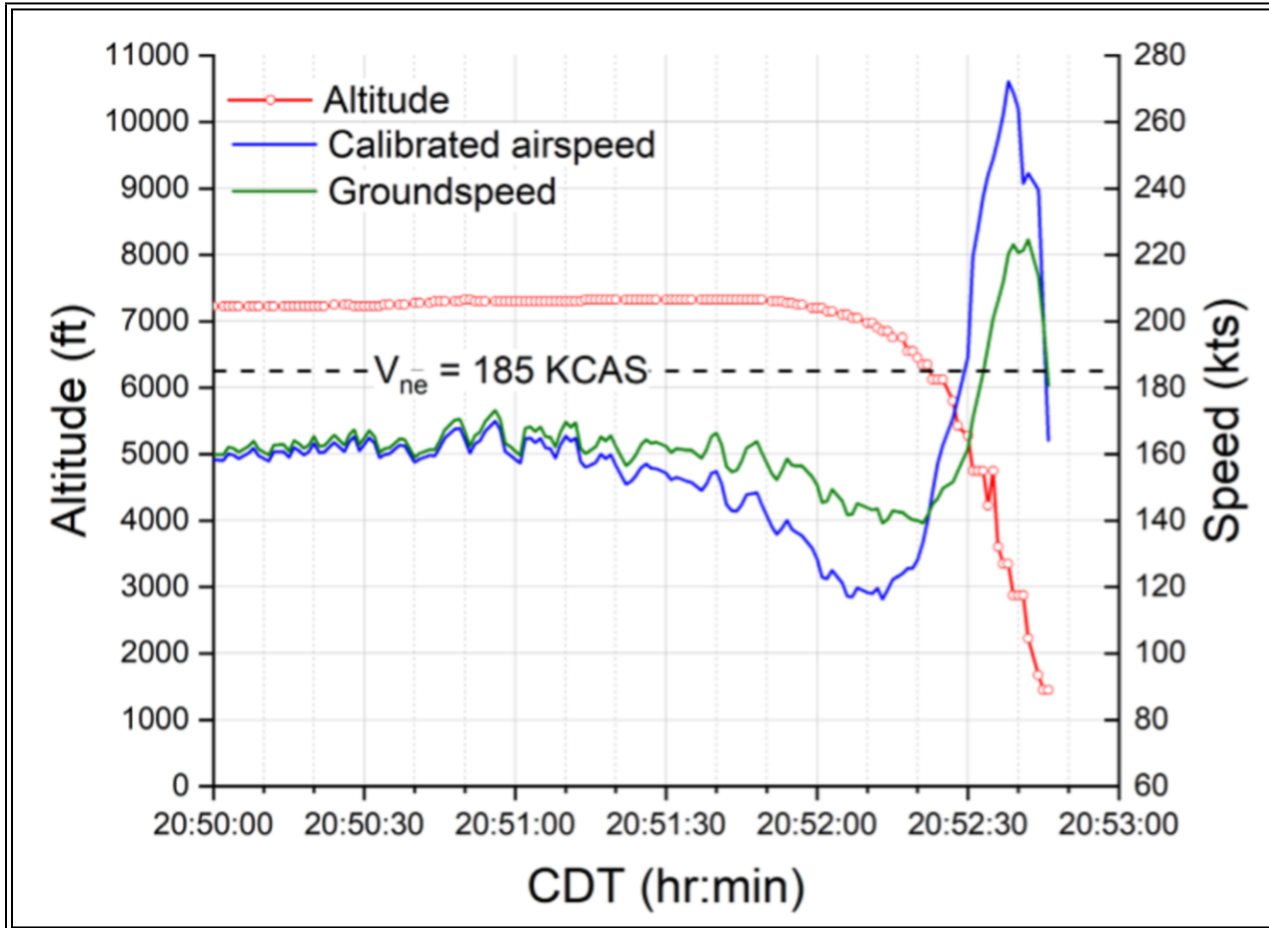
A National Transportation Safety Board (NTSB) performance study reviewed the final few minutes of ADS-B data and found that a descent was initiated at 2051:50. In the subsequent 20 seconds, the airplane slowed from 160 knots calibrated airspeed (KCAS) to 120 KCAS and entered a right turn. The descent then rapidly accelerated, airspeed rapidly increased, and the right turn tightened into a descending spiral.

At 2052:29, the airplane exceeded its never-exceed speed (VNE) of 185 KCAS in the descent, and about 10-15 seconds later, the airplane reached a maximum recorded speed of about 270

KCAS. The final data point was at 2052:46; the airplane was at an altitude of 1,450 ft msl, flying south-southwest about 165 KCAS. The wreckage was located about 1,000 ft from the final reported position at an elevation of about 300 ft msl. Figure 2 provides an overview of this calculated performance information based upon ADS-B data.

Figure 2. End of flight altitude (msl) and calculated groundspeed and calibrated airspeed.
