# Aviation Investigation Final Report

<b>Location:</b>	Brownsville, Tennessee	<b>Accident Number:</b>	ERA21FA189
<b>Date &amp; Time:</b>	April 20, 2021, 20:52 Local	<b>Registration:</b>	N4303G
<b>Aircraft:</b>	Piper PA-28RT-201T	<b>Aircraft Damage:</b>	Destroyed
<b>Defining Event:</b>	VFR encounter with IMC	<b>Injuries:</b>	2 Fatal
<b>Flight Conducted Under:</b>	Part 91: General aviation - Personal

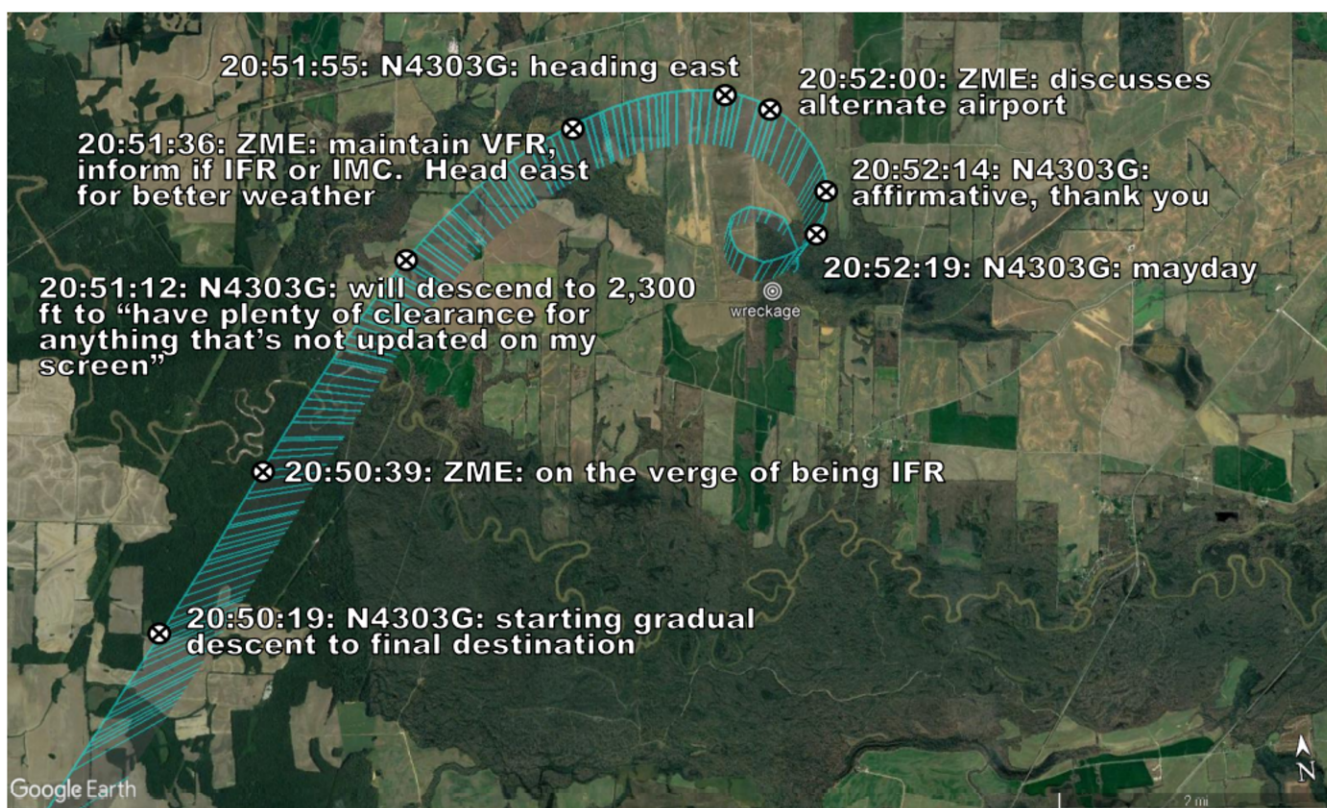
Review of air traffic control communications provided by the FAA revealed that in the final few minutes of the flight, the pilot was communicating with Memphis Air Route Traffic Control Center (Memphis Center) while receiving visual flight rules (VFR) flight-following services. About 2 minutes and 30 seconds prior to radar contact being lost, the pilot stated to the controller that he was flying at 7,500 ft msl, his destination was CEY, and added that he was planning to "start my descent now" and he was going to make it a "gradual descent."

The controller responded by providing the CEY altimeter setting and advised the pilot of moderate precipitation "starting now lasting all the way to the [destination] airport." The controller further stated, in part, that "everything between now and [CEY] is on the verge of being i f r [instrument flight rule] conditions. It looks likes ceilings are down around about 1,500 ft most everywhere."

The pilot responded, "ok affirmative I'm gonna still descend down" to "2,000 3,000 feet to have plenty of clearance for anything that's not updated on my screen if that's ok and until I get within 10 miles I'll drop to my final descent." The controller responded by advising the pilot to

maintain VFR and provided an additional weather observation report for an airport along the route of flight that was reporting IFR conditions. The controller advised that a course to the east may help him remain clear of the weather and advised that McKellar-Sipes Regional Airport (MKL) was still reporting clear skies.

The pilot acknowledged the controller and said he would fly east to stay out of the weather. The controller responded by providing one additional airport reporting VFR conditions that was about 20 miles south of his destination, which the pilot acknowledged. About 35 seconds later, a “mayday” call was announced over the radio. There was no call sign associated with the distress call, nor any further information given with the call. The controller attempted to reach the pilot several times after the mayday call; however, no further communications were received. Figure 1 provides an overview of the final minutes of the ADS-B flight track overlaid with paraphrased controller-pilot communications.

Figure 1. End of flight ADS-B data with controller-pilot communication paraphrased. N4303G is the accident airplane and ‘ZME’ is Memphis Center.

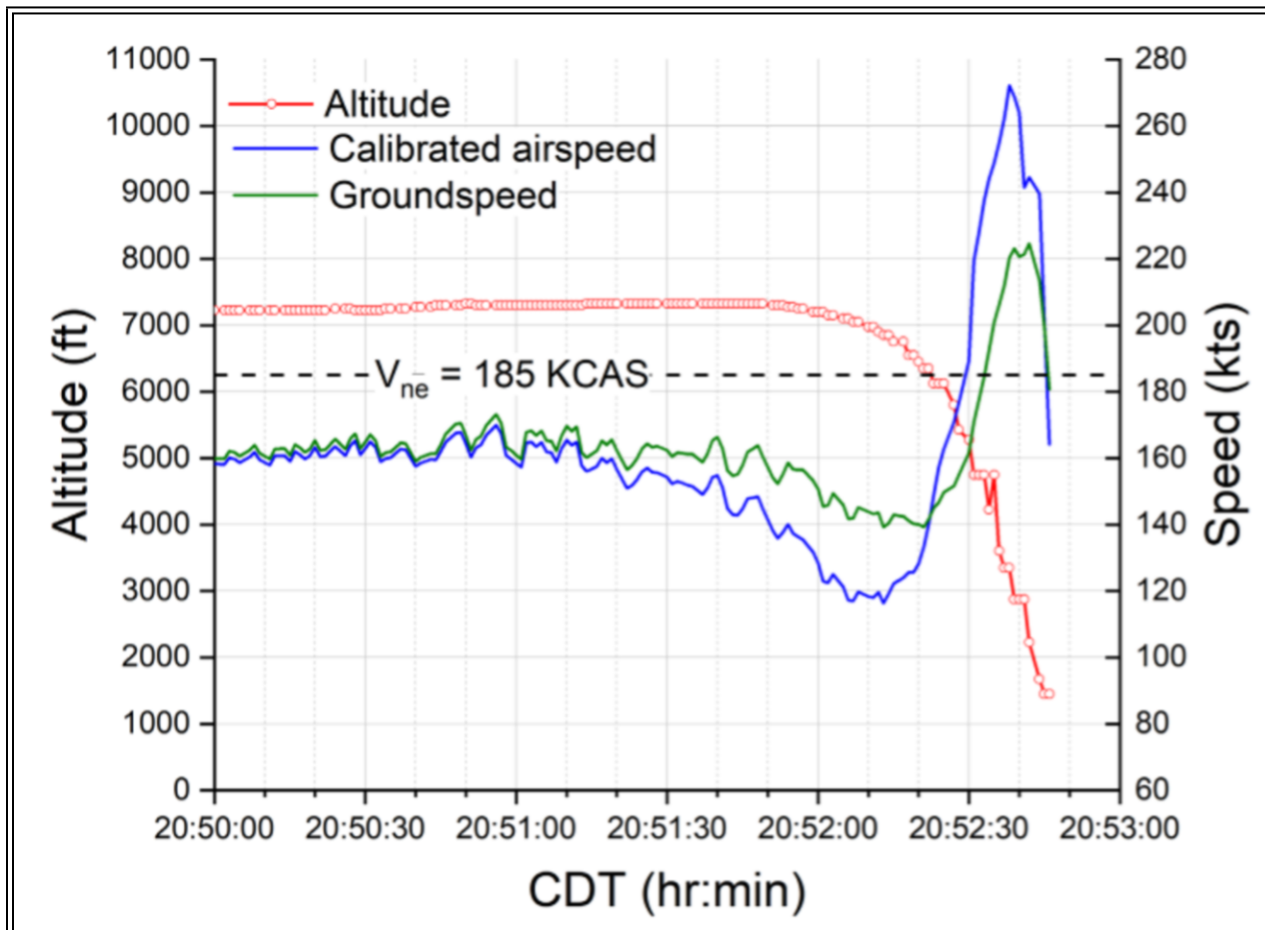
A National Transportation Safety Board (NTSB) performance study reviewed the final few minutes of ADS-B data and found that a descent was initiated at 2051:50. In the subsequent 20 seconds, the airplane slowed from 160 knots calibrated airspeed (KCAS) to 120 KCAS and entered a right turn. The descent then rapidly accelerated, airspeed rapidly increased, and the right turn tightened into a descending spiral.

At 2052:29, the airplane exceeded its never-exceed speed (VNE) of 185 KCAS in the descent, and about 10-15 seconds later, the airplane reached a maximum recorded speed of about 270

KCAS. The final data point was at 2052:46; the airplane was at an altitude of 1,450 ft msl, flying south-southwest about 165 KCAS. The wreckage was located about 1,000 ft from the final reported position at an elevation of about 300 ft msl. Figure 2 provides an overview of this calculated performance information based upon ADS-B data.

Figure 2. End of flight altitude (msl) and calculated groundspeed and calibrated airspeed.

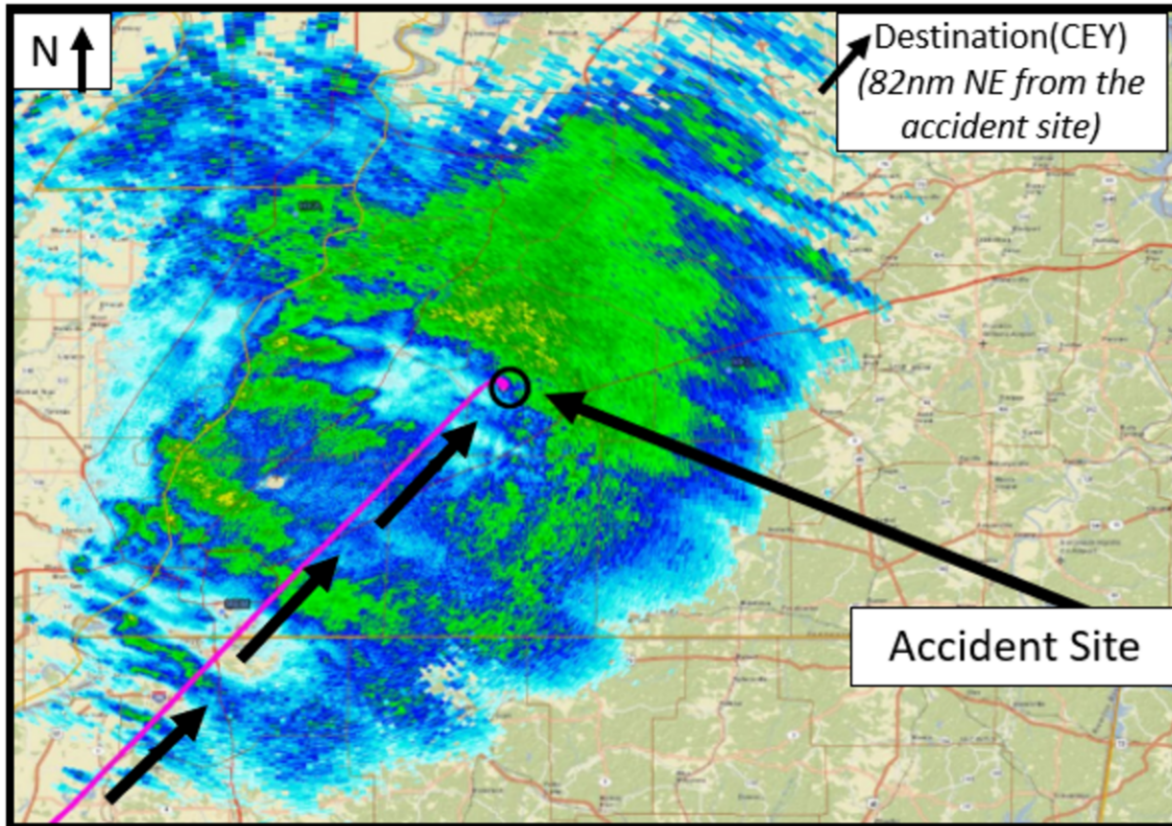
Review of data from the nearest weather surveillance radar station revealed that airplane's flight track in the final few minutes of flight approached an area of light precipitation. Figure 3 shows the airplane's flight track, precipitation, and the accident site.

Figure 3. Overview of the flight track and weather surveillance radar data near the time of the accident
