Aviation Investigation Final Report

Location:	Anchorage, Alaska	Accident Number:	ANC21LA033
Date & Time:	April 25, 2021, 18:28 Local	Registration:	N77219
Aircraft:	Cessna 140	Aircraft Damage:	Substantial
Defining Event:	Fuel starvation	Injuries:	2 None
Flight Conducted Under:	Part 91: General aviation - Personal

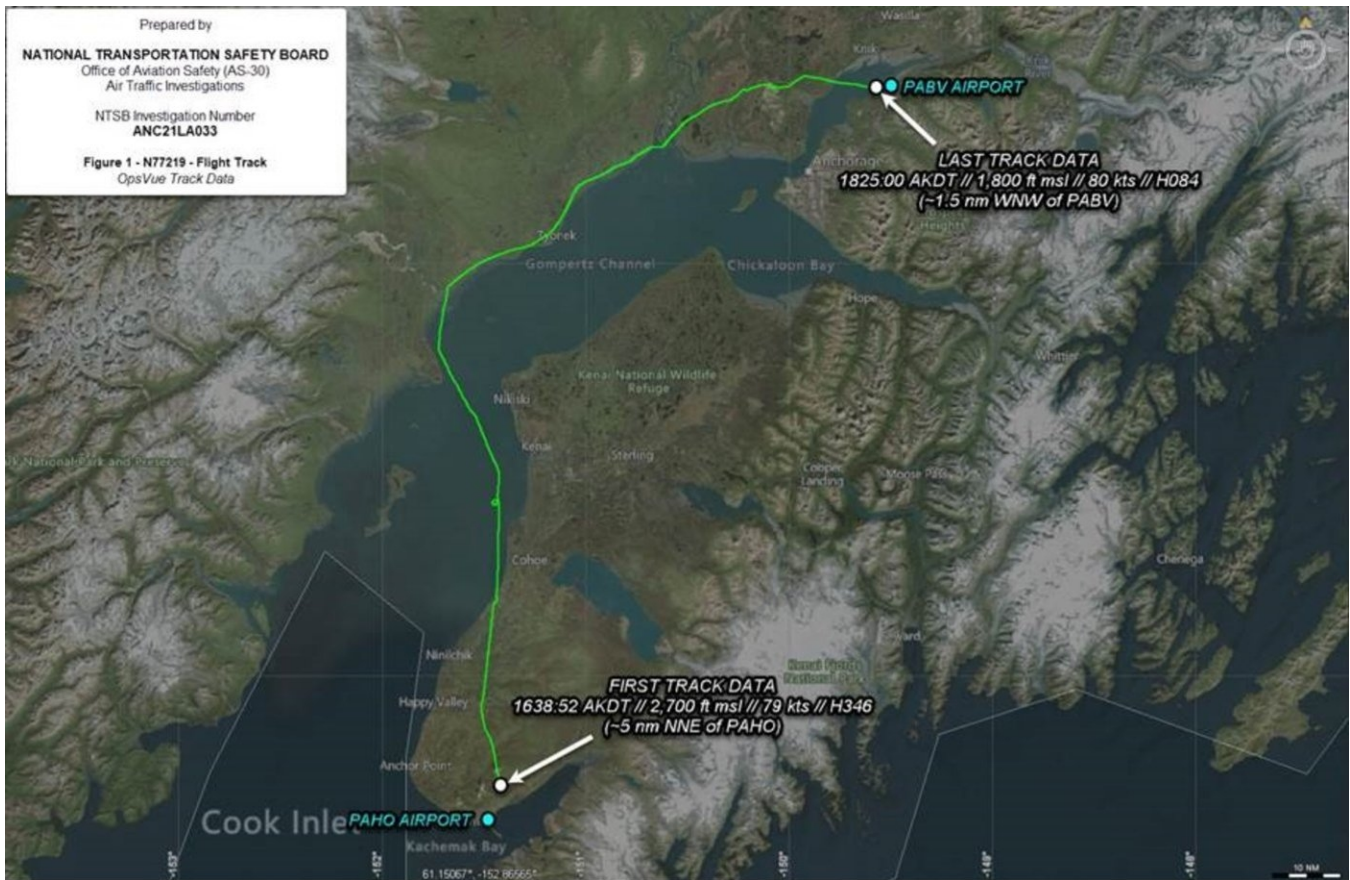
The pilot reported that the cross-country flight originated at the Birchwood Airport (BCV) with stops at Quartz Creek Airport (JLA), Cooper Landing, Alaska, and a planned fuel stop in Homer Airport (HOM) Homer, Alaska. While in Homer, 13 gallons of fuel was added before the airplane departed at 1633 for BCV with a total of 15 gallons of fuel onboard (see figure 1).

Figure 1 – Flight track for last leg of accident flight.
