Aviation Investigation Final Report

Location:	Eden, North Carolina	Accident Number:	ERA21FA195
Date & Time:	April 28, 2021, 13:24 Local	Registration:	N53DE
Aircraft:	BELL HELICOPTER TEXTRON CANADA 429	Aircraft Damage:	Destroyed
Defining Event:	Part(s) separation from AC	Injuries:	1 Fatal, 2 Serious
Flight Conducted Under:	Part 91: General aviation - Aerial observation

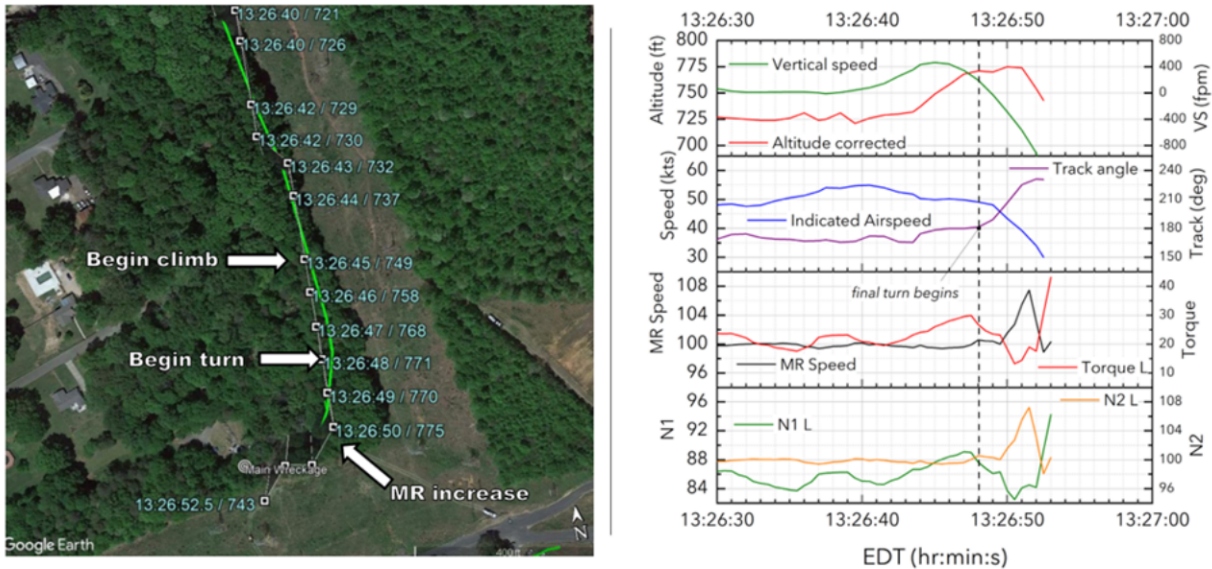
During the final minutes of flight, the helicopter was traveling at an airspeed between 50 and 60 kts parallel to powerlines at an altitude between 700 and 775 ft msl (Figure 1). Nr was near 100%, torque varied between 15% and 25%, and the engine gas generator (N1) speeds were between 84 and 88%.

Figure 1- Combined map of flight track with corresponding flight parameters.

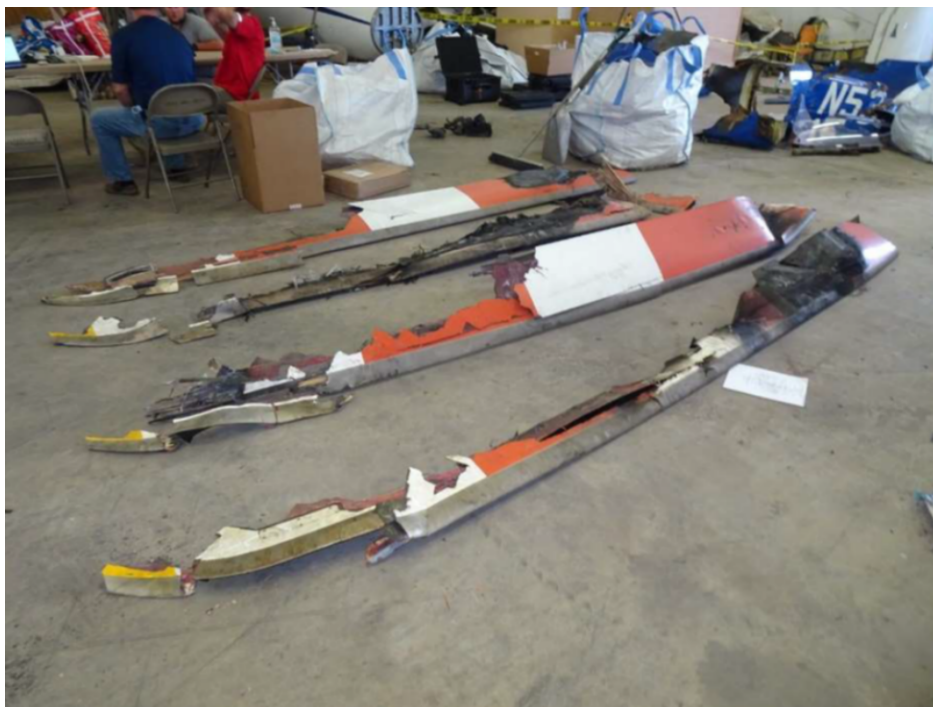
The four main rotor blades were reconstructed in their respective positions and laid out by their designated colors, Green, Red, Orange, and Blue (Figure 2). Three separated leading edge pieces near the tip end, including the tip cap lap joint, were found in the debris field surrounding the main wreckage. Two swept tip ends, which were fractured and separated,

were reconstructed by the investigation team to the 'blue' and 'orange' main rotor blades. Two additional swept tip ends, also fractured and separated, exhibited impact damage with a width consistent with contact with the tail rotor drive system aft snubber and belonged to the 'red' and 'green' main rotor blades (Figure 3). All four swept tip ends were found in the debris field leading up to and around the main wreckage.

Figure 2- A reconstruction of the four main rotor blades; From top to bottom, Green, Red, Orange, and Blue.

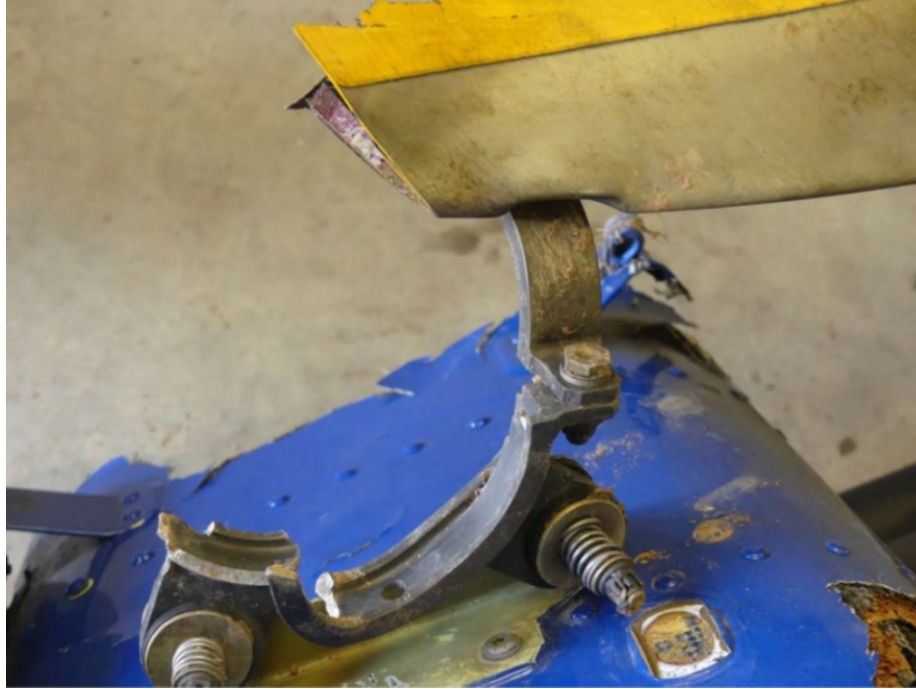
Figure 3- An approximate reconstruction of rotor blade impact damage on the blade tip that is consistent with the dimensions of the snubber housing.

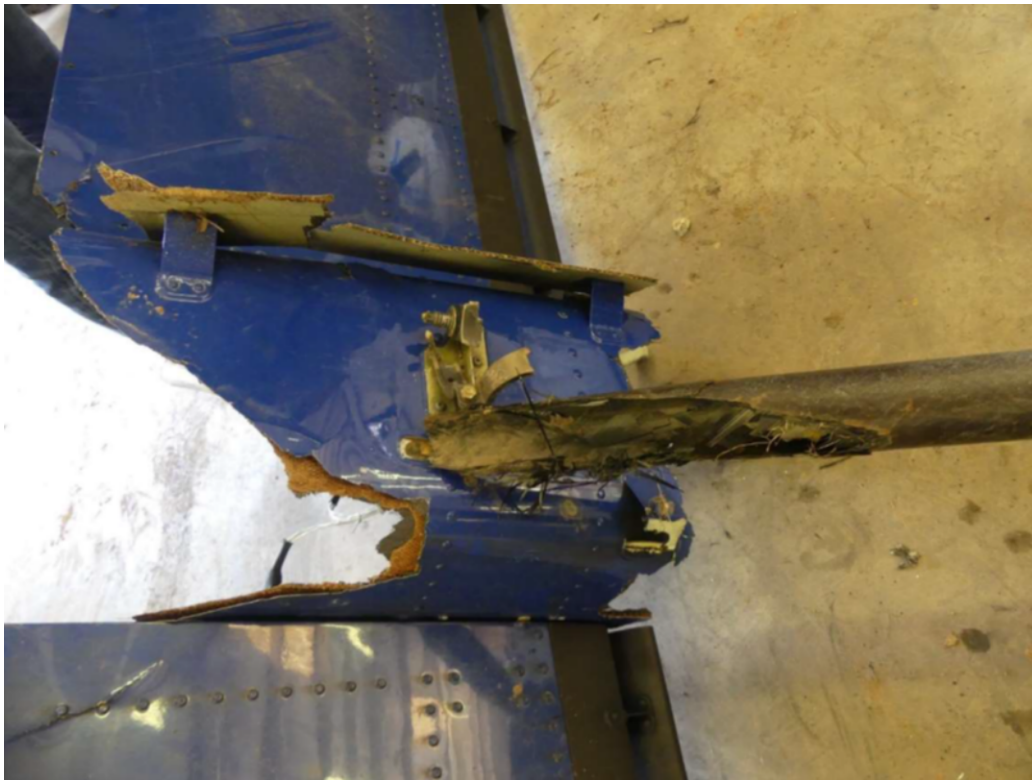
The steel tail rotor drive shaft was continuous to the fan blower shaft. The fan blower shaft and oil cooler blower remained installed on the airframe but were crushed from impact forces. The drive shaft was attached at its forward end to the shaft segment running through the oil cooler blower assembly, one of the lobes (or "ears") on the adapter assembly was fractured. The forward segmented drive shaft was fractured about 25 inches aft of its forward attachment flange. Two additional pieces from the forward segmented drive shaft were recovered: 1) the midsection of the forward segmented drive shaft, containing the stainless steel snubber sleeve, was found in the wreckage adjacent to the tail boom and 2) the aft section of the forward segmented drive shaft, about 40 inches in length, remained attached to a separated section of the tail boom and remained connected to a forward portion of the aft segmented drive shaft, about 23 inches in length, and the hanger bearing between them. The segmented drive shaft hanger bearing and its mount remained attached to the tail boom. A 34-inch -long section of the aft segmented drive shaft was found embedded near-vertically into the ground, with about 18 inches buried. The aft portion of the 34-inch section of the aft segmented drive shaft exhibited an angled cut (Figure 4).

Figure 4 - The 34-inch section of the aft segmented drive shaft, the aft end of which exhibited the angular cut.
