Aviation Investigation Final Report

Location:	Oxford, Iowa	Accident Number:	CEN21FA207
Date & Time:	May 2, 2021, 15:52 Local	Registration:	N1215M
Aircraft:	Cessna T210M	Aircraft Damage:	Destroyed
Defining Event:	Loss of control on ground	Injuries:	1 Fatal
Flight Conducted Under:	Part 91: General aviation - Personal

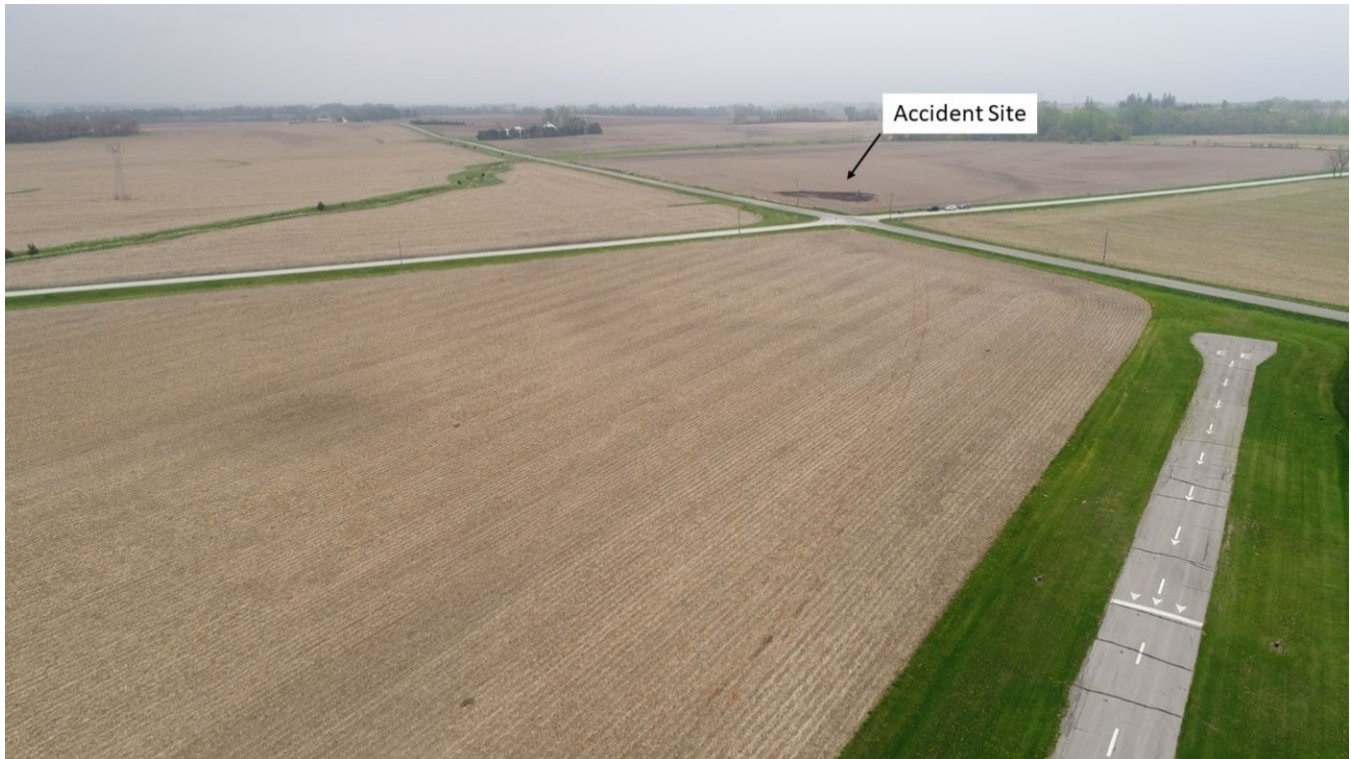
The main wreckage was located in a harvested corn field about 750 ft east of the end of runway 15. Landing gear tire marks were noted in the field and measured about 1,200 ft in length. The distance from the end of the tire marks to the power pole/power line was about 300 ft. Figure 1 shows the end of runway 15, tire marks in the field, power lines, and accident site with the postaccident fire damage.

Figure. Image showing the end of runway 15, tire marks in the field, power lines, and accident site with the postaccident fire damage
