Aviation Investigation Final Report

Location:	Hattiesburg, Mississippi	Accident Number:	CEN21FA209
Date & Time:	May 4, 2021, 23:01 Local	Registration:	N322TA
Aircraft:	Mitsubishi MU2B	Aircraft Damage:	Destroyed
Defining Event:	Loss of control in flight	Injuries:	4 Fatal, 2 Minor
Flight Conducted Under:	Part 91: General aviation - Personal

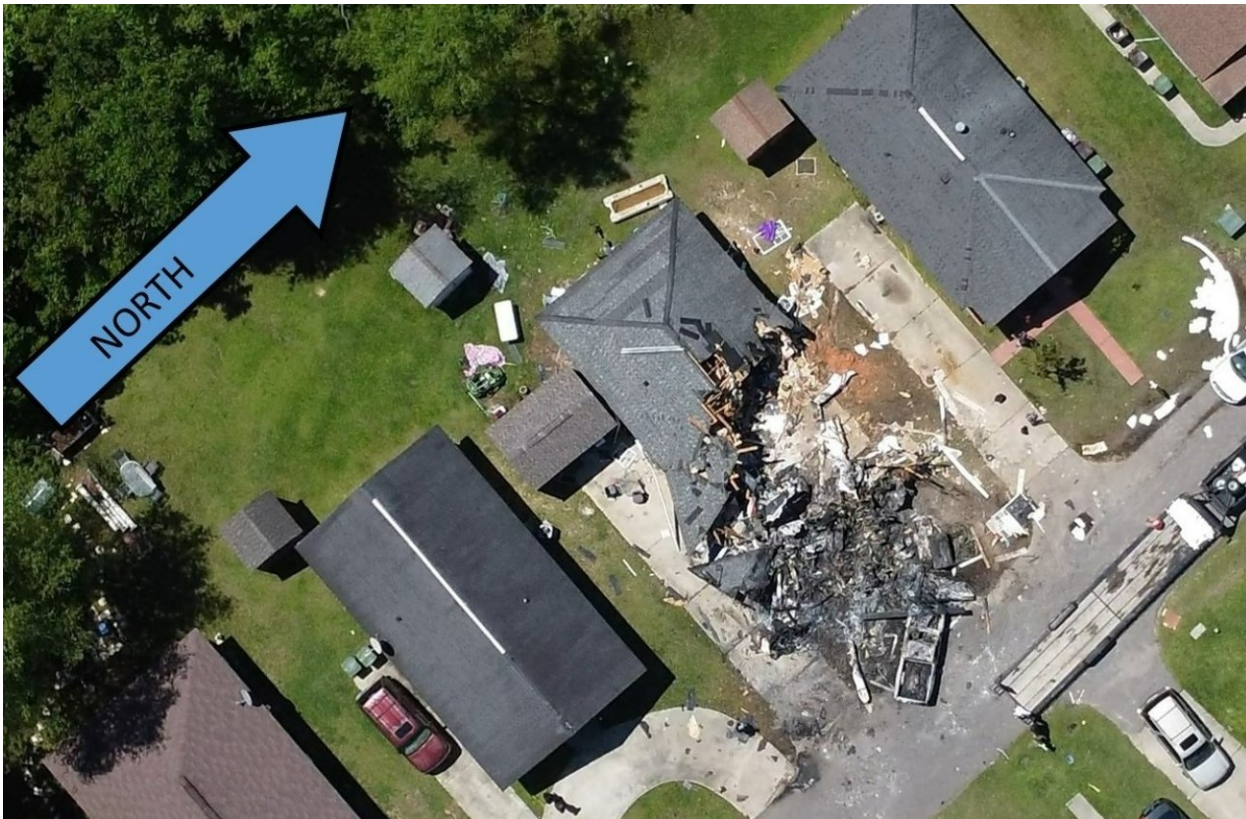
The accident site was located 2.24 miles from the approach end of runway 13. The postimpact fire consumed most of the airplane and the residence. The accident site was largely contained to one area with a small debris field, consistent with a low-energy impact, as shown in figure 2.

Figure 2. Accident site.
