# Aviation Investigation Final Report

<b>Location:</b>	Hattiesburg, Mississippi	<b>Accident Number:</b>	CEN21FA209
<b>Date &amp; Time:</b>	May 4, 2021, 23:01 Local	<b>Registration:</b>	N322TA
<b>Aircraft:</b>	Mitsubishi MU2B	<b>Aircraft Damage:</b>	Destroyed
<b>Defining Event:</b>	Loss of control in flight	<b>Injuries:</b>	4 Fatal, 2 Minor
<b>Flight Conducted Under:</b>	Part 91: General aviation - Personal

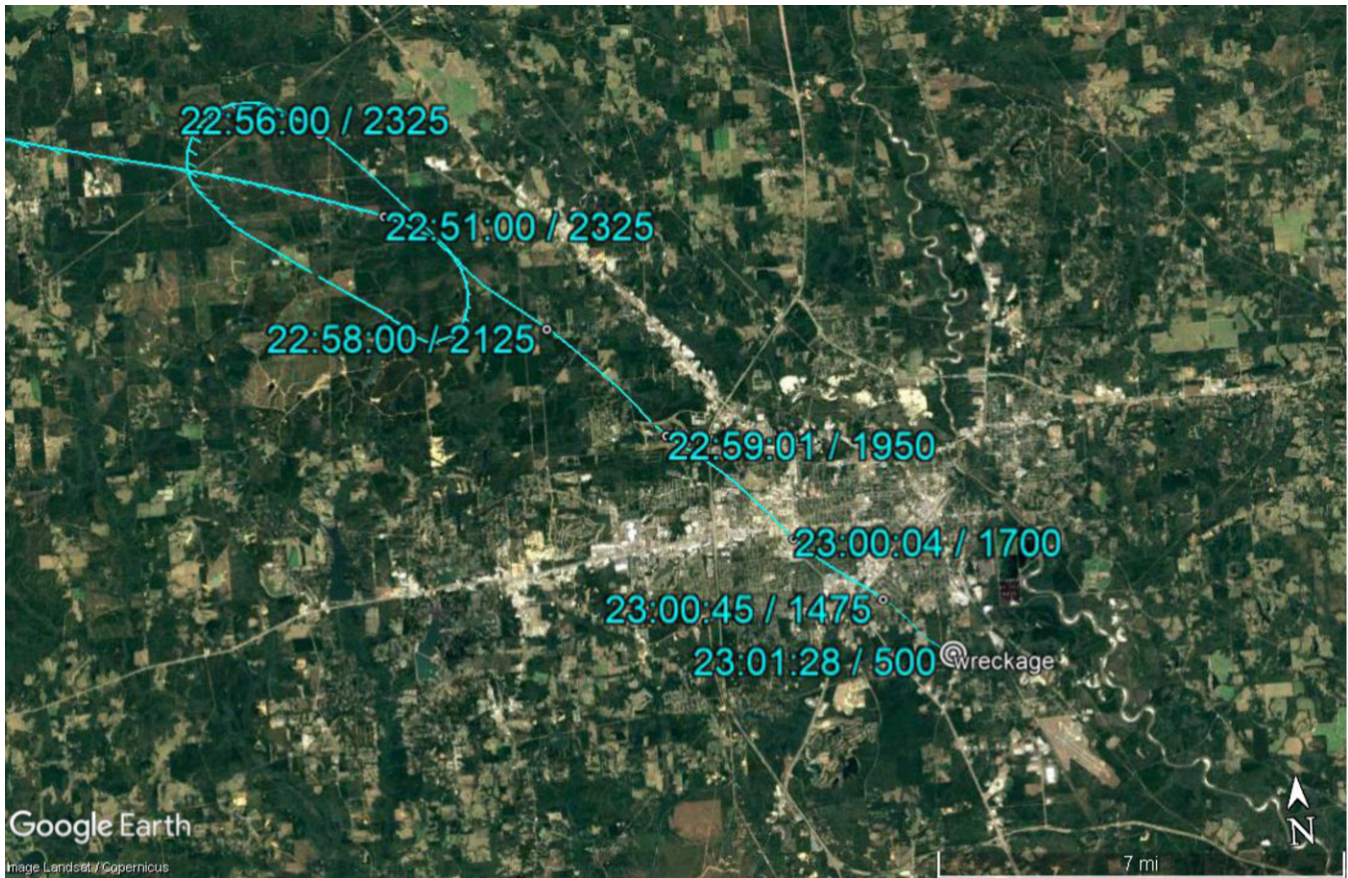
Automatic Dependent Surveillance–Broadcast (ADS-B) data provided by the Federal Aviation Administration captured the accident flight. About 2251, the pilot began to fly the procedure turn for the RNAV approach; at 2252:12, the airplane’s airspeed was 88 knots. The airspeed fluctuated before the airplane accelerated back to 140 knots as the airplane crossed HILGA and descended to 2,000 ft msl. As the airplane approached the final approach fix (CUPPA), the airplane descended before the fix and crossed it 300 ft low. The airplane’s descent stopped for about 30 seconds, and the airplane then descended about 1,300 ft per minute. The airplane’s airspeed decreased as the airplane continued to descend; at 2301:24, when the airplane’s airspeed was about 85 knots its altitude was 500 ft msl. The last recorded data point showed the airplane at an altitude of about 460 ft msl and 750 ft from the accident site. The airplane impacted the front of an occupied residence, and a postimpact fire ensued. Figure 1 shows the airplane’s approach path and wreckage location.

Figure 1. Airplane’s approach path with accident site location with times and altitudes annotated.

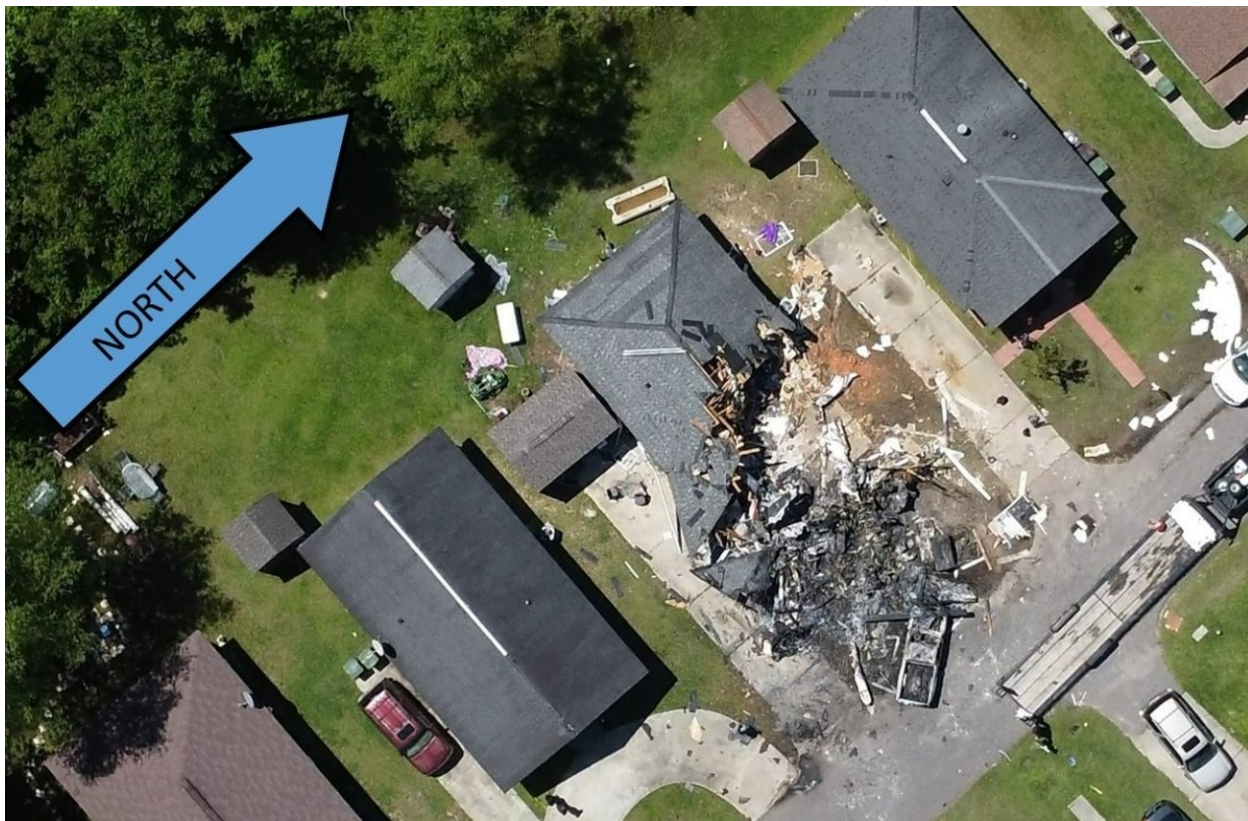
The accident site was located 2.24 miles from the approach end of runway 13. The postimpact fire consumed most of the airplane and the residence. The accident site was largely contained to one area with a small debris field, consistent with a low-energy impact, as shown in figure 2.

Figure 2. Accident site.

Postaccident examination of the wreckage found that the airplane was configured with its landing gear down and flaps at 20°. All major flight controls were found at the accident site. Disassembly of both engines revealed debris consistent with roofing tiles in the combustion chambers. In addition, both engines contained signatures of rotational scoring and torsional fractures. Both propellers displayed witness marks indicating blade positions between 25° and 28°, which was consistent with a low power setting. Examination of the airframe, engines, and
