Aviation Investigation Final Report

Location:	St Petersburg-Clearwater, Florida	Incident Number:	OPS21LA002
Date & Time:	April 29, 2021, 15:07 Local	Registration:	N306NV (A1); N370SD (A2)
Aircraft:	Airbus A319-112 (A1); Cessna M337B (A2)	Aircraft Damage:	None (A1); None (A2)
Defining Event:	Air traffic event	Injuries:	129 None (A1); 1 None (A2)
Flight Conducted Under:	Part 121: Air carrier - Scheduled (A1); Part 91: General aviation - Personal (A2)

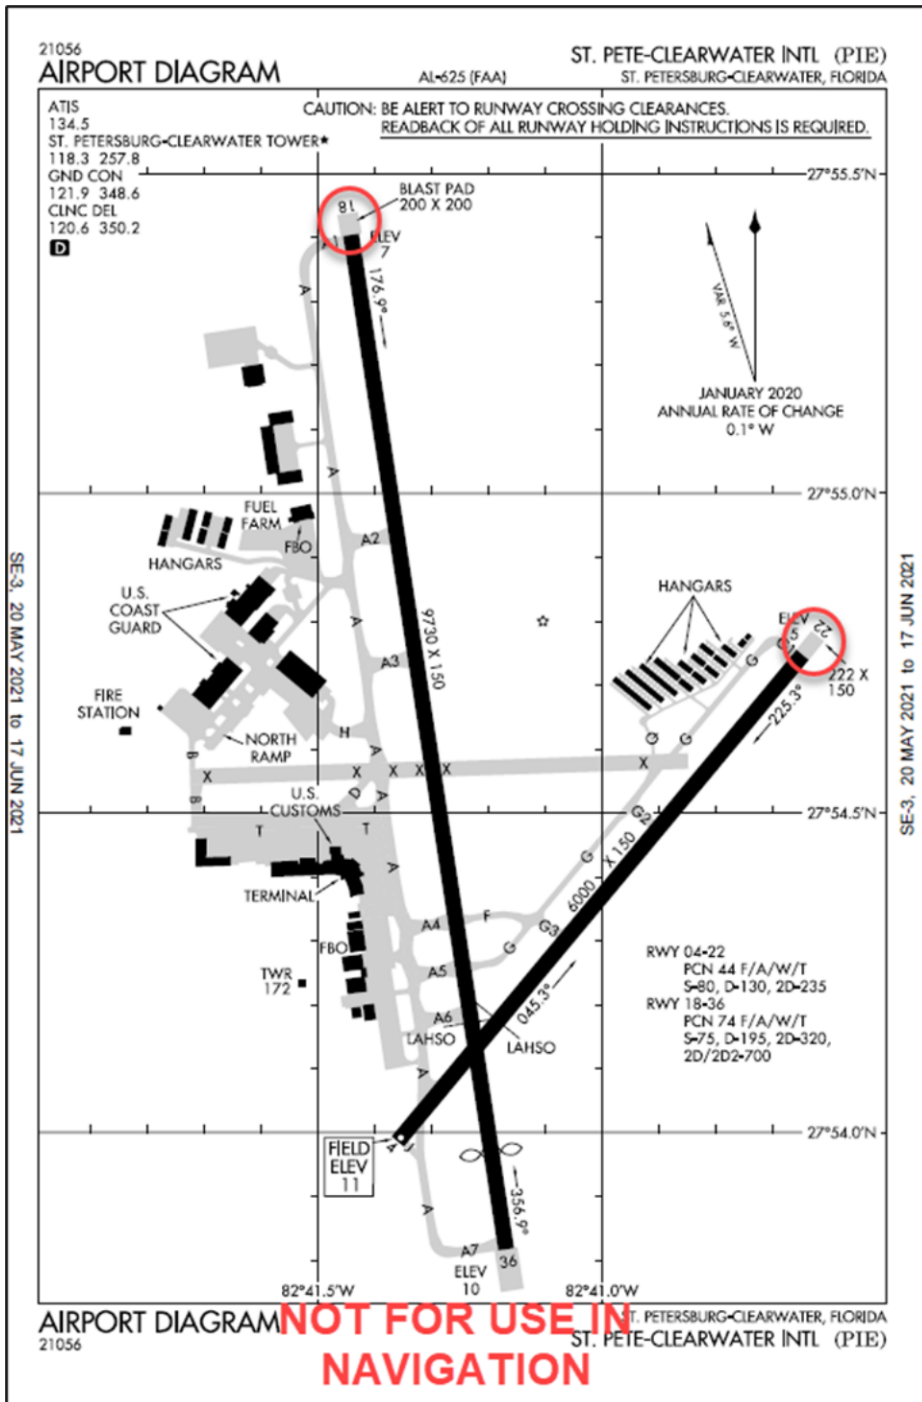
Figure 1 is the PIE airport diagram and shows the locations of runway 22 and runway 18 circled in red.

Figure 1. PIE airport diagram showing locations of runway 18 and runway 22.

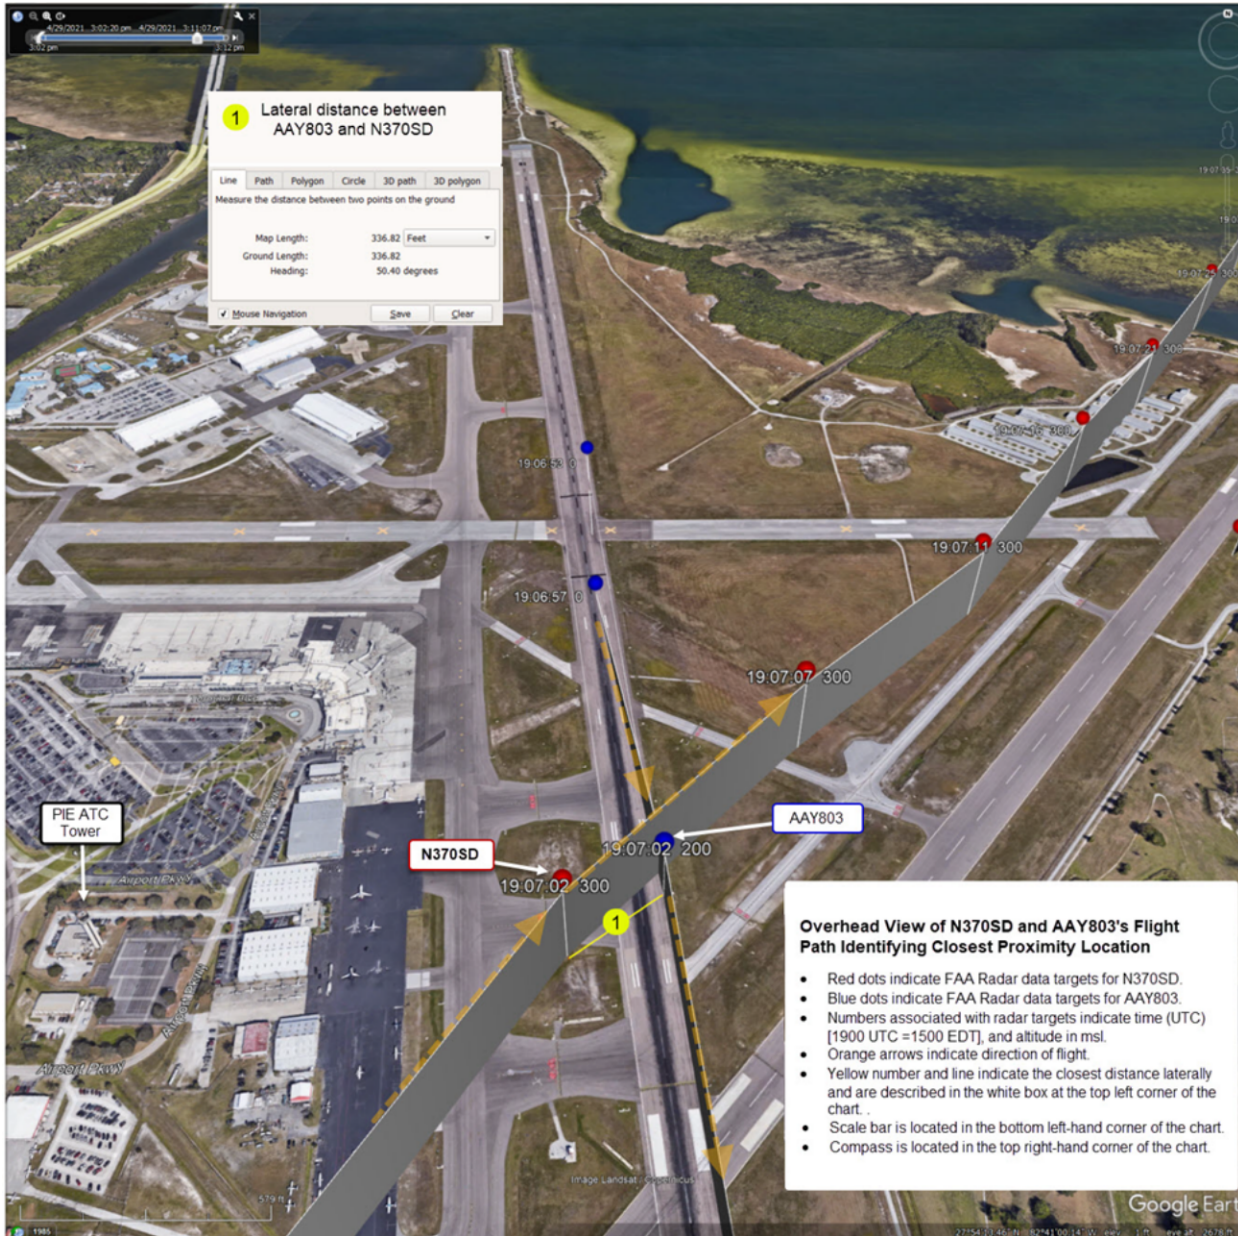
FAA radar data showed that at 1507:02 N370SD was on a right downwind for runway 22, at an altitude of 300 feet and a lateral distance of about 800 feet from the centerline of runway 22, when it overflew runway 18. At the same time AAY803 was at 200 feet departing runway 18. The closest proximity was 100 feet vertically and 369 feet laterally.

Figure 2 is satellite imagery overlaid with FAA radar data showing the closest proximity between N370SD and AAY803. The figure provides a close-up overhead view of the location. A legend of pertinent information is located in the bottom right corner of this figure.

Figure 2. FAA Radar data overlaid on satellite imagery illustrating the flights routes of N370SD and AAY803, and the location of the closest proximity to each other.

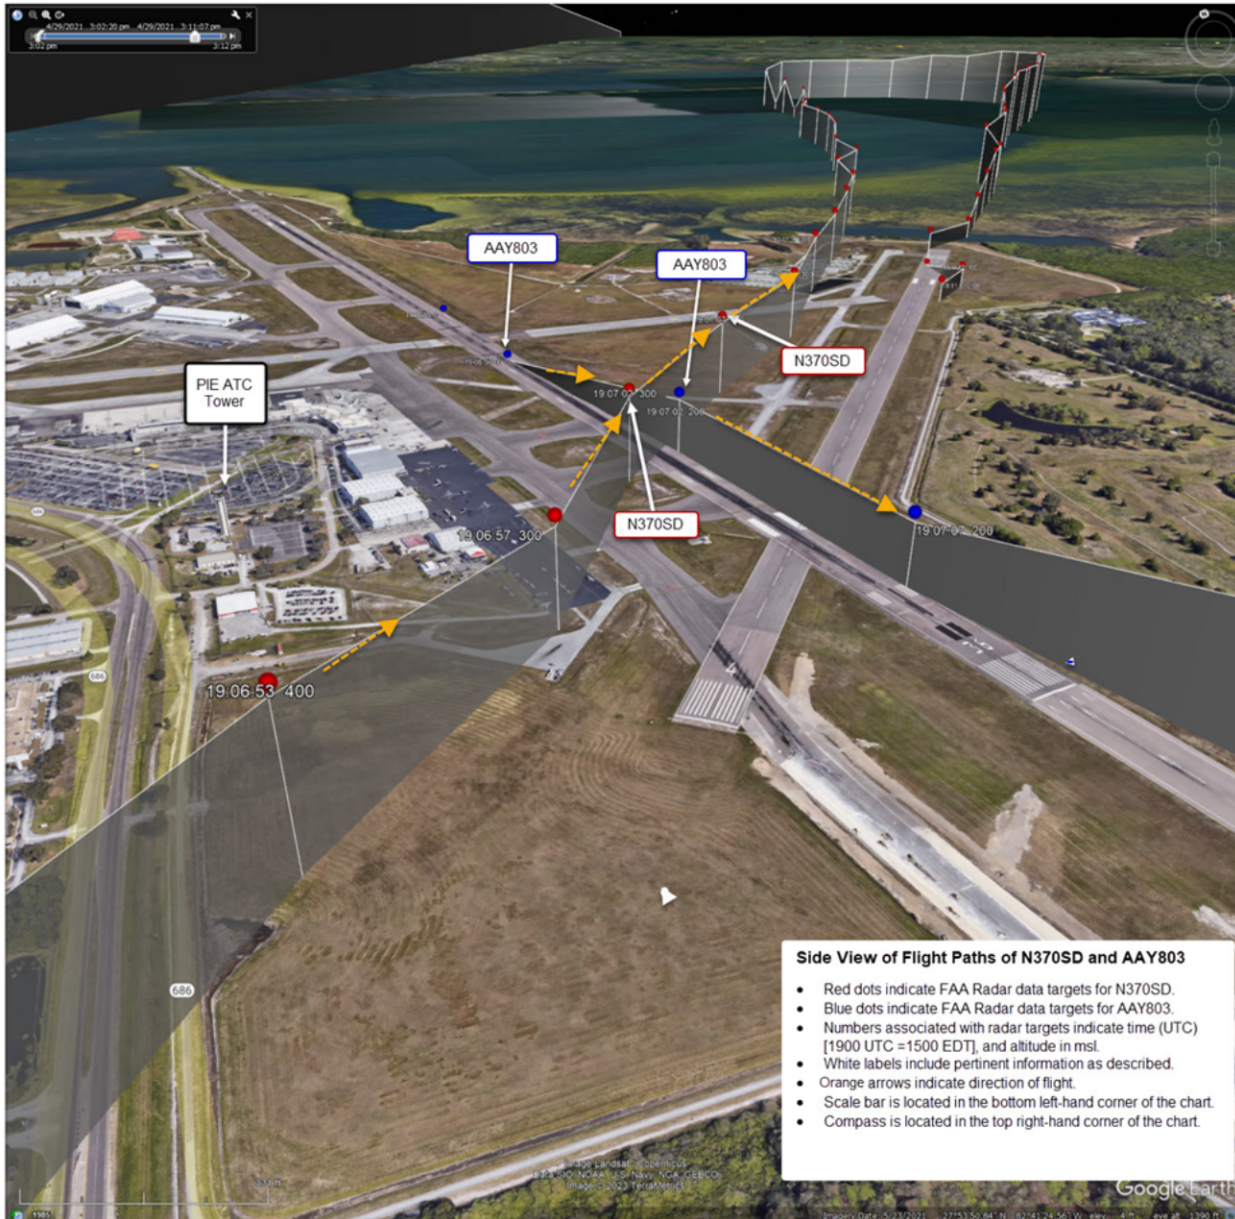
Figure 3 is satellite imagery overlaid with FAA radar data illustrating flight paths of N370SD and AAY803 from a side view. A legend of pertinent information is located in the bottom right corner of this figure.

Figure 3. FAA Radar data overlaid satellite imagery illustrating the flight paths of N370SD and AAY803, from a side view perspective.
