Aviation Investigation Final Report

Location:	Merrill, Wisconsin	Accident Number:	CEN21LA213
Date & Time:	May 11, 2021, 15:00 Local	Registration:	N793Y
Aircraft:	Beech C23	Aircraft Damage:	Substantial
Defining Event:	Loss of engine power (partial)	Injuries:	2 Minor
Flight Conducted Under:	Part 91: General aviation - Personal

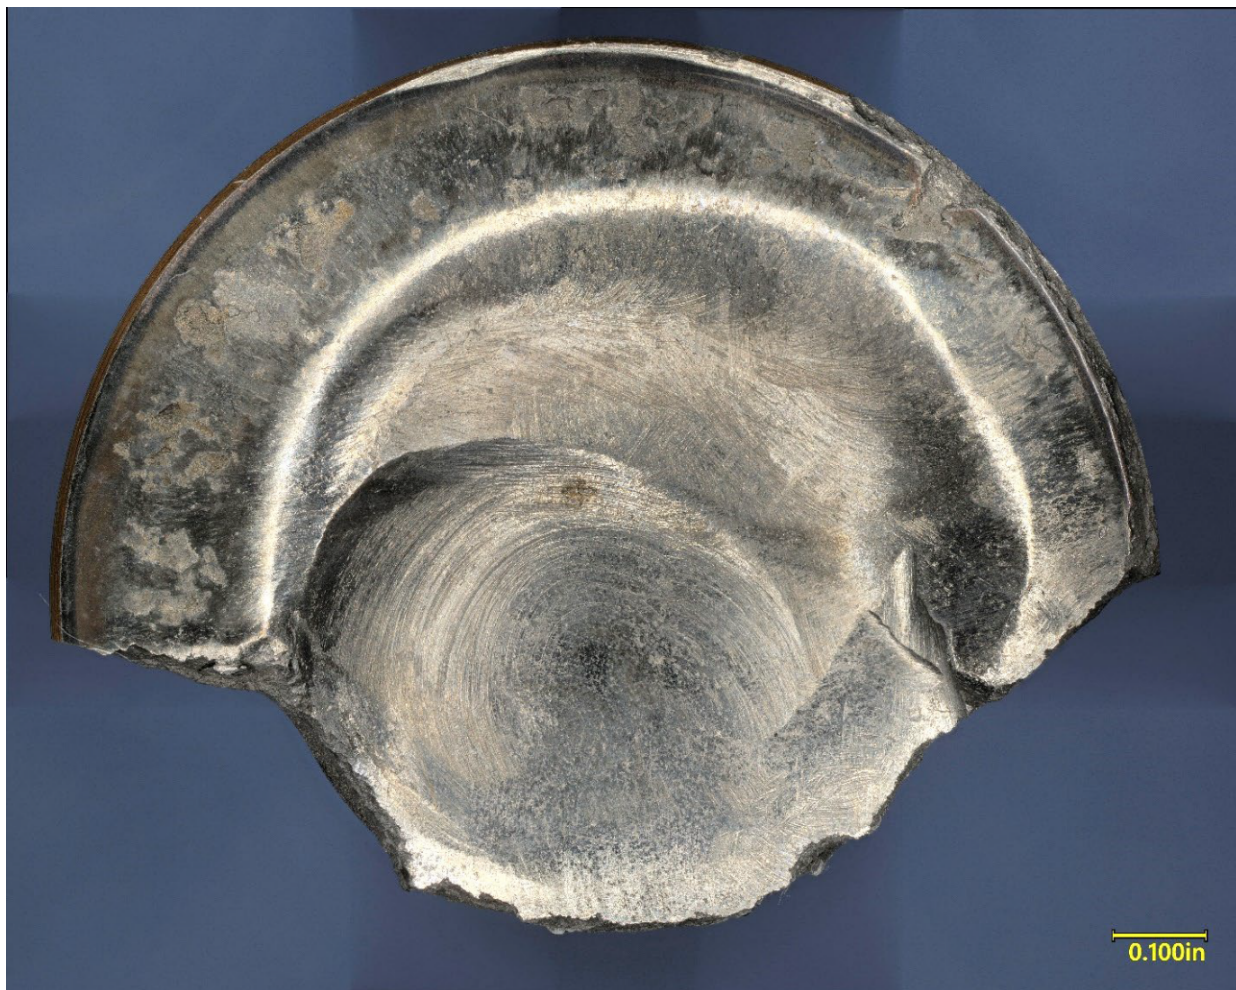
Examination of the tappets by the National Transportation Safety Board Materials Laboratory revealed that the tappets fractured from overstress. The fracture started along the heads facing their corresponding camshaft lobes, which proceeded towards the back surface. While there were no indications of pre-existing cracks, such as from fatigue, there was evidence of pitting and surface wear on many of the tappet head faces that contact the camshaft. Of note was the No. 2 exhaust tappet, the only tappet that underwent wear on the tappet face significant enough to change its geometry.

Figure 1 shows the No. 2 exhaust tappet face, which was reflective and consistent with polishing from repeated contact with the mating camshaft lobe. The depression at the center of the tappet head corresponding to the stem exhibited circular wear marks. The fracture surface on the bottom of the figure was circular, conforming to the geometry of the stem radius. Figure 2 shows the widespread spalling of the remaining surface, demonstrating the degree of material loss on this part.

Figure 1. View of the #2 exhaust tappet head.

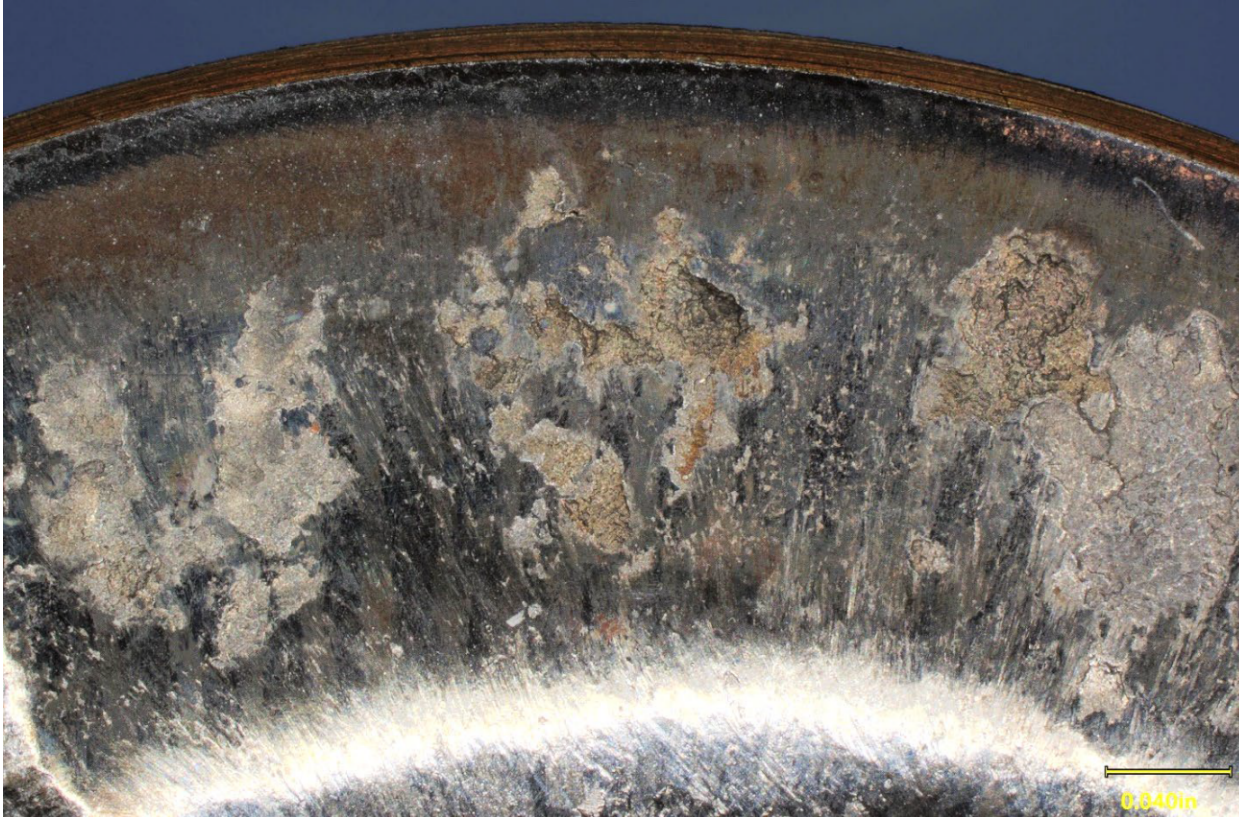
Figure 2. Worn areas of the #2 exhaust tappet head, showing spalling and pitting.
