Aviation Investigation Final Report

Location:	Englewood, Colorado	Accident Number:	CEN21FA215
Date & Time:	May 12, 2021, 10:23 Local	Registration:	N280KL (A1); N416DJ (A2)
Aircraft:	Swearingen SA226TC (A1); CIRRUS DESIGN CORP SR22 (A2)	Aircraft Damage:	Substantial (A1); Substantial (A2)
Defining Event:	Midair collision	Injuries:	1 None (A1); 2 None (A2)
Flight Conducted Under:	Part 91: General aviation - Positioning (A1); Part 91: General aviation - Personal (A2)

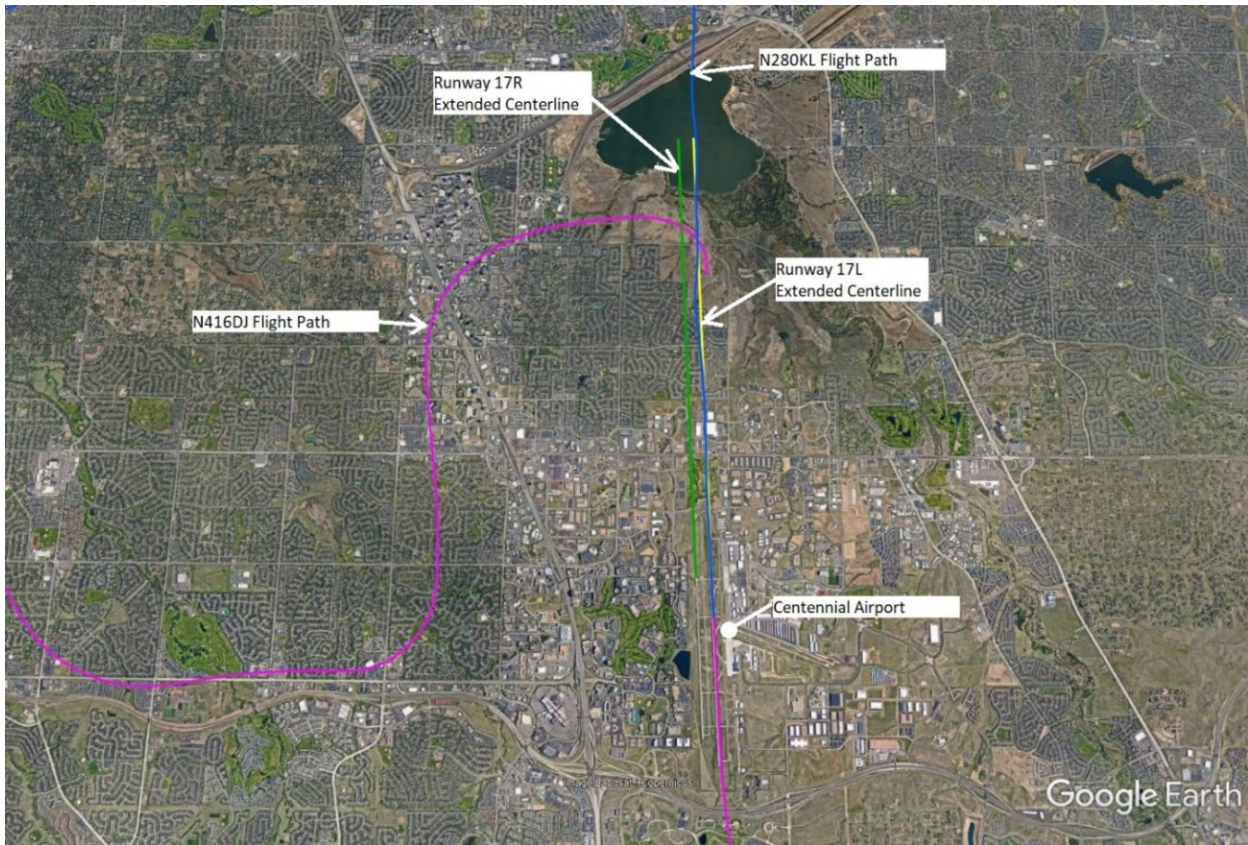
Figure 1 – Plot of ADS-B and RDM flight path information

At the time of the accident, parallel runways 17R and 17L were being utilized for simultaneous operations at APA. Automatic Dependent Surveillance-Broadcast (ADS-B) data was provided by the Federal Aviation Administration (FAA), and data from the on-board Remote Data Module (RDM) was downloaded from the Cirrus. The data showed that the Cirrus departed APA for a local flight about 0921, and the Swearingen departed the Salida Airport (ANK), Salida, Colorado, about 0956. About 1022:43, the Swearingen was about 5.5 nm from APA and had completed a right turn to align with the final approach course to runway 17L. At this same time, the Cirrus was on the downwind leg of the right-hand traffic pattern for runway 17R just before commencing a right turn to the base leg of the traffic pattern.

The Swearingen continued its approach and remained aligned with runway 17L. The Cirrus continued the right-hand traffic pattern through the base leg, and then began to turn toward the final approach course for the runway. The Cirrus continued through the extended centerline for runway 17R, and then continued to the extended centerline for runway 17L where it collided with the Swearingen. The airplanes collided at 1023:52 when they were about 3.2 nm from APA. The Swearingen was aligned with runway 17L while the Cirrus had not completed the turn from base to final and was heading about 146° when the collision occurred.

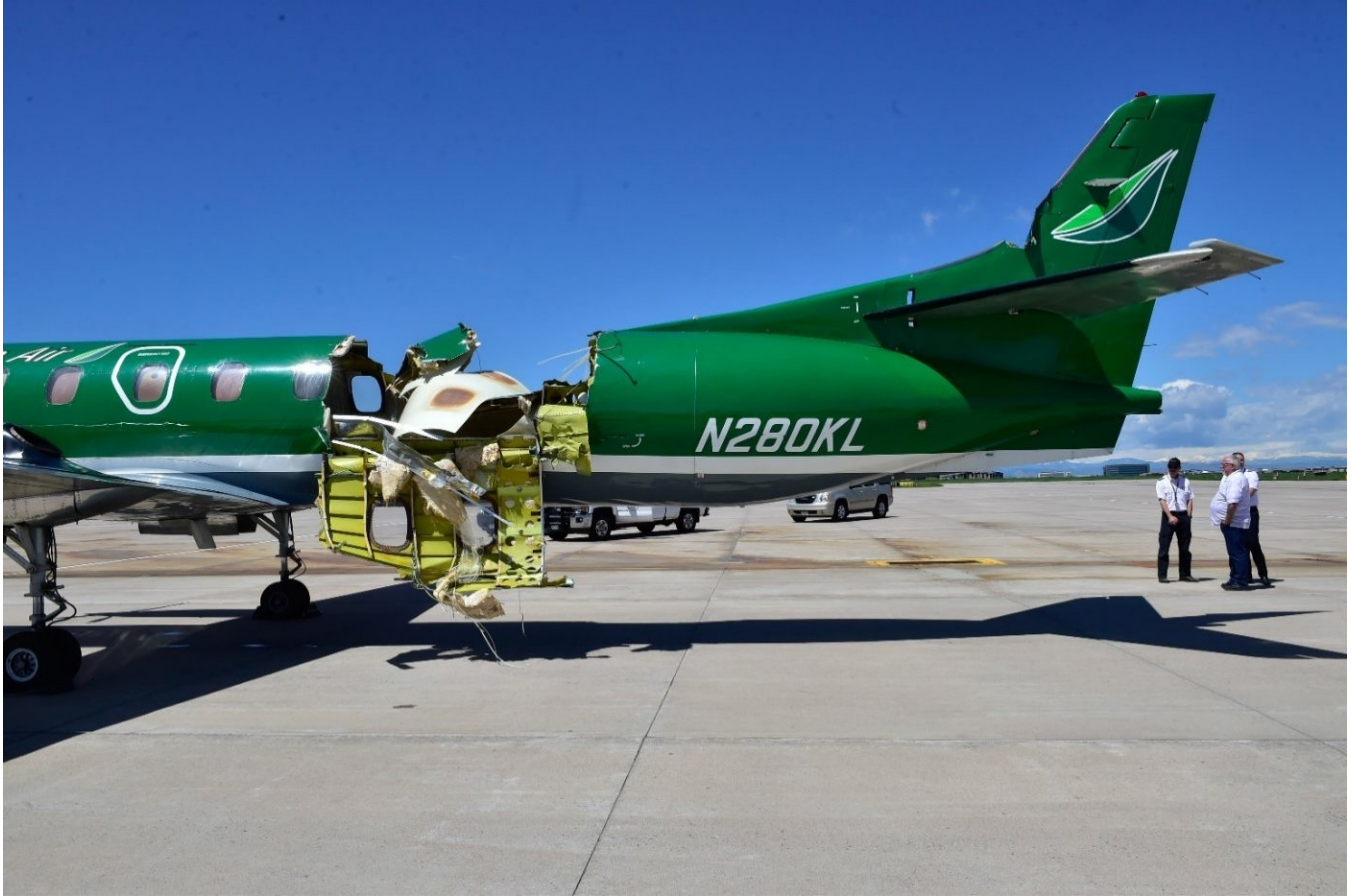
Figure 2 – Photograph of the Swearingen after the accident.

After the impact, the pilot of the Swearingen declared an emergency, continued to APA, and landed successfully on runway 17L. The pilot of the Cirrus reported that the airplane was not controllable after the impact, and he deployed the Cirrus Airframe Parachute System (CAPS). The Cirrus came to rest about 3 nm north of APA. Both airplanes sustained substantial damage (see figures 2 & 3)
