# Aviation Investigation Final Report

<b>Location:</b>	Young Harris, Georgia	<b>Accident Number:</b>	CEN21LA224
<b>Date &amp; Time:</b>	May 6, 2021, 10:45 Local	<b>Registration:</b>	FA3HW43WTF
<b>Aircraft:</b>	DJI Matrice	<b>Aircraft Damage:</b>	Minor
<b>Defining Event:</b>	Miscellaneous/other	<b>Injuries:</b>	1 Serious
<b>Flight Conducted Under:</b>	Part 107: Small UAS

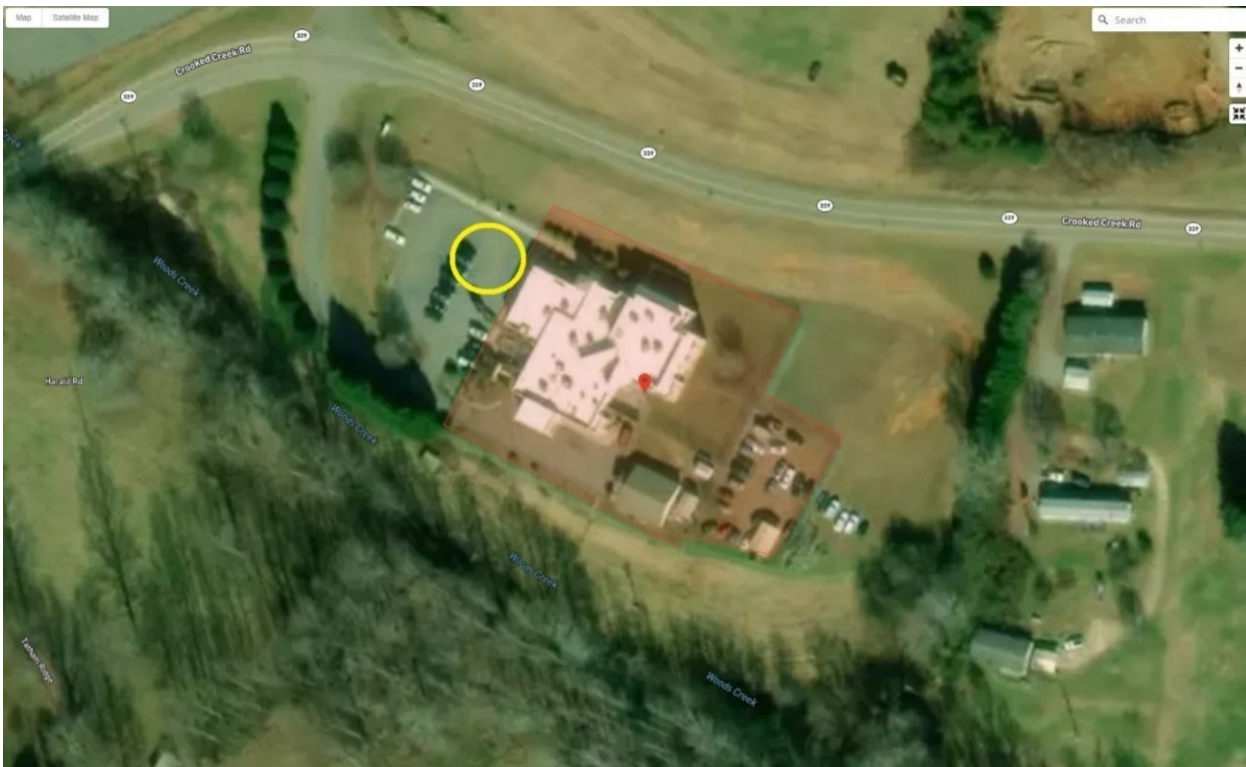
The purpose of the flight was to demonstrate for the local sheriff's office the drone capabilities with a payload of a Zenmuse H20T camera and a Wingsland Z15 spotlight. The flight location was very close to a DJI GEO Zone no-fly zone (NFZ) designated as a "restricted zone."

Figure 1. Restricted Zone in red and approximate accident site denoted with a yellow circle.

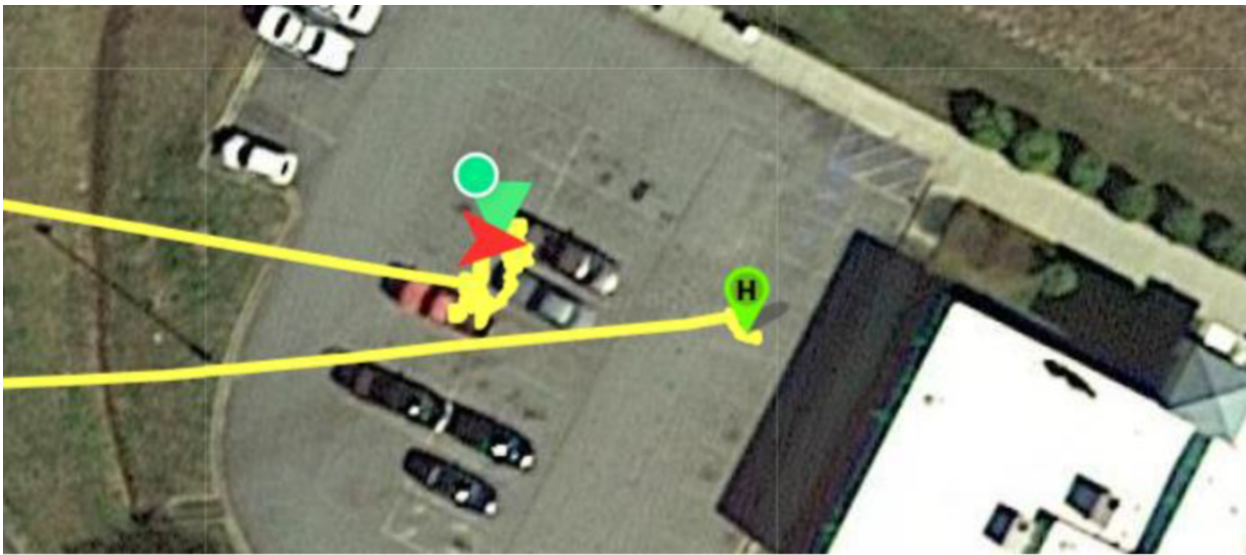
Figure 2. Accident flight path in yellow

The accident flight logs and data were extracted and revealed that the home point was set within the buffer zone of the restricted zone. About 7 minutes after takeoff at 393 ft agl, the RTH function was initiated. The drone returned to 56 ft from the home point and stopped at the boundary of the buffer zone, when the DJI app prompted a restricted zone warning and the drone remained in RTH mode. The drone remained about 7 ft agl and would not respond to the RPIC's multiple control inputs since it was still in RTH mode. The logs showed multiple

altitude fluctuations and increased motor thrust, without corresponding control inputs, which indicated an external force was exerted on the drone. On four occasions, the RPIC exited RTH mode then reactivated RTH a few seconds later, and the drone would not respond to manual control inputs with RTH mode active. The battery level reached 9% and a battery installation error was prompted. The battery level reached 7%, and a critically low battery auto landing was initiated. The drone did not maintain altitude despite increased motor thrust, which indicated an external force was again exerted on the drone.
