# Aviation Investigation Final Report

<b>Location:</b>	Myrtle Beach, South Carolina	<b>Accident Number:</b>	ERA21FA224
<b>Date &amp; Time:</b>	May 21, 2021, 18:14 Local	<b>Registration:</b>	N575BC
<b>Aircraft:</b>	Piper PA-31P	<b>Aircraft Damage:</b>	Destroyed
<b>Defining Event:</b>	Aircraft maintenance event	<b>Injuries:</b>	1 Fatal
<b>Flight Conducted Under:</b>	Part 91: General aviation - Personal

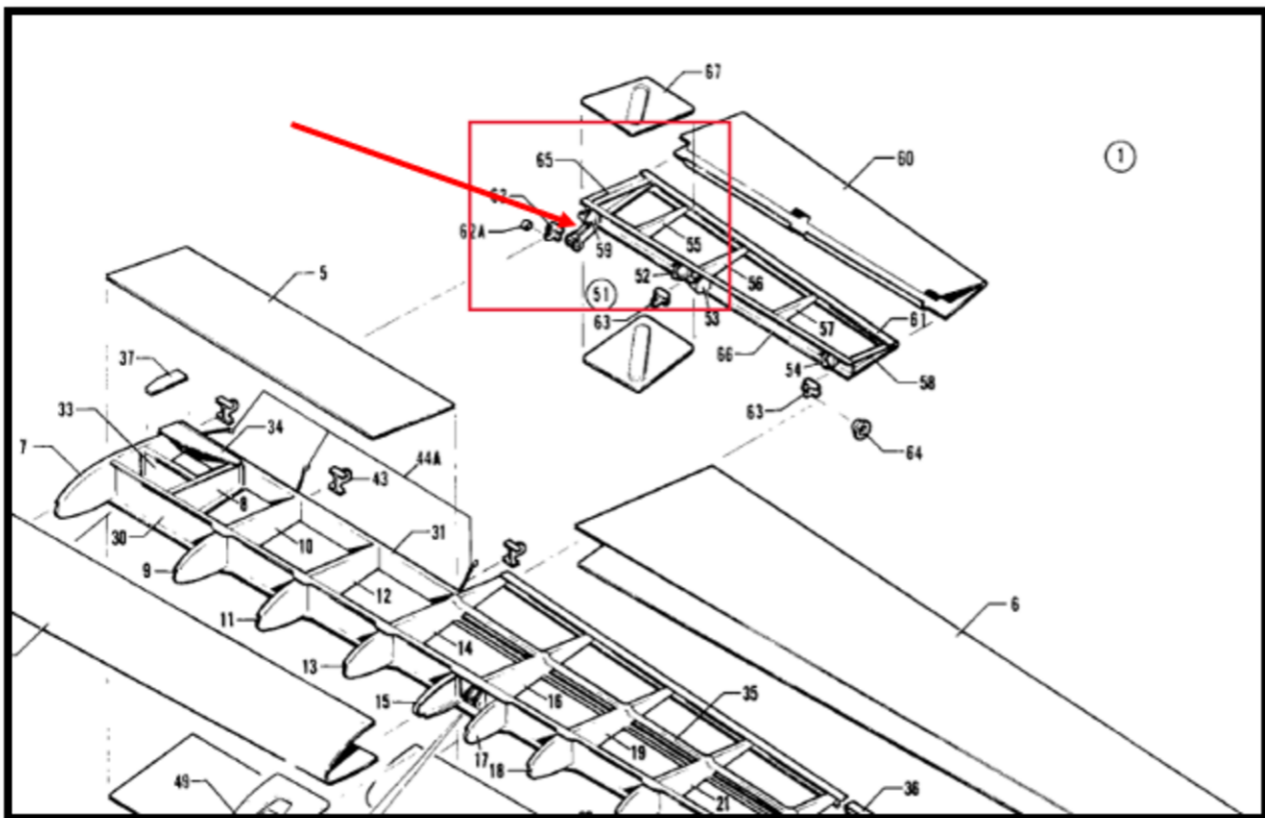
The maintenance facility also maintained a different version of the accident airplane, which was designed with the elevator trim tab control rod and control horn positioned on the bottom of the trim tab. It is possible that the mechanic may have thought the trim tab installation on the accident airplane was the same, which could explain why the mechanic inadvertently installed the elevator trim tabs in reverse. Although the illustrated parts catalog (IPC) warned in the introduction section that the IPC should not be used for rigging and installation purposes, a figure on a subsequent page of the IPC incorrectly depicted the elevator trim tab control horn positioned on the bottom side of the elevator trim tab. Had the mechanic referred to this figure, it may have contributed to the incorrect installation of the trim tabs.

According to the Piper PA-31P illustrated parts catalog, the Elevator Assembly figure incorrectly depicted the control horn on the bottom of the trim tab. (see Figure 1.) The illustrated parts catalog also noted in the Introduction section that, "UNDER NO CIRCUMSTANCES SHALL THIS CATALOG BE USED FOR RIGGING AND INSTALLATION PURPOSES."

Figure 1. Excerpt from Illustrated Parts Catalog showing the control horn located on the bottom side of the elevator trim tab.

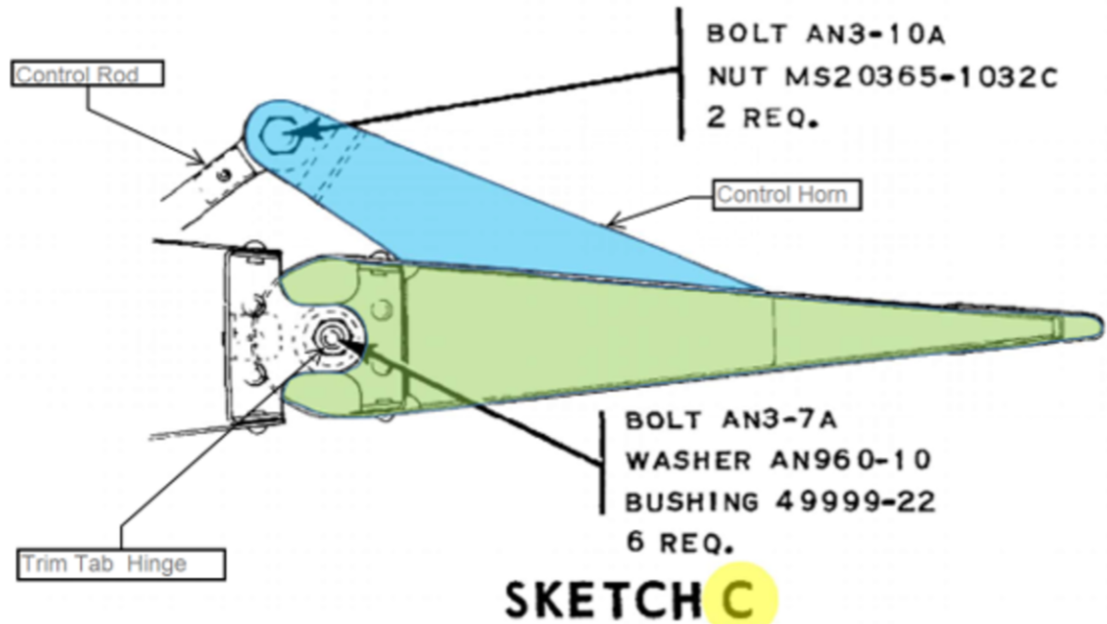
Further examination of the elevator trim tabs revealed that both were installed upside-down and reversed (the left tab was installed on the right elevator and the right tab on the left elevator). As a result, the control horns on both trim tabs and their respective control rods, which should have been located on the top side of the trim tabs above the tab's hinge line, were instead located on the bottom side of the tabs below the tab's hinge line. This installation resulted in a reversal of the direction of the trim tabs' movements; a command of nose-up trim from the cockpit controls would incorrectly move the trim tabs in the nose-down direction, and vice versa.

According to the Piper PA-31P maintenance manual, the elevator and elevator trim control figures correctly depicted that the control rod attached to the control horn as located on the top of the elevator trim tab. The instructions to install the elevator trim tab indicated to, "refer to figure 4-5." Figure 2 is an excerpt from Figure 4-5 in the maintenance manual.

Figure 2. Excerpt from Airplane Maintenance Manual showing the trim tab hinge, with the control horn, and control rod located on the top side of the elevator trim tab.
