# Aviation Investigation Final Report

| <b>Location:</b> | Crossville, Tennessee | <b>Accident Number:</b> | ERA21FA232 |
| <b>Date &amp; Time:</b> | May 25, 2021, 07:30 Local | <b>Registration:</b> | N26889 |
| <b>Aircraft:</b> | GULFSTREAM AMERICAN CORP<br>AA-5A | <b>Aircraft Damage:</b> | Destroyed |

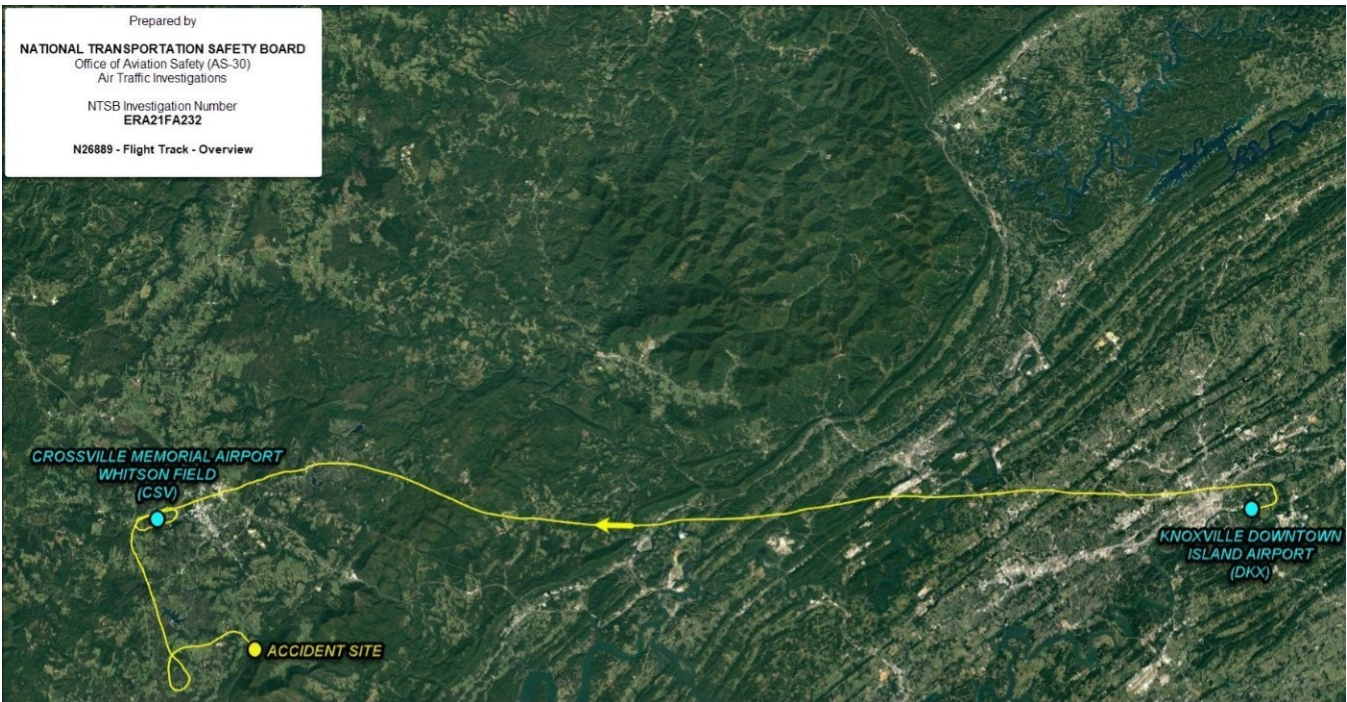
Figure 1. – Overview of Accident Flight

Track data obtained from the Federal Aviation Administration (FAA), an interview with the pilot’s flight instructor, and telephone records revealed that the airplane departed Crossville Memorial Airport (CSV), Crossville, Tennessee, on the second leg of a cross-country flight about 0715. The next planned stop was Cleveland Regional Jetport (RZR), Cleveland, Tennessee, about 50 miles south of CSV. The airplane climbed on a southerly track to 3,700 ft mean sea level (msl) before beginning a gradual descent about 0718. The airplane continued its descent on its southerly track until about 0723 and 3,000 ft msl, when the airplane entered a 450° descending right turn.

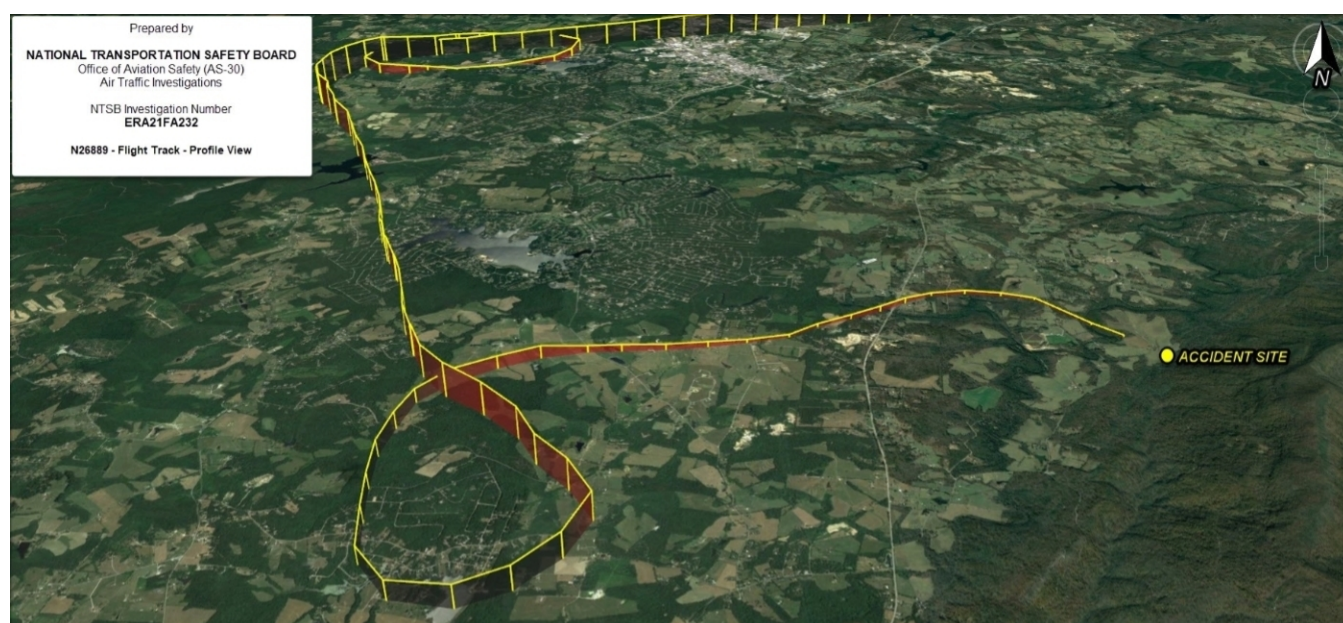
Figure 2. Profile View of Accident Flight

At 0726, about 2,300 ft msl, the pilot placed a phone call to his flight instructor. The instructor stated that the pilot reported that the engine was not making full power, producing about 1,700 rpm versus the normal cruise power setting of about 2,400 rpm. The instructor stated that the pilot remained calm during the conversation, and he assisted with troubleshooting, including asking about the fuel state, magneto switch position, and carburetor heat position. The pilot thought he was “40 to 50” miles from CSV. The instructor told him to land at the nearest airport, but the pilot reported that the airplane had slowed to 70 knots. The instructor then advised the pilot to perform an emergency landing to a field. The pilot reported that there were “trees and mountains.” Shortly thereafter, the instructor heard the sound of an impact and the connection was lost.

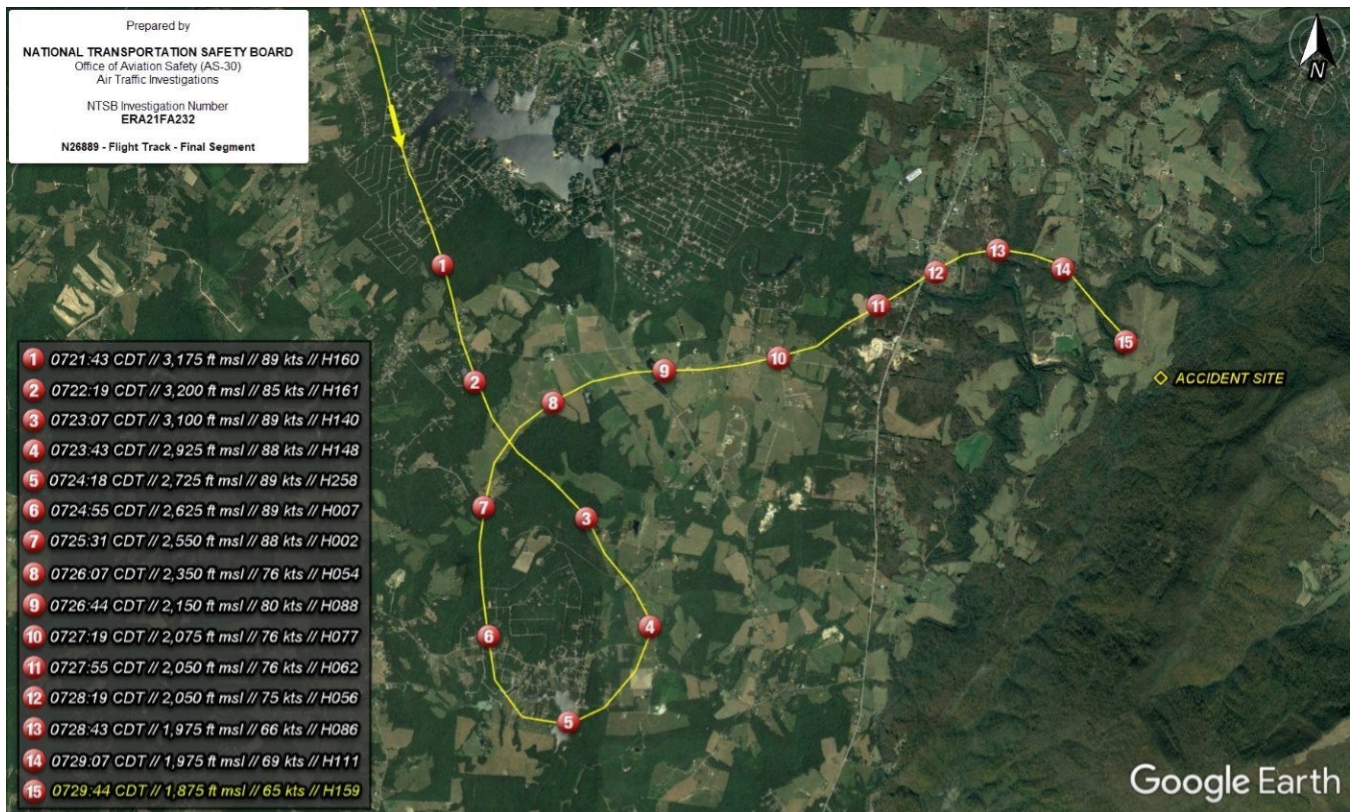
Figure 3. View of Flight Track Final Segment

The airplane completed its course reversal about 8 miles south of CSV and traversed a large cultivated field before impacting rising terrain on a heavily wooded ridgeline.
