# Aviation Investigation Final Report

<b>Location:</b>	McDermott, Ohio	<b>Accident Number:</b>	CEN21FA238
<b>Date &amp; Time:</b>	May 28, 2021, 10:48 Local	<b>Registration:</b>	N515DL
<b>Aircraft:</b>	Lancair Evolution	<b>Aircraft Damage:</b>	Destroyed
<b>Defining Event:</b>	Loss of control in flight	<b>Injuries:</b>	2 Fatal
<b>Flight Conducted Under:</b>	Part 91: General aviation - Personal

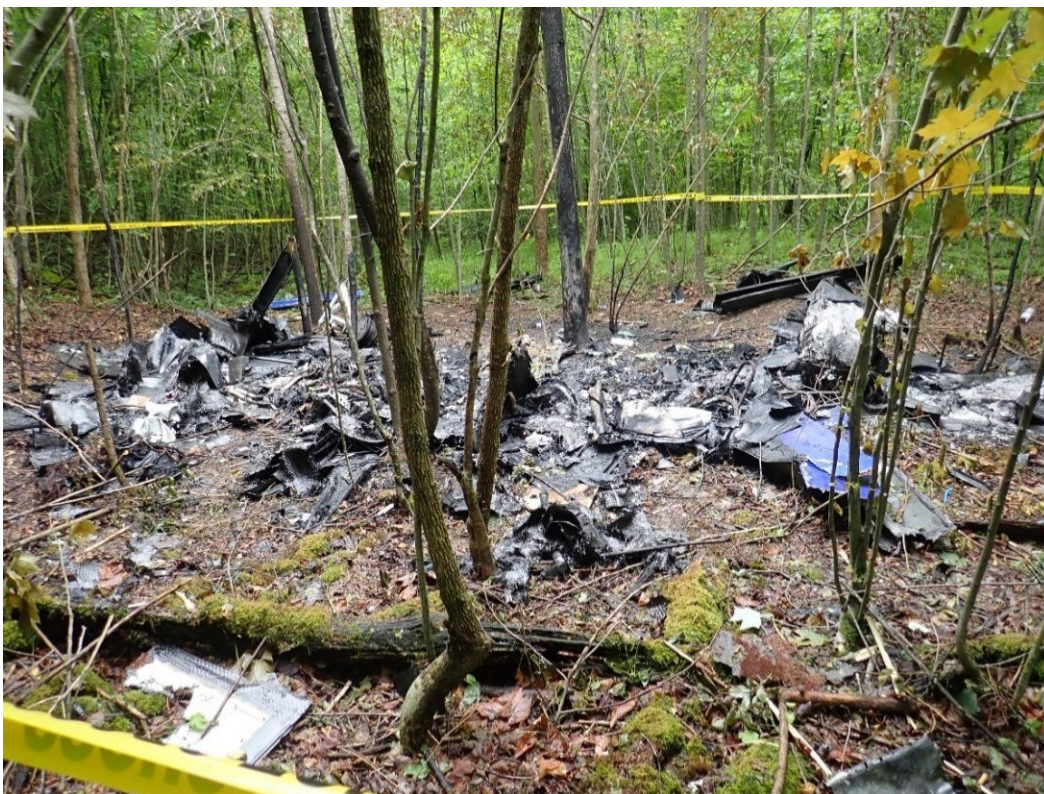
Photo 1 - Accident Site

The airplane descended at a nearly vertical angle and impacted a wooded area. The wreckage was significantly fire damaged (reference Photo 1).
