# Aviation Investigation Final Report

<b>Location:</b>	San Angelo, Texas	<b>Accident Number:</b>	CEN21LA243
<b>Date &amp; Time:</b>	May 27, 2021, 18:25 Local	<b>Registration:</b>	N274CV
<b>Aircraft:</b>	PHILLIPS RALPH W VANS RV8	<b>Aircraft Damage:</b>	Substantial
<b>Defining Event:</b>	Loss of engine power (total)	<b>Injuries:</b>	1 Serious
<b>Flight Conducted Under:</b>	Part 91: General aviation - Personal

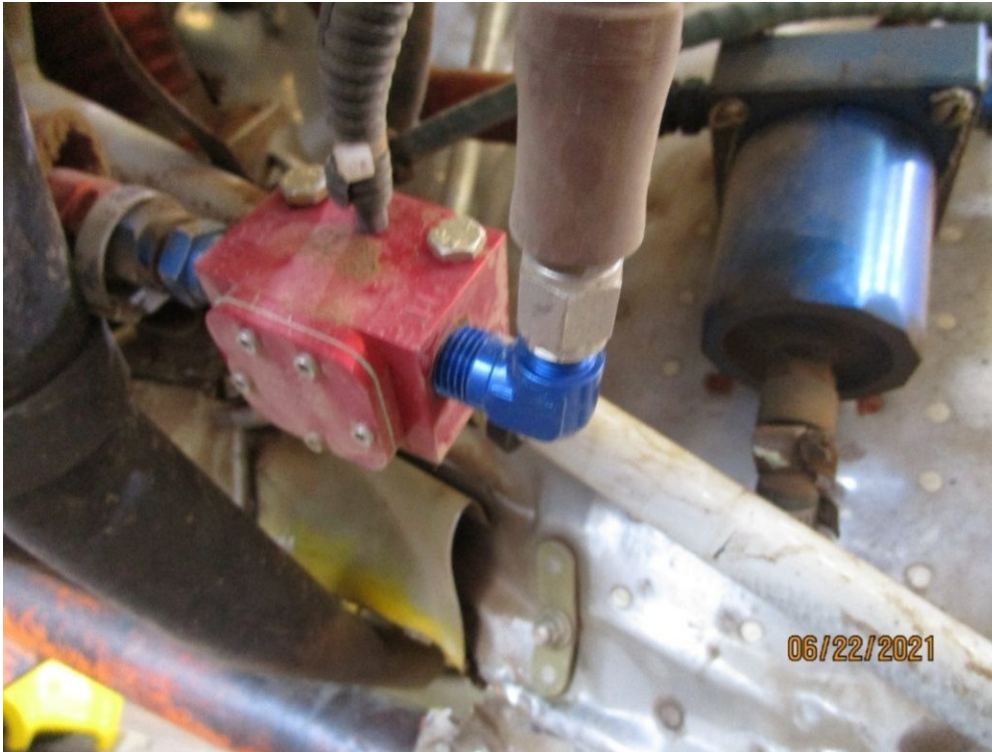
Figure 1: “Red Cube” Fuel Flow Transducer

The installation of the glass panel also added a fuel flow transducer to the fuel line, between the pressure side of the engine driven fuel pump and carburetor. The engine-driven fuel pump outflow fitting had two fittings installed. The 3/8” port was capped off with an AN929 fitting. The other port had a number 4 reduced flow fitting installed in the fuel line leading to the carburetor (through the fuel flow transducer).

The fuel system was equipped with a fuel flow transducer located in the fuel line between the pressure side of the engine-driven fuel pump and carburetor (see figure 1). The addition of the fuel flow transducer was required to provide fuel flow reading on the new panel.

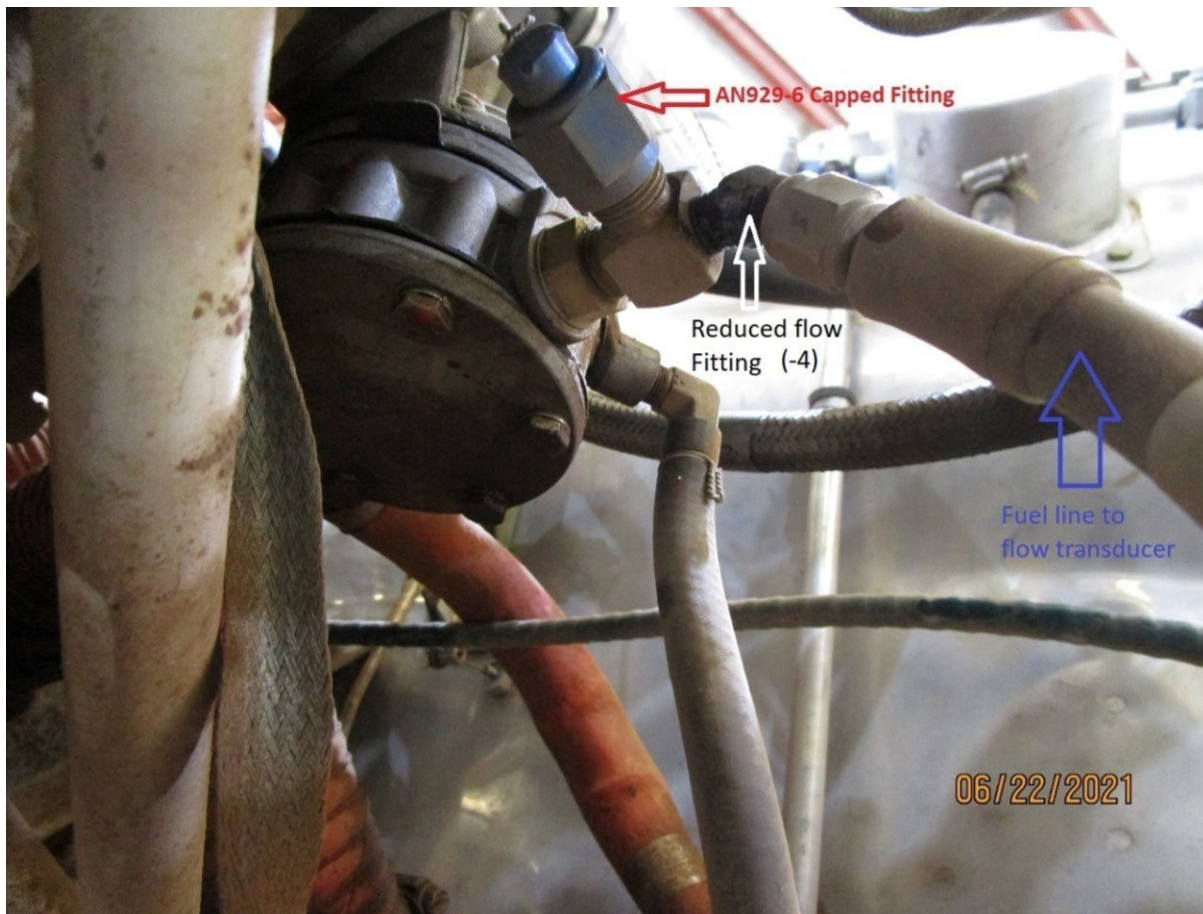
Figure 2: Fuel Line as it exited to the Engine Driven Fuel Pump

The pressure side of the engine driven fuel pump outflow fitting had two fittings installed. The 3/8's port was capped off with an AN929 fitting. The other port had a number 4 fitting installed in the fuel line (which ran to the fuel flow transducer – see figure 2 & 3).

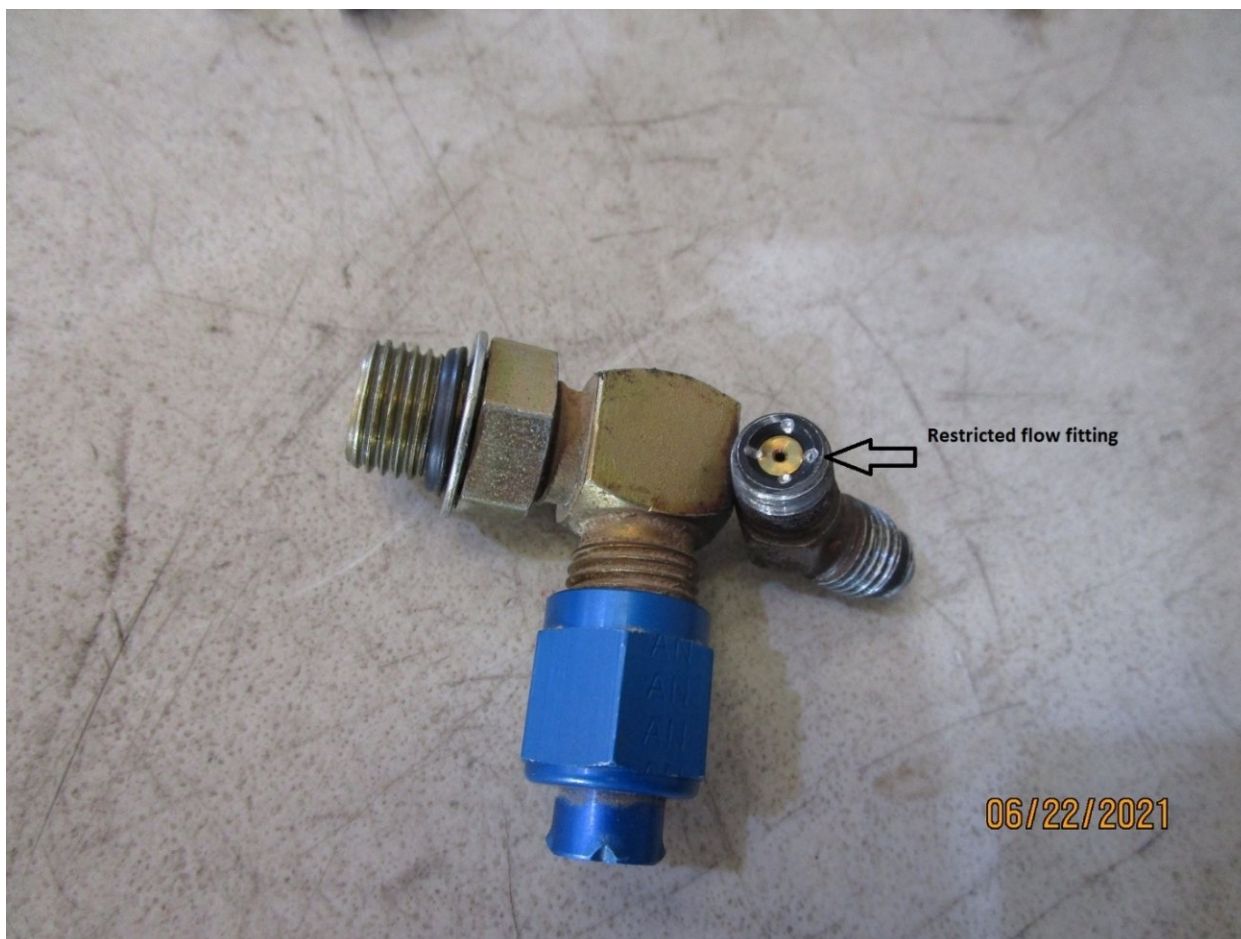
Figure 3: Fuel Pump Fittings

The reduced flow fitting would have prevented sufficient fuel flow to the carburetor once the fuel in the carburetor was consumed. The accident is consistent with the loss of engine power due to fuel starvation.

The loss of engine power due to fuel starvation. Contributing to the accident was the installation of a reduced flow fitting in the fuel line to the carburetor by maintenance personnel.
