Aviation Investigation Final Report

Location:	Truckee, California	Accident Number:	WPR21FA228
Date & Time:	June 15, 2021, 10:45 Local	Registration:	N89423
Aircraft:	CIRRUS DESIGN CORP SR20	Aircraft Damage:	Substantial
Defining Event:	Loss of control in flight	Injuries:	1 Fatal, 1 Serious
Flight Conducted Under:	Part 91: General aviation - Instructional

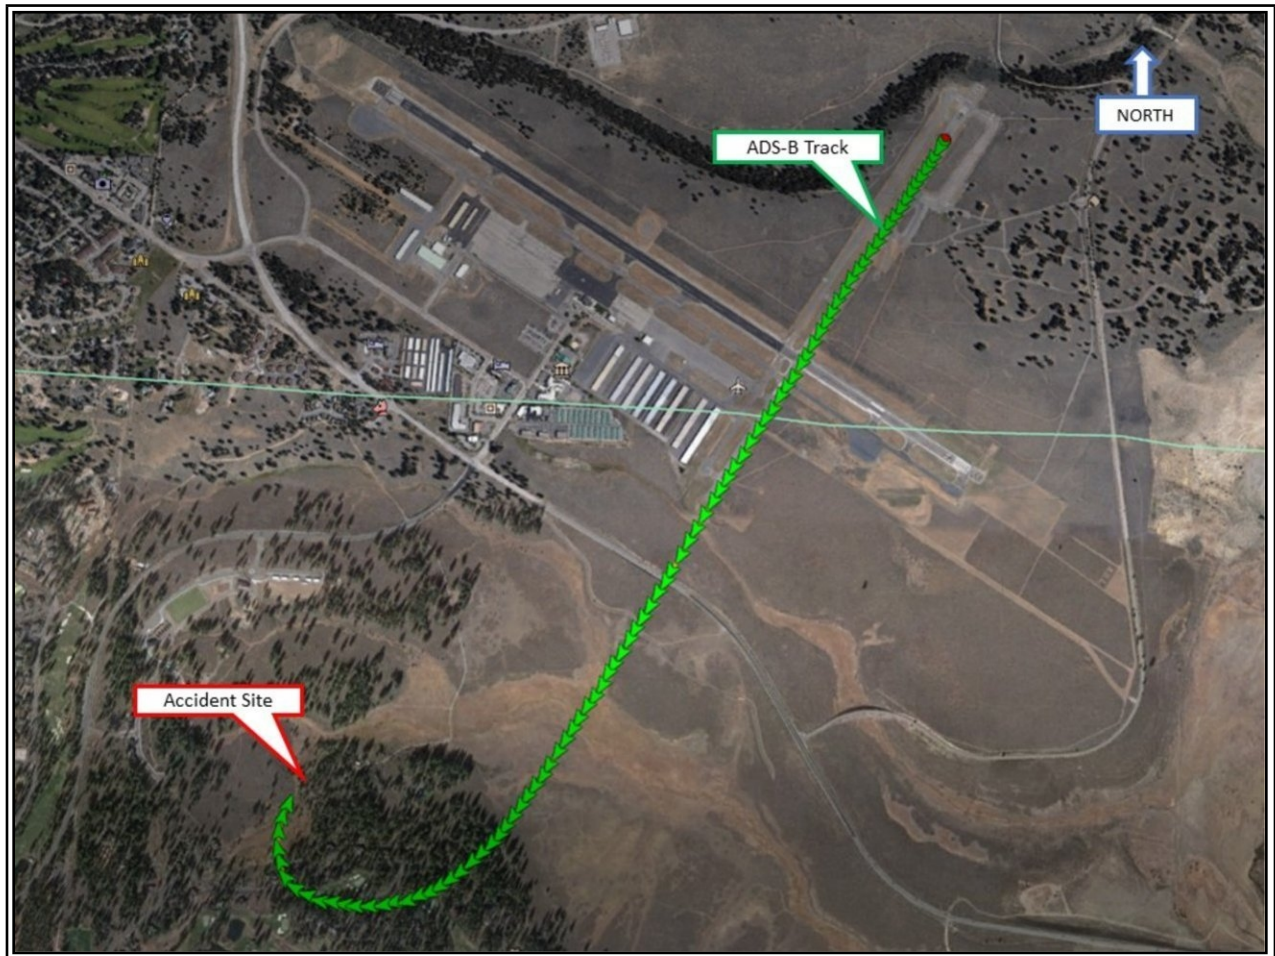
Figure 1. Airplane flight track based on ADS-B data.

Recorded automatic dependent surveillance-broadcast (ADS-B) data provided by the Federal Aviation Administration (FAA) showed that the airplane departed at 1042:49 and that, at 1044:05, it had climbed to an altitude of 6,325 ft and was flying along a southwesterly heading. At 1044:14, the airplane was at an altitude of 6,300 ft and on a northerly heading. The airplane remained on a northerly heading and continued to descend. The last ADS-B data point, at 1044:21, indicated that the airplane was at an altitude of 6,050 ft and was about 116 ft south of the accident site. Figure 1 shows the airplane's flight track.

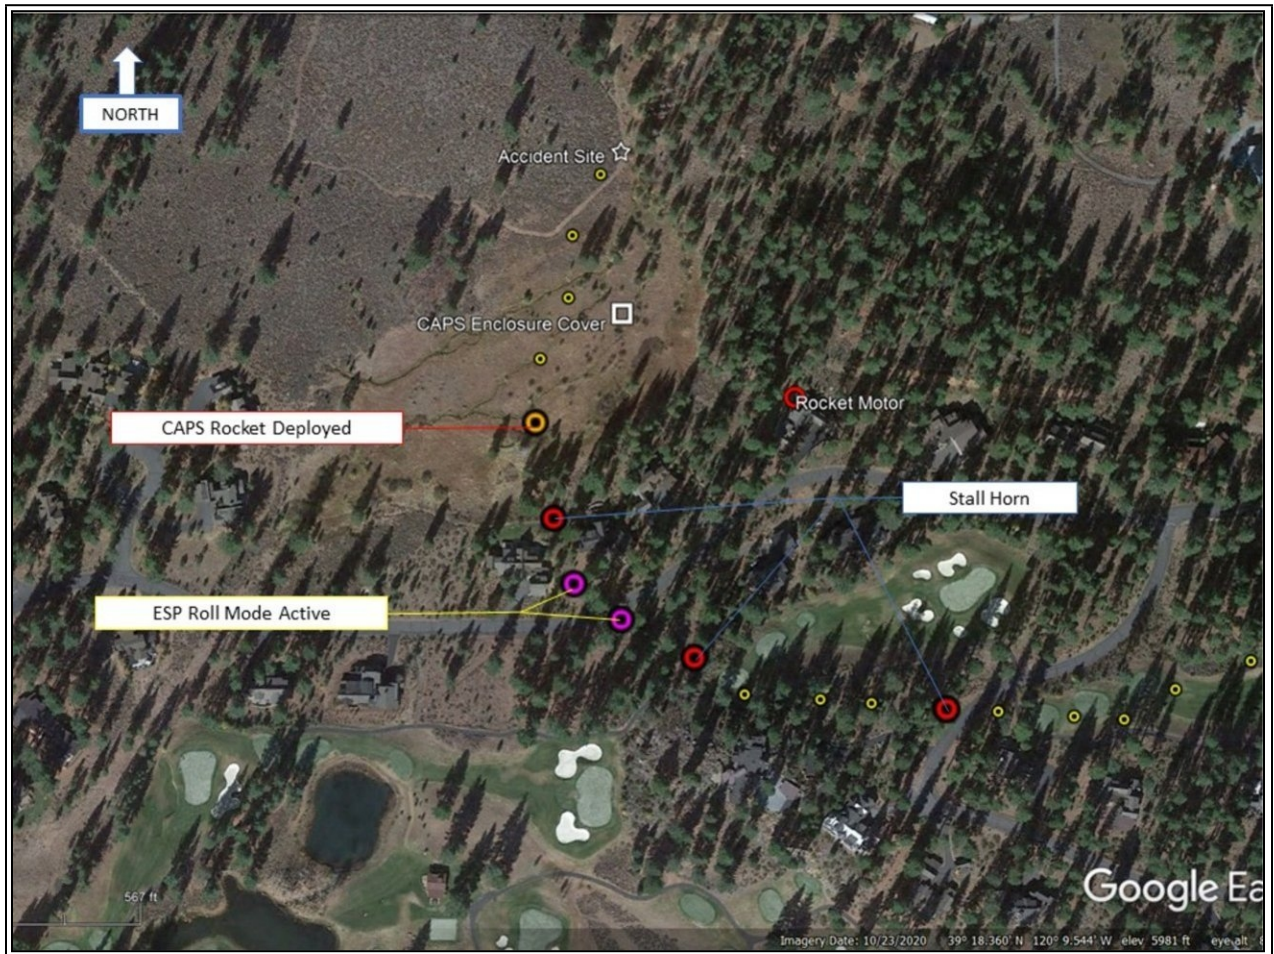
Figure 2. Airplane’s flightpath along with RDM-recorded events.

The airplane's RDM showed that, throughout the flight, the flap switch was at the 50% position. The RDM also showed that the stall warning activated three times: at 1044:09 with an indicated airspeed of 69 knots, a 12° pitch attitude, and an 11° bank; at 1044:13 with an indicated airspeed of 78 knots, a 4° pitch attitude, and a 36° bank; and at 1044:16 with an indicated airspeed of 71 knots, a -16° pitch attitude, and an 81° bank. The ESP system activated in roll mode at 1044:14 and 1044:15 as the airplane entered a steep right roll. The

CAPS activated shortly thereafter, and the recording ended at 1044:21. Figure 2 shows the RDM data overlaid on an image of the area surrounding the accident site.
