# Aviation Investigation Final Report

<b>Location:</b>	San Diego, California	<b>Incident Number:</b>	OPS21LA003
<b>Date &amp; Time:</b>	June 10, 2021, 17:45 Local	<b>Registration:</b>	N8674B (A1); N197SY (A2)
<b>Aircraft:</b>	Boeing 737-8H4 (A1); EMBRAER S A ERJ 170-200 LR (A2)	<b>Aircraft Damage:</b>	None (A1); None (A2)
<b>Defining Event:</b>	Comm system malf/failure	<b>Injuries:</b>	177 None (A1); 77 None (A2)
<b>Flight Conducted Under:</b>	Part 121: Air carrier - Scheduled (A1); Part 121: Air carrier - Scheduled (A2)

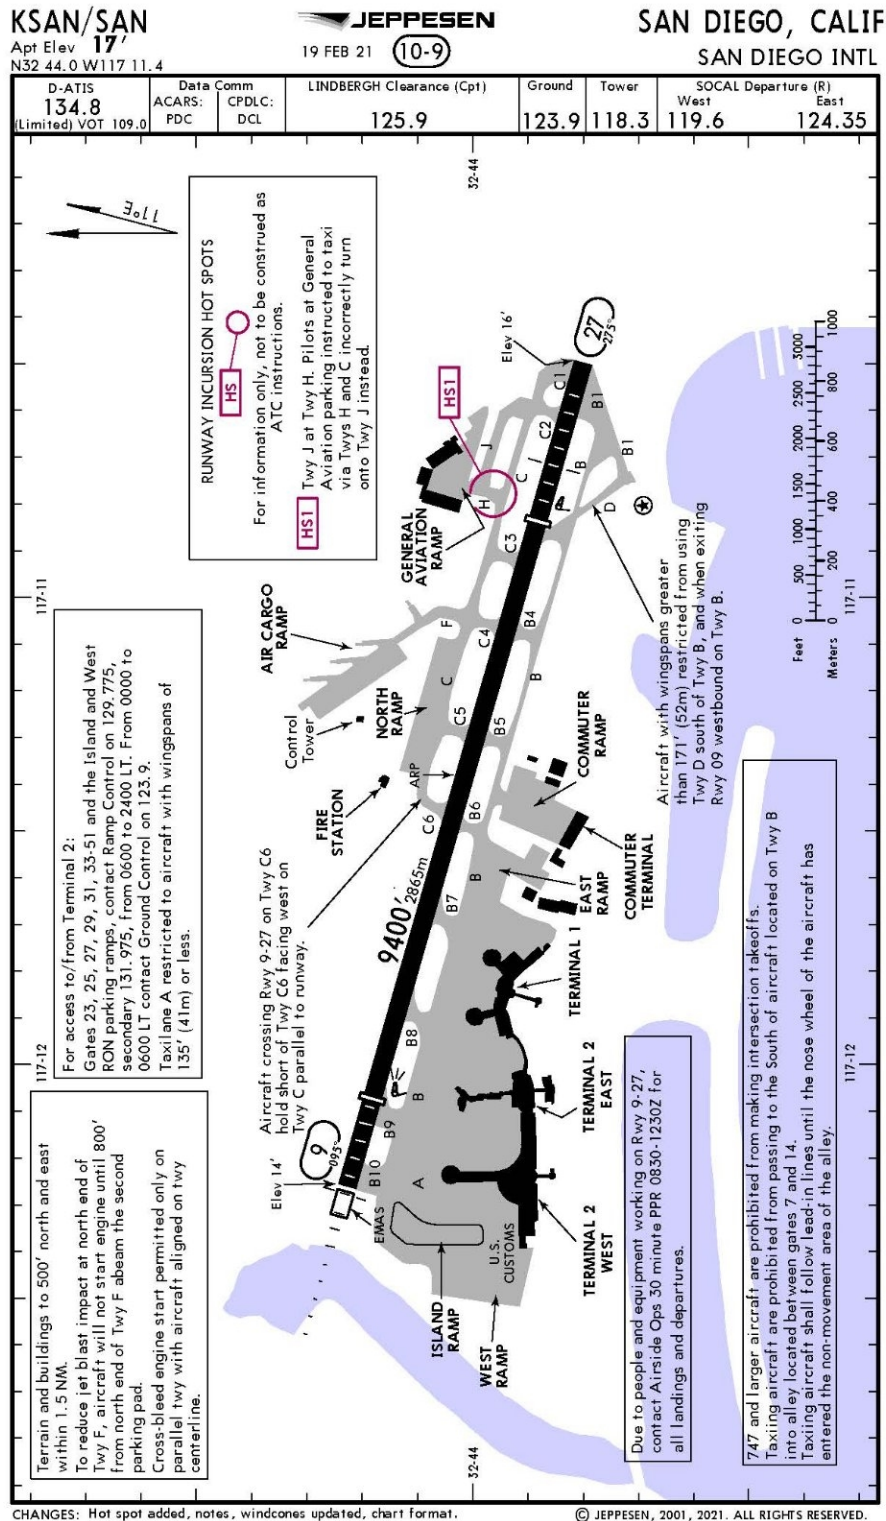
**Figure 3: SAN Airport Diagram (Source: Jeppesen)**

According to the FAA Chart Supplements, runway 9/27 was a 9,401-foot-long and 200-foot-wide, grooved, asphalt, and concrete runway. Runway 27 was equipped with 4-light PAPI system and had 7,591 ft of runway available for landing and 9,401 ft available for takeoff. The runway had an 1,810-foot displaced threshold.
