# Aviation Investigation Final Report

<b>Location:</b>	San Diego, California	<b>Incident Number:</b>	OPS21LA003
<b>Date &amp; Time:</b>	June 10, 2021, 17:45 Local	<b>Registration:</b>	N8674B (A1); N197SY (A2)
<b>Aircraft:</b>	Boeing 737-8H4 (A1); EMBRAER S A ERJ 170-200 LR (A2)	<b>Aircraft Damage:</b>	None (A1); None (A2)
<b>Defining Event:</b>	Comm system malf/failure	<b>Injuries:</b>	177 None (A1); 77 None (A2)
<b>Flight Conducted Under:</b>	Part 121: Air carrier - Scheduled (A1); Part 121: Air carrier - Scheduled (A2)

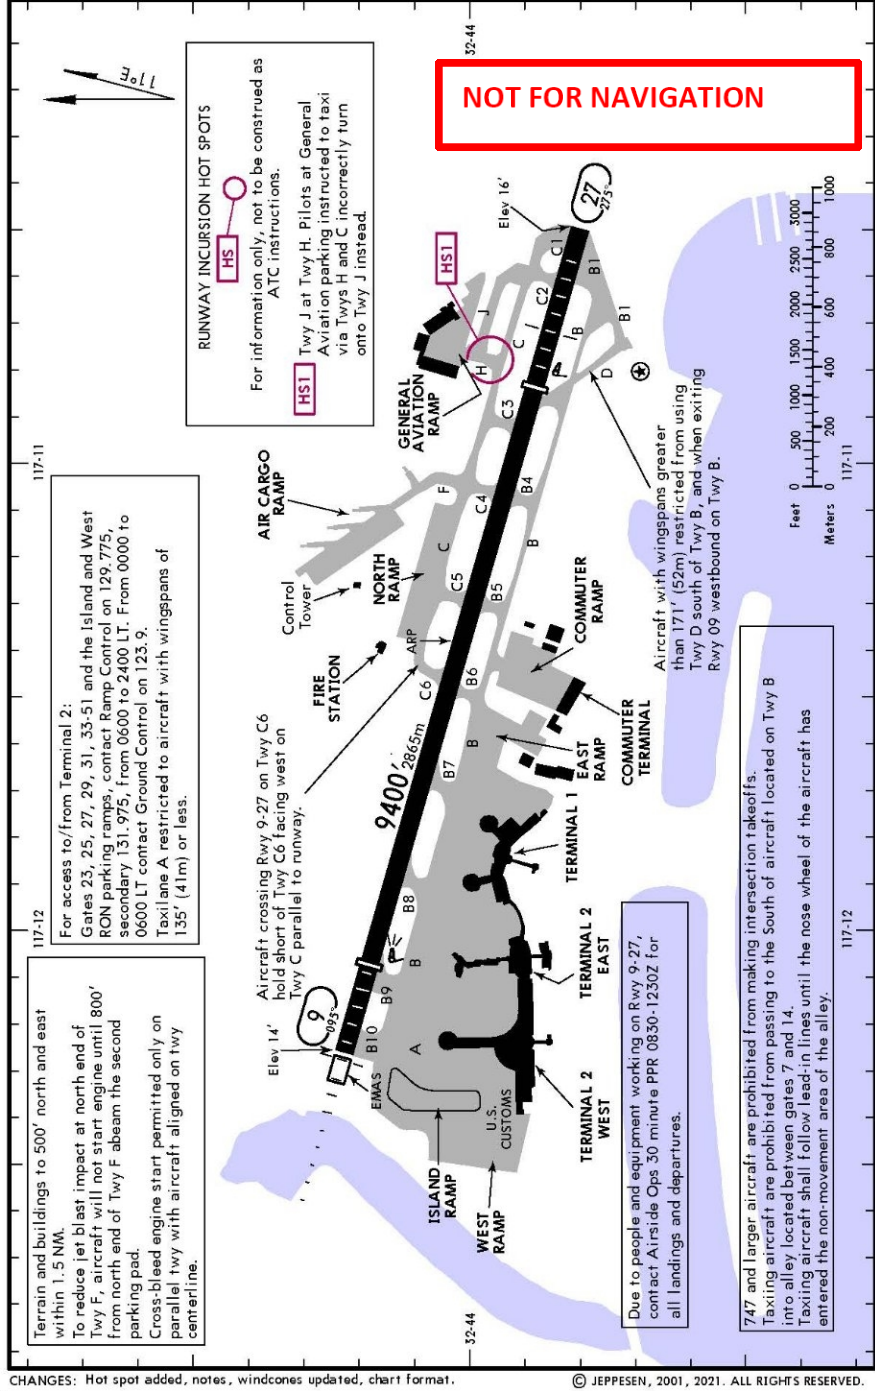
Figure 3: SAN Airport Diagram (Source: Jeppesen)

According to the FAA Chart Supplements, runway 9/27 was a 9,401-foot-long and 200-foot-wide, grooved, asphalt, and concrete runway. Runway 27 was equipped with 4-light PAPI system and had 7,591 ft of runway available for landing and 9,401 ft available for takeoff. The runway had an 1,810-foot displaced threshold.
