# Aviation Investigation Final Report

<b>Location:</b>	Conway, Arkansas	<b>Accident Number:</b>	CEN21FA277
<b>Date &amp; Time:</b>	June 18, 2021, 13:57 Local	<b>Registration:</b>	N62WR
<b>Aircraft:</b>	CIRRUS DESIGN CORP SR20	<b>Aircraft Damage:</b>	Substantial
<b>Defining Event:</b>	Loss of control in flight	<b>Injuries:</b>	1 Fatal
<b>Flight Conducted Under:</b>	Part 91: General aviation - Personal

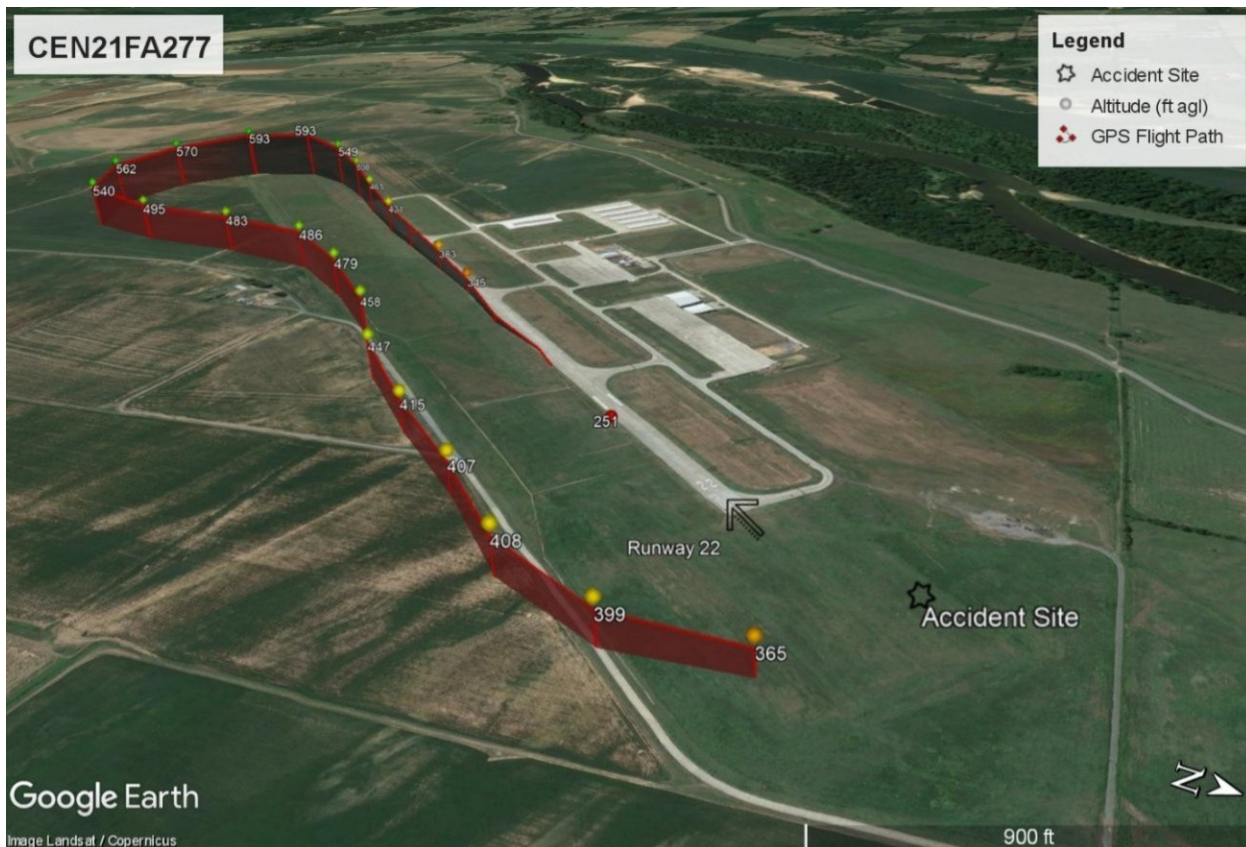
Recovered GPS data from the airplane revealed that the highest altitude achieved on the flight was 593 ft above ground level (agl) when the airplane was on a crosswind leg in the traffic pattern. The airplane then began a continuous descent until impact. The downwind leg was flown about 0.1 nautical mile south of the runway (see figure 1).

Figure 1: Pictorial view of flight path

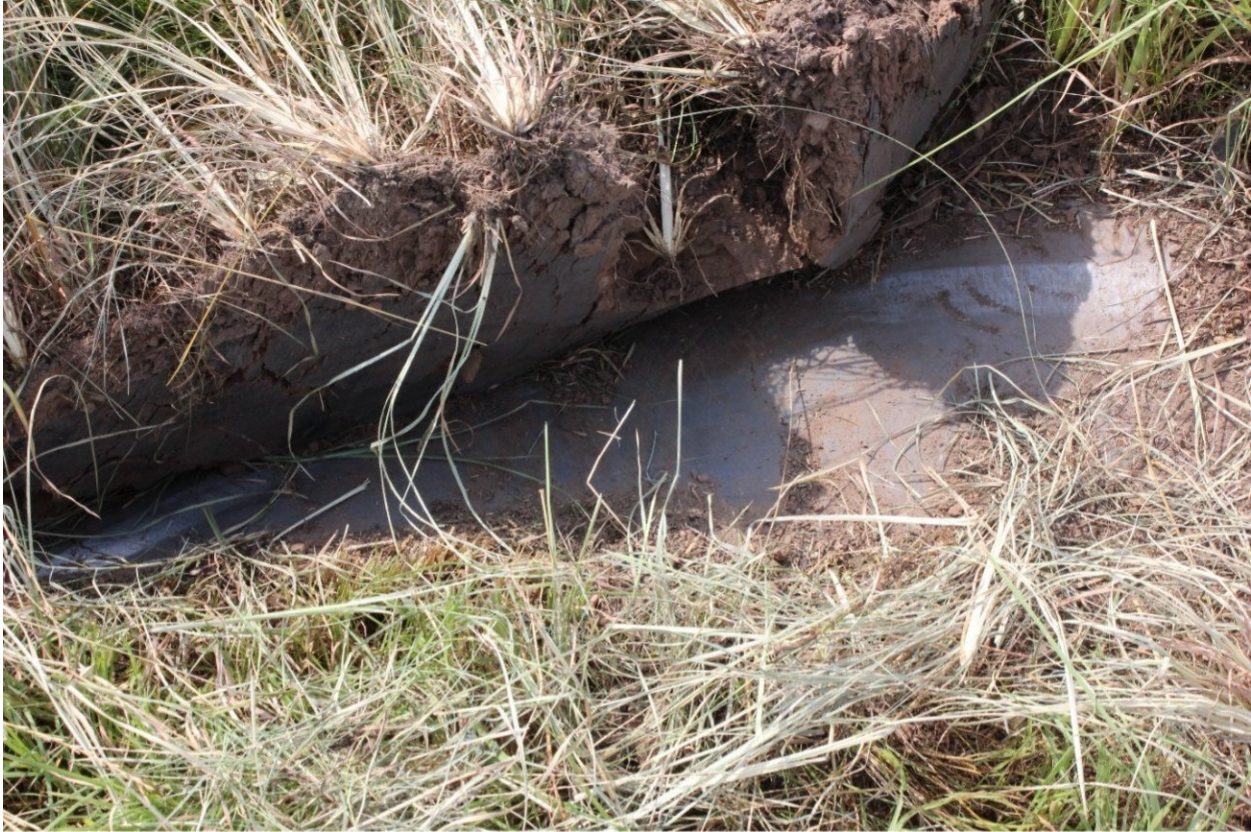
The airplane impacted the ground in a nose-low, inverted attitude. The right wing was fractured, and pieces of the wing were located in the initial ground scar. Propeller slash marks were found in the ground near the initial impact point and contained white paint transfer signatures (see figure 2). The propeller blades were found fractured and separated from the crankshaft flange.

*Figure 2: Propeller slash mark with white paint transfer*

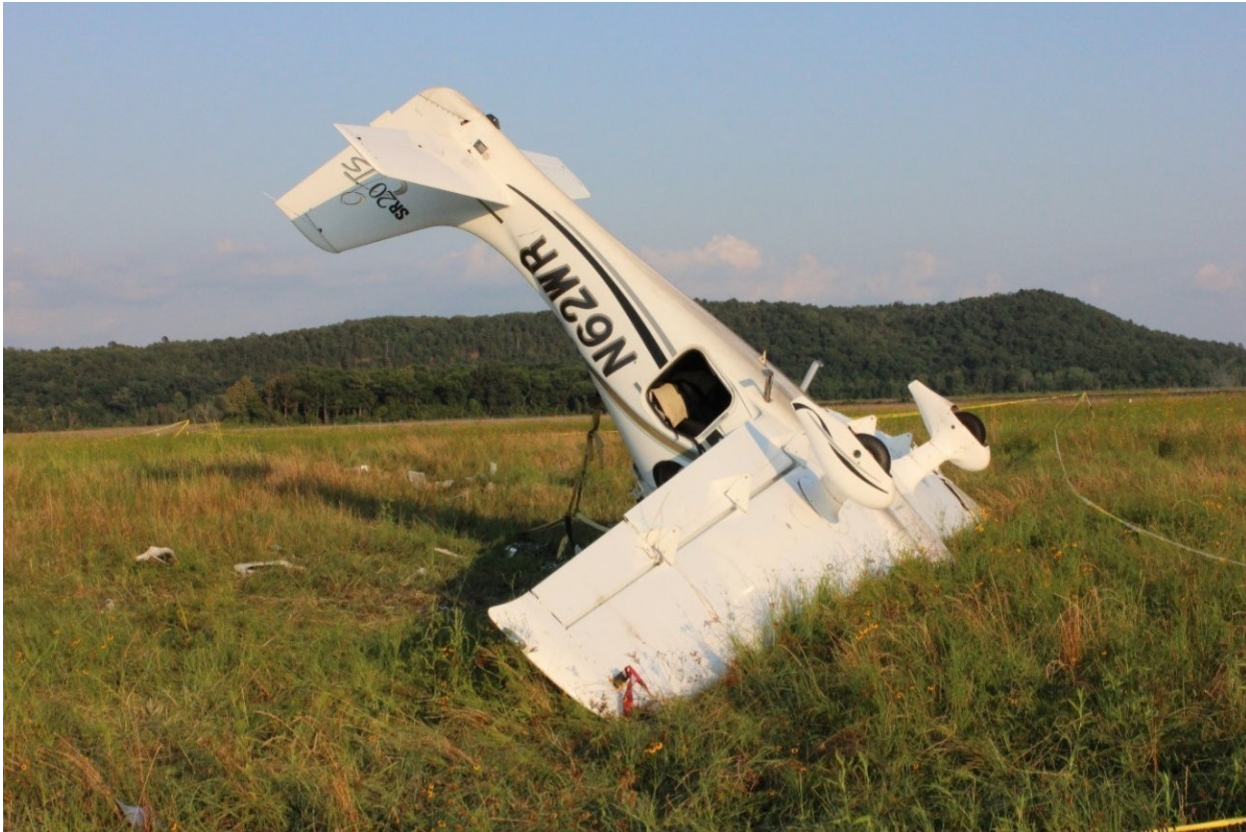
The pilot's failure to maintain adequate airspeed, which resulted in an aerodynamic stall and spin. Contributing to the accident was the failure of the pilot to perform an adequate preflight inspection, to include removal of the pitot tube cover.

Fragments of windscreen were found in the vicinity of the propeller. During the impact sequence, the Cirrus Airframe Parachute System (CAPS) deployed, and the canopy was found still bundled in a straight line away from the wreckage. The total debris field from the CAPS rocket to the main wreckage was about 110 ft. A postaccident examination revealed the pitot tube cover remained secured on the pitot tube with a “REMOVE BEFORE FLIGHT” banner attached (see figure 3).

*Figure 3: Airplane as it came to rest with pitot tube cover secured in place*
