# Aviation Investigation Final Report

<b>Location:</b>	Likely, California	<b>Accident Number:</b>	WPR21FA232
<b>Date &amp; Time:</b>	June 20, 2021, 09:00 Local	<b>Registration:</b>	N617Y
<b>Aircraft:</b>	Kitfox Series 6	<b>Aircraft Damage:</b>	Substantial
<b>Defining Event:</b>	Collision during takeoff/land	<b>Injuries:</b>	1 Fatal, 1 Serious
<b>Flight Conducted Under:</b>	Part 91: General aviation - Personal

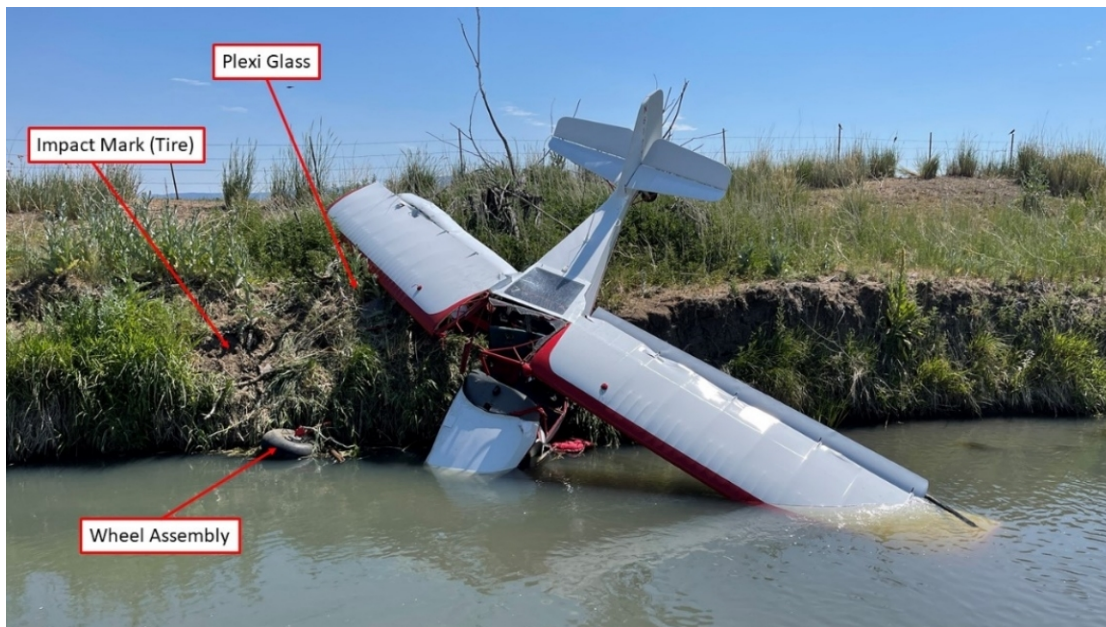
The airplane impacted the eastern edge of an irrigation levee as seen in figure 1. Debris remained within about 5 ft of the main wreckage. The fuselage came to rest upright on a magnetic heading of about 243°, with the engine and left wing partially submerged within water. A ground impression consistent with the size of a tire was observed about 4 ft north of the main wreckage.

*Figure 1: View of the main wreckage.*

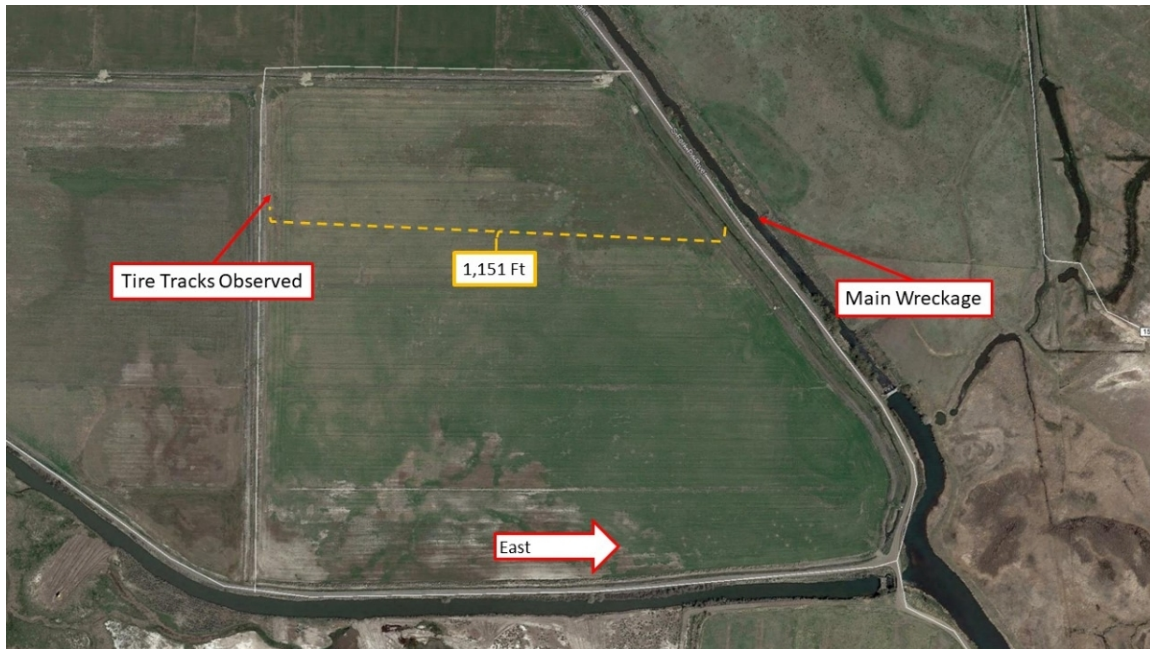
Examination of the departure field revealed that flattened grass, consistent with tire tracks, extended from the western edge of the field toward the canal. The length of the field from the western edge to the eastern edge was about 1,151 ft, as noted in figure 2. The field featured rough terrain, with vegetation about 2 to 3 ft in height as seen in figure 3. Along the eastern edge of a field was an area of elevated terrain/levee that was about 10 to 20 ft above the field.

*Figure 2: Overview of the accident site depicted on Google Earth.*

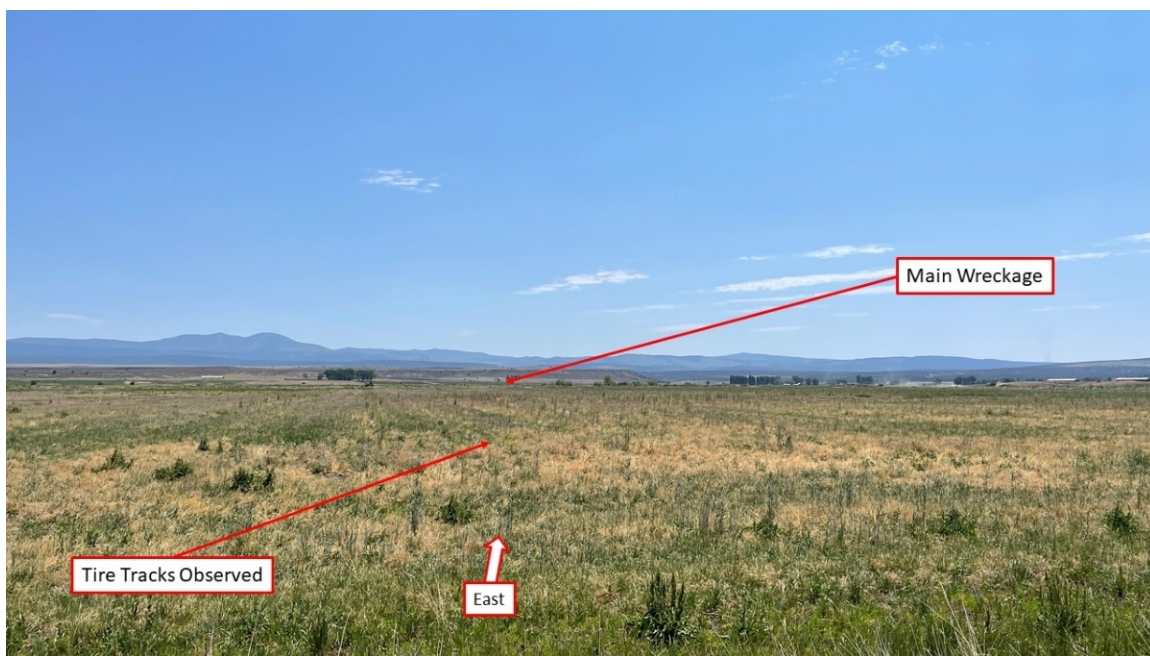
The height of the vegetation most likely increased resistance on the tires during the takeoff roll, which reduced the airplane's acceleration. Coupled with the high-density altitude conditions, it is likely that the airplane's required takeoff distance exceeded the field length available, which resulted in impact with terrain.

*Figure 3: View of the departure field looking east.*
