Aviation Investigation Final Report

Location:	Likely, California	Accident Number:	WPR21FA232
Date & Time:	June 20, 2021, 09:00 Local	Registration:	N617Y
Aircraft:	Kitfox Series 6	Aircraft Damage:	Substantial
Defining Event:	Collision during takeoff/land	Injuries:	1 Fatal, 1 Serious
Flight Conducted Under:	Part 91: General aviation - Personal

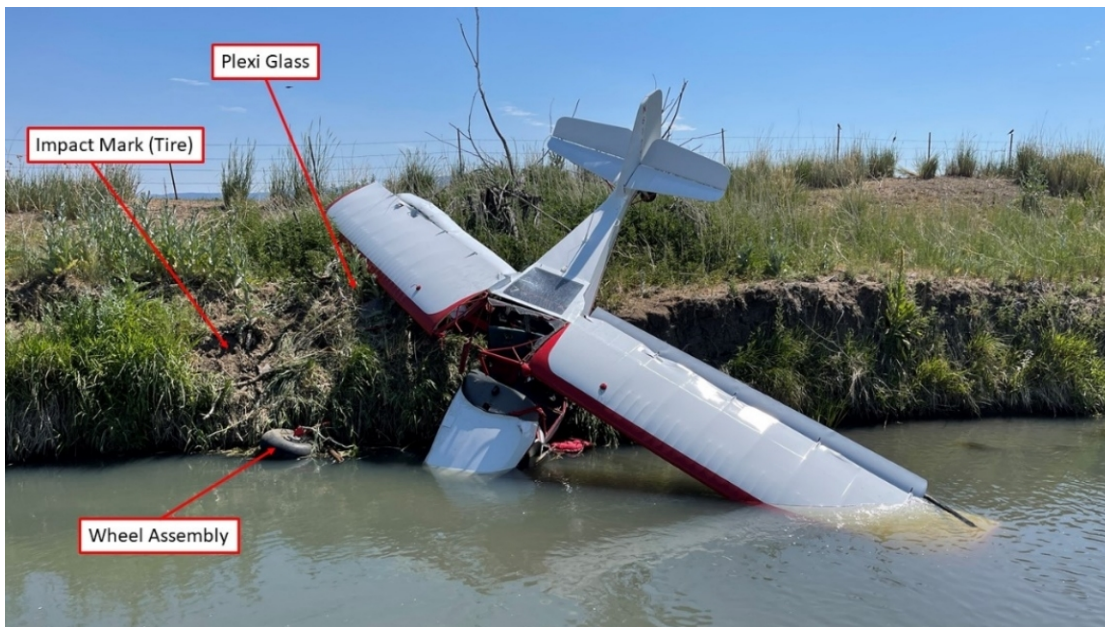
Figure 1: View of the main wreckage.

The airplane impacted the eastern edge of an irrigation levee as seen in figure 1. Debris remained within about 5 ft of the main wreckage. The fuselage came to rest upright on a magnetic heading of about 243°, with the engine and left wing partially submerged within water. A ground impression consistent with the size of a tire was observed about 4 ft north of the main wreckage.

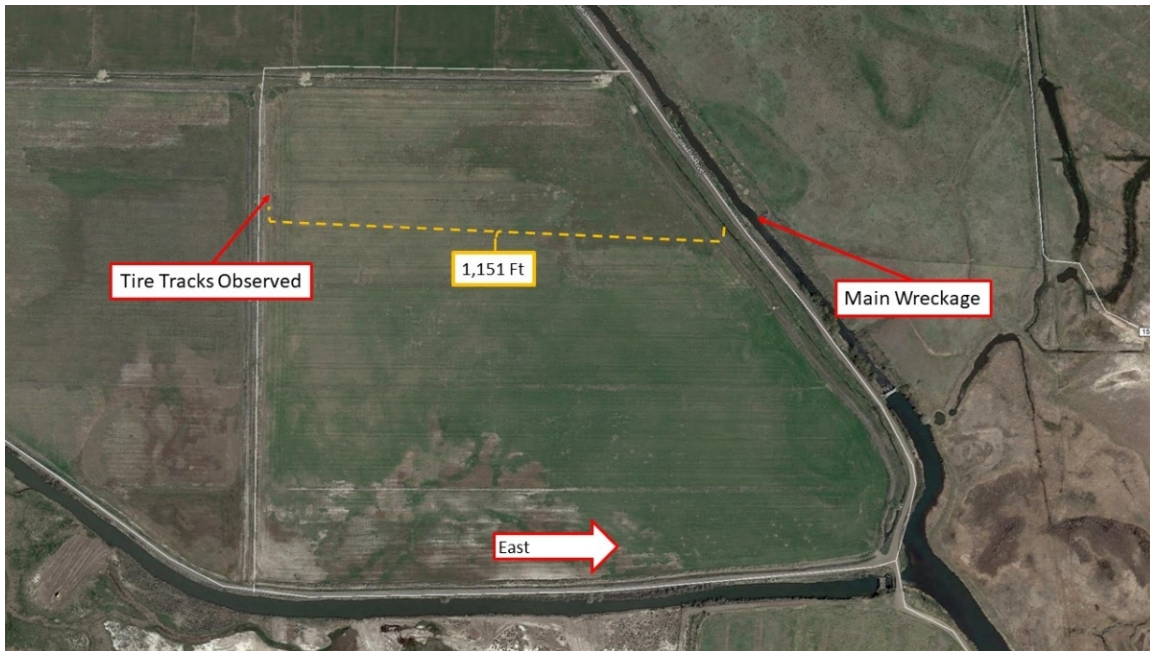
Figure 2: Overview of the accident site depicted on Google Earth.

Examination of the departure field revealed that flattened grass, consistent with tire tracks, extended from the western edge of the field toward the canal. The length of the field from the western edge to the eastern edge was about 1,151 ft, as noted in figure 2. The field featured rough terrain, with vegetation about 2 to 3 ft in height as seen in figure 3. Along the eastern edge of a field was an area of elevated terrain/levee that was about 10 to 20 ft above the field.

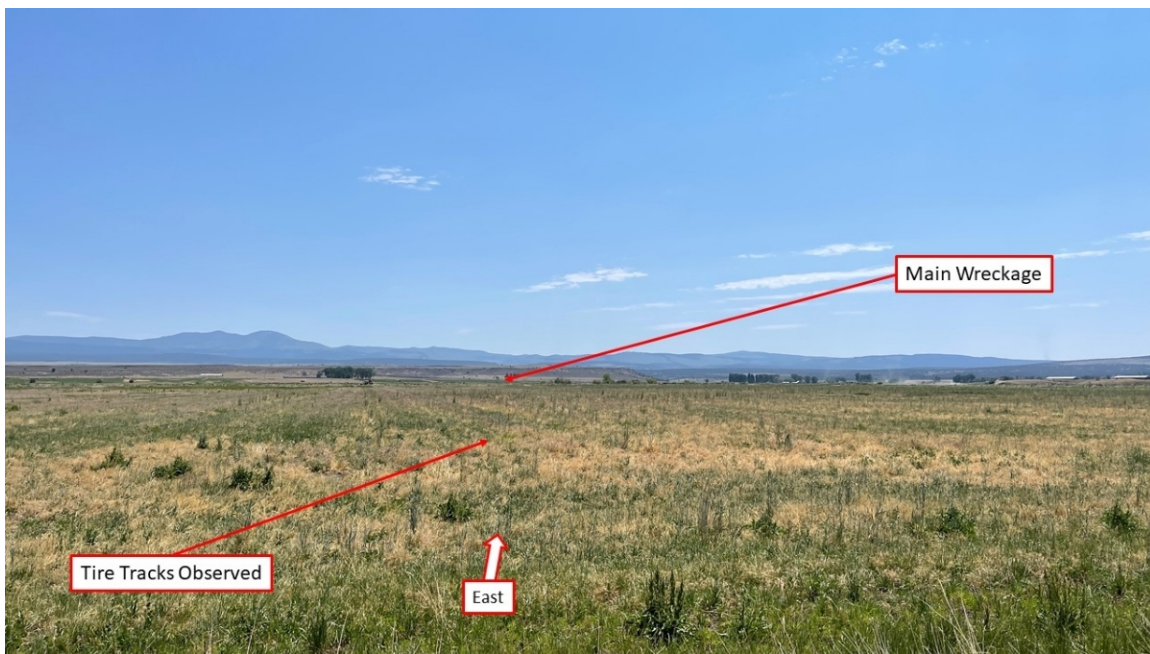
Figure 3: View of the departure field looking east.

The height of the vegetation most likely increased resistance on the tires during the takeoff roll, which reduced the airplane's acceleration. Coupled with the high-density altitude conditions, it is likely that the airplane's required takeoff distance exceeded the field length available, which resulted in impact with terrain.
