# Aviation Investigation Final Report

<b>Location:</b>	Albuquerque, New Mexico	<b>Accident Number:</b>	WPR21FA242
<b>Date &amp; Time:</b>	June 26, 2021, 07:07 Local	<b>Registration:</b>	N158NM
<b>Aircraft:</b>	CAMERON BALLOONS US O-120	<b>Aircraft Damage:</b>	Destroyed
<b>Defining Event:</b>	Collision during takeoff/land	<b>Injuries:</b>	5 Fatal
<b>Flight Conducted Under:</b>	Part 91: General aviation - Other work use

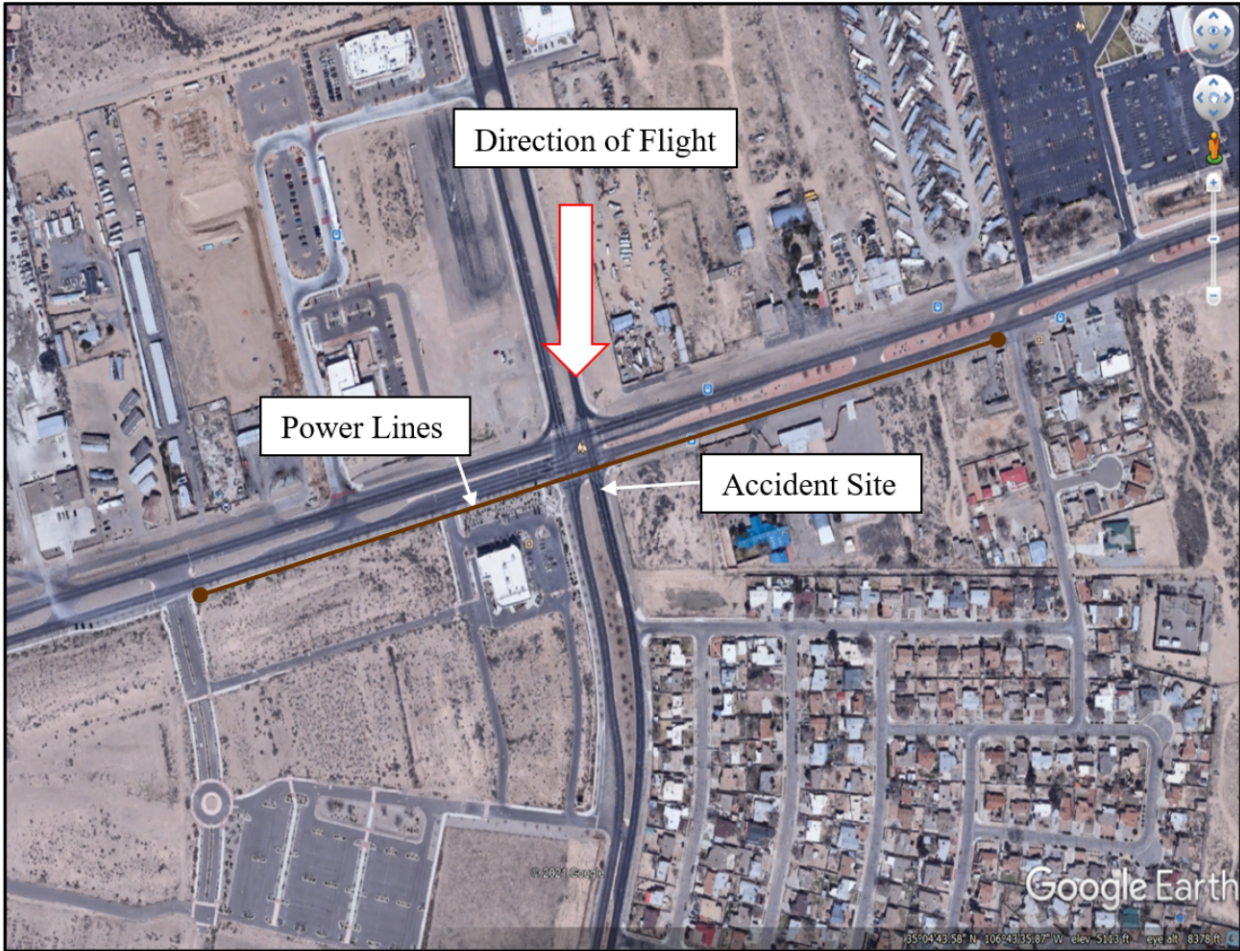
Figure 1: Road Intersection of Unser Blvd and Central Ave.

A review of surveillance video from a local business revealed that the balloon began a climb before the road intersection where the power lines were located across from the road. Video then depicted the balloon descending into the power lines as it crossed about perpendicular to the wires. Shortly thereafter, the balloon contacted a high-tension power line, an arc appeared, and the basket separated from the envelope. The balloon's envelope was later located about 0.6 miles south from the accident site in a private residence.

The accident site was located at a major road intersection. Several power lines ran perpendicular to the south/north road and crossed the intersection. The power lines were located on the south side of the road that went east to west. The power lines were hung between metal poles that were about 78 ft in height. Additionally, between the two poles that the power lines crossed the road intersection, there were two static lines that were located on top of all the wires. One static line was missing on the south side. Further, there was a discoloration on a power line above, near where the balloon's basket was located on the road. The basket separated from the balloon's envelope and came to rest on its side.
