Aviation Investigation Final Report

Location:	Hood River, Oregon	Accident Number:	WPR21LA250
Date & Time:	June 28, 2021, 10:30 Local	Registration:	N10TA
Aircraft:	L-BIRD LLC CCX-2000	Aircraft Damage:	Substantial
Defining Event:	Loss of engine power (total)	Injuries:	1 None
Flight Conducted Under:	Part 91: General aviation - Flight test

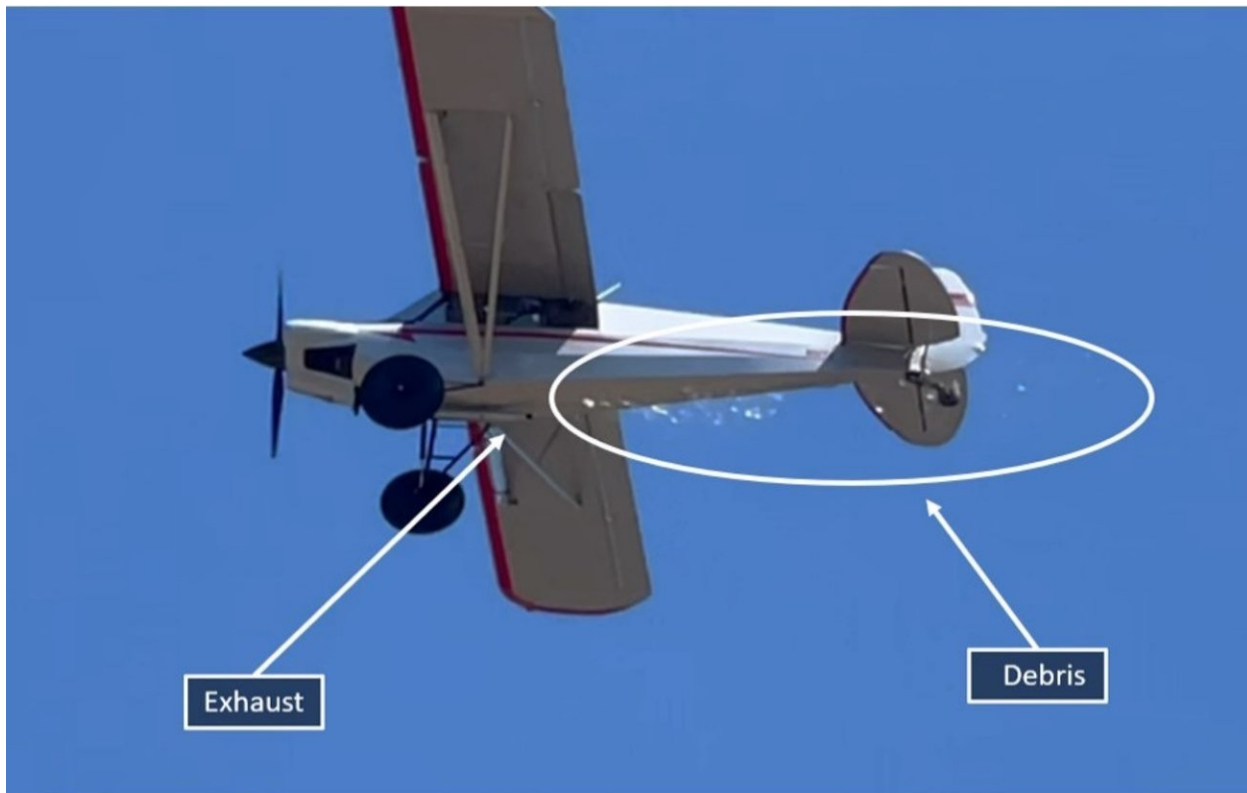
A video recording of the takeoff revealed, about 24 seconds after takeoff, metallic shiny debris trailing from the airplane, as seen in figure 1.

Figure 1: Airplane during takeoff.

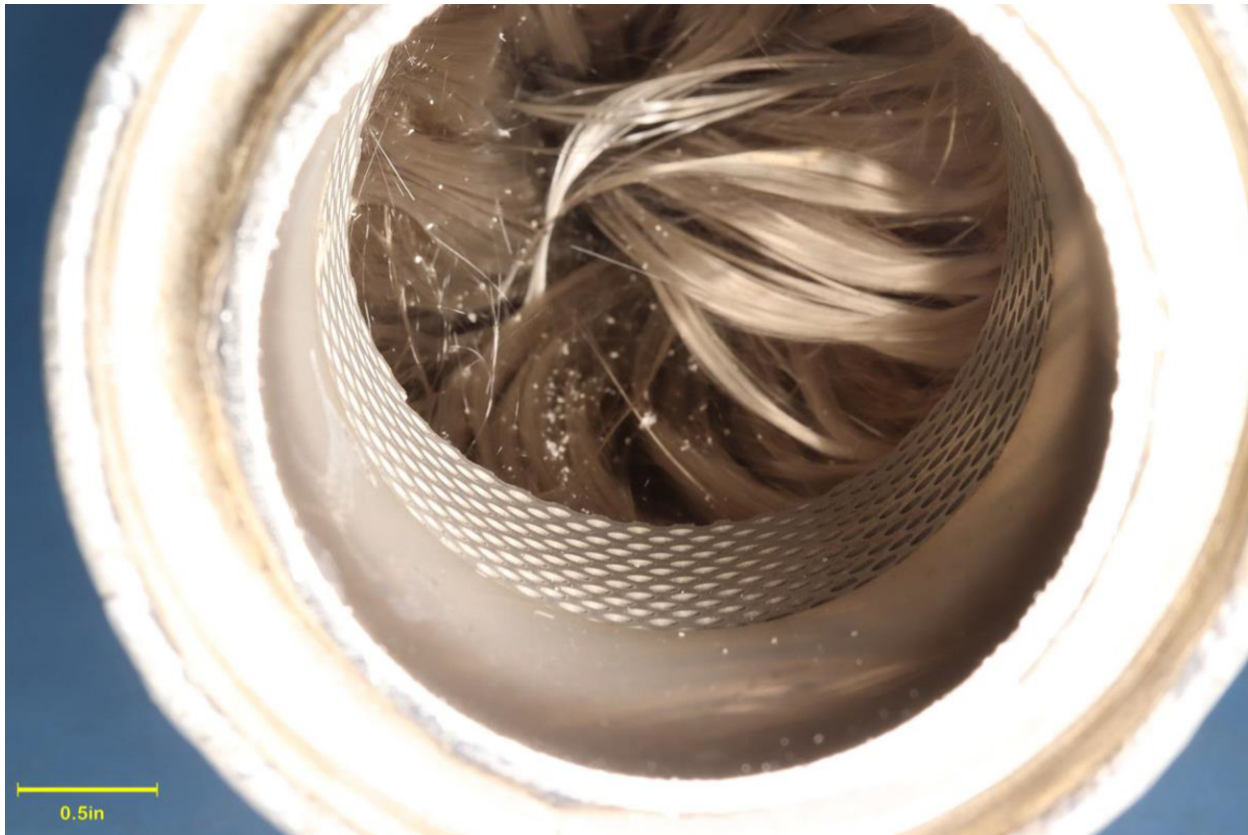
The muffler inlet and exhaust tubes were sectioned from the muffler body. At the inlet end, the inner tube was fractured 360° around its circumference approximately 3.5 to 4.0 inches from the inlet end and the fiberglass packing had fallen inward, obstructing the view further inside

Figure 2. Image of the muffler body inlet, showing the fractured perforated inner tube and the fiberglass packing that had fallen inward.

The fracture features of the inner tube were consistent with a failure that started in tension near the 7 o'clock position and transitioned to bending as it progressed around both sides of the tube and terminated near the 1 o'clock position. The fractured ligaments, when viewed under magnification, had a specular appearance with no apparent crack growth features that would be typical of fatigue or overstress fractures. The ligament fractures were examined in a scanning electron microscope equipped with an energy-dispersive X-ray spectrometer (EDS). The observations were consistent with a high-temperature creep separation/fracture.

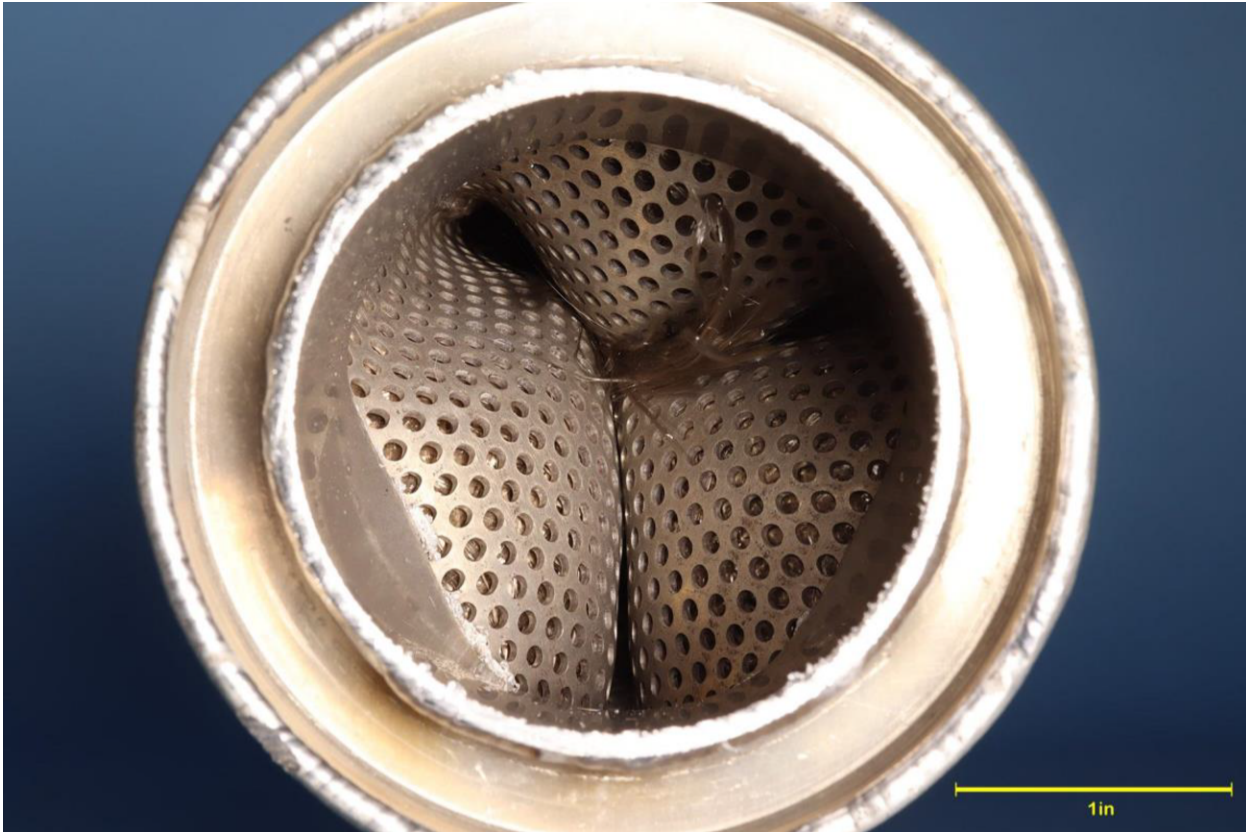
the muffler. At the exhaust end, the inner tube had collapsed inward in three nominally symmetric segments, pinching the outlet end shut. (see figures 2 and 3.)

Figure 3. Image of the muffler body outlet, showing the collapsed inner tube.
