Aviation Investigation Final Report

Location:	Roff, Oklahoma	Accident Number:	CEN21FA300
Date & Time:	July 2, 2021, 02:25 Local	Registration:	N302Z
Aircraft:	Beech 35-33	Aircraft Damage:	Destroyed
Defining Event:	Loss of control in flight	Injuries:	2 Fatal
Flight Conducted Under:	Part 91: General aviation - Personal

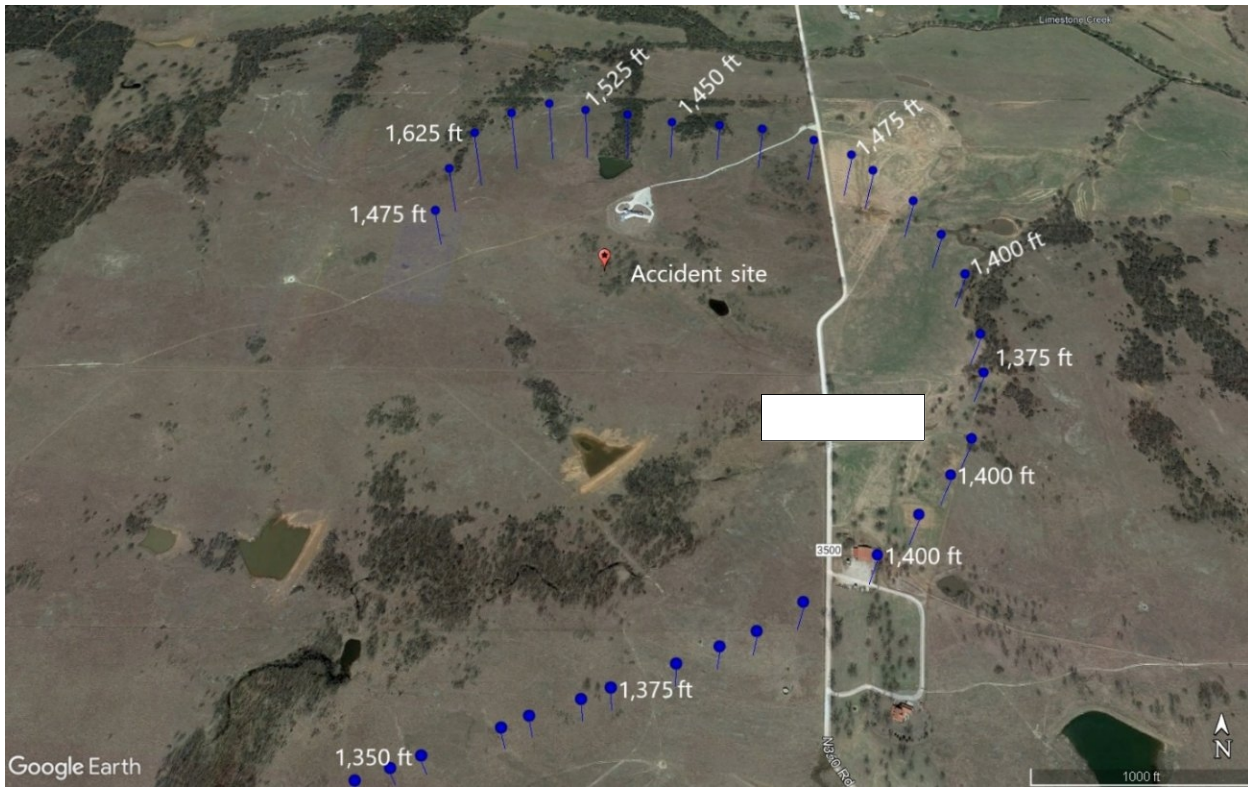
Toward the end of the flight, the airplane made a left turn during which the airplane climbed to an altitude of about 1,600 ft at a rate of about 2,000 feet per minute. Subsequently, the airplane began descending at a rate that exceeded 2,700 feet per minute. The last ADS-B return showed that the airplane was about 0.2 miles west of the last radar return, about 280 ft above ground level, and along a track of 190°. The airplane's last recorded groundspeed was 89 knots. The airplane impacted trees on a remote ranch about 14 nautical miles southwest of ADH. The figure below shows the airplane's flight track (based on ADS-B data) during the accident flight.

Figure. Accident airplane flight track.
