Aviation Investigation Final Report

Location:	Honolulu, Hawaii	Accident Number:	DCA21FA174
Date & Time:	July 2, 2021, Local	Registration:	N810TA
Aircraft:	Boeing 737-275C	Aircraft Damage:	Destroyed
Defining Event:	Loss of engine power (partial)	Injuries:	1 Serious, 1 Minor
Flight Conducted Under:	Part 121: Air carrier - Non-scheduled

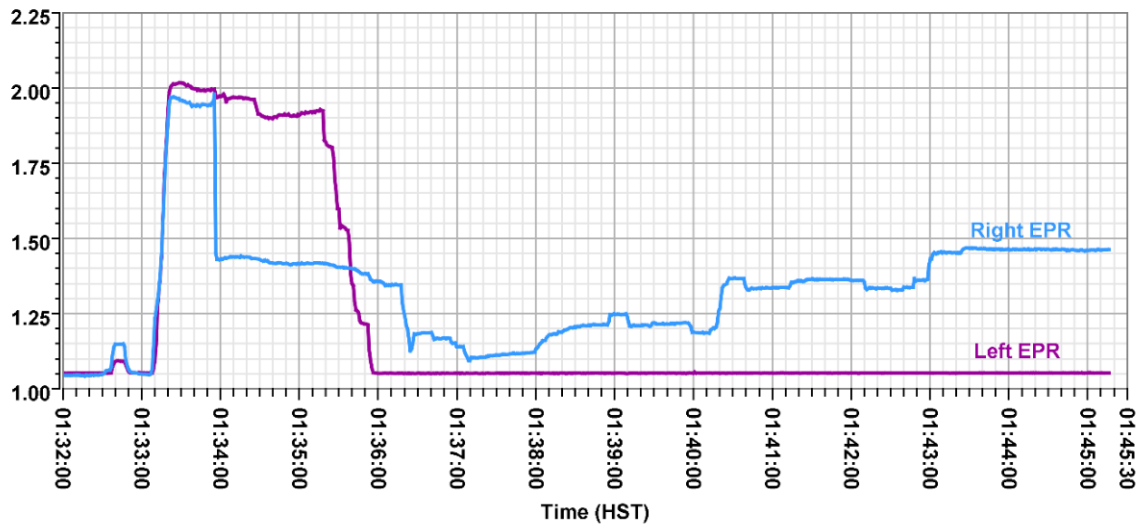
Figure 2. Left and right EPR values during the accident flight.

Note: The EPR decrease on the left engine between 0135:00 and 0136:00 (in purple) occurred between events 6 and 7 in figure 1.

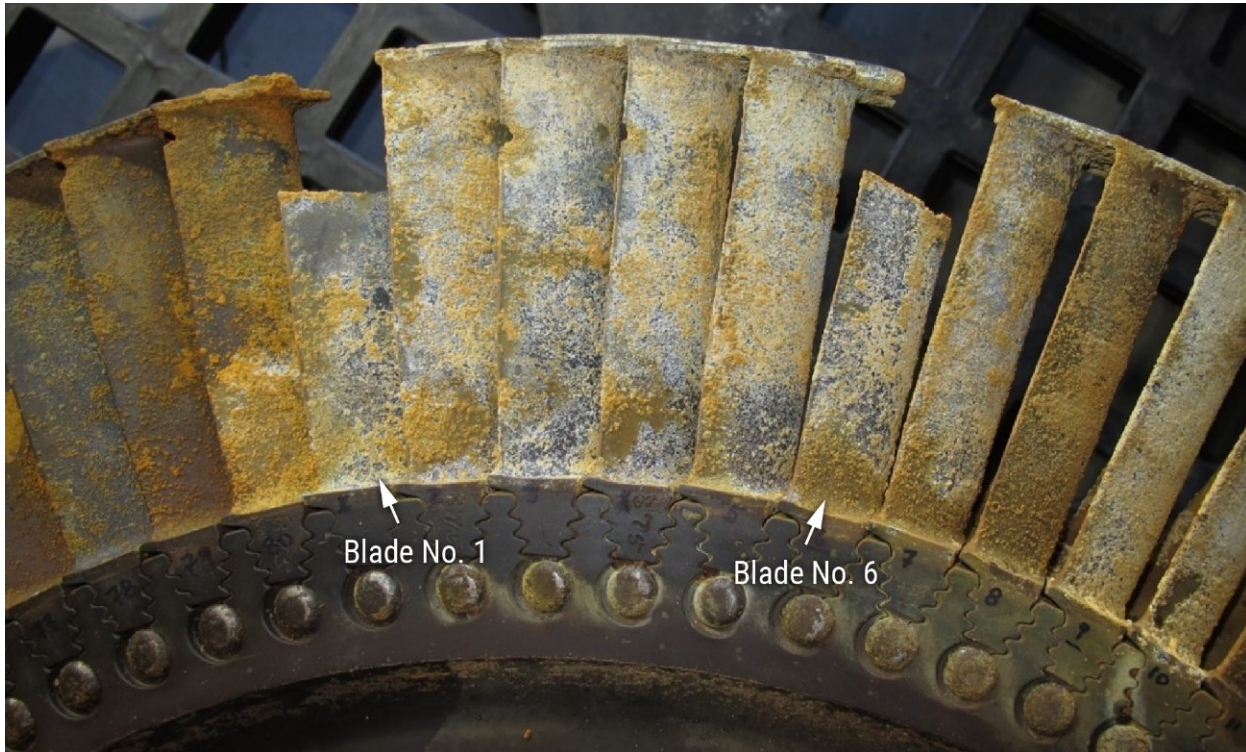
The teardown of the right engine showed that two high-pressure turbine stage 1 blades were missing their outer spans and that both had failed from a stress rupture fracture due to oxidation and corrosion of the internal blade lightening (weight-reduction) holes, which resulted in a loss of load-bearing cross-section. The blade failures caused downstream (secondary) damage to the low-pressure turbine, resulting in a loss of thrust, which would have been presented to the flight crew as a decrease in EPR on the right engine (along with the thud sound recorded on the CVR and the yaw to the right).

The low-pressure compressor blades in stages 2 through 6 were bent opposite the direction of rotation, as were the high-pressure compressor blades in stages 7 through 13. The high-pressure turbine disk was intact, and all stage 1 blades and blade retention rivets were secure. The outer spans of two high-pressure turbine stage 1 blades were missing. The high-pressure turbine stage 1 blades were numbered clockwise from 1 to 80, with the trailing fractured blade designated as blade No. 1 and the leading fractured blade designated as blade No. 6, as

shown in figure 4. The liberated portions of the blades were not recovered.

Figure 4. Fractured blades on the right engine high-pressure turbine.

Blade Nos. 1 and 6 were fractured transversely about 2.4 and 2.7 inches, respectively, above the platform trailing edge. Blade Nos. 3, 4, 79, and 80 exhibited trailing-edge outer diameter impact damage toward the outer span. Other blade trailing edges showed varying damage with missing material up to 0.04 inches radially. The blade fracture surfaces were heavily coated with ocean deposits.

The two fractured high-pressure turbine blades (Nos. 1 and 6) were examined at Pratt & Whitney's Materials and Processes Engineering Lab in East Hartford, Connecticut. The examination determined that the blades failed by stress rupture resulting from a loss of load-bearing material due to oxidation and corrosion. The oxidation occurred around the blades' internal lightening (weight-reduction) holes and had significantly reduced each blade's load-bearing cross-section. The fracture through the oxidized regions exhibited comparatively flat features, consistent with brittle fracture. The fracture across the remaining load-bearing blade material either exhibited a rough (intergranular) texture, which was consistent with stress rupture, or was covered by ocean deposits.

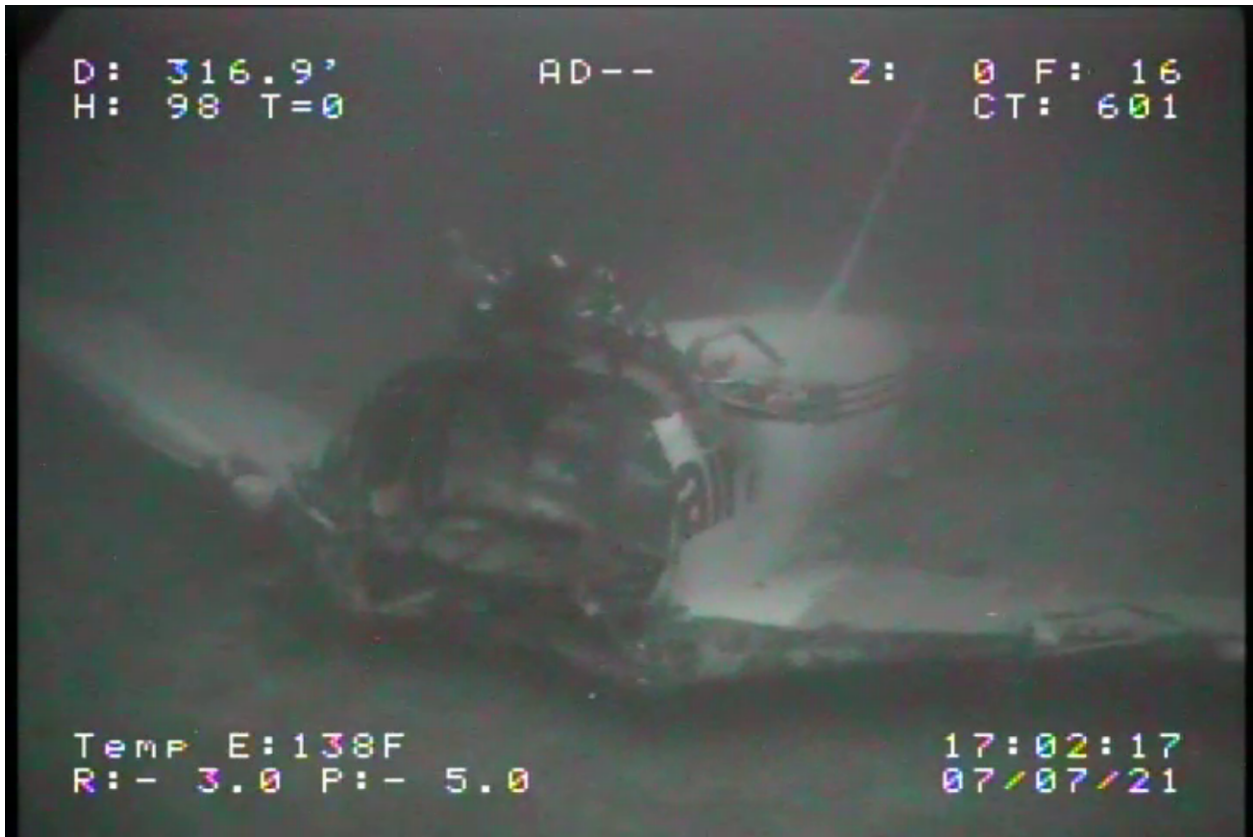
The airplane's forward fuselage section separated from the rest of the airplane near the leading edge of the wing. Most of the fuselage structure below the main cabin and cockpit floor separated from the forward fuselage. The separated structure below the floor was crushed and torn. The aft fuselage lower section was damaged, and portions of belly skin had

Figure 5. Aft fuselage (Source: Sea Engineering Inc.).

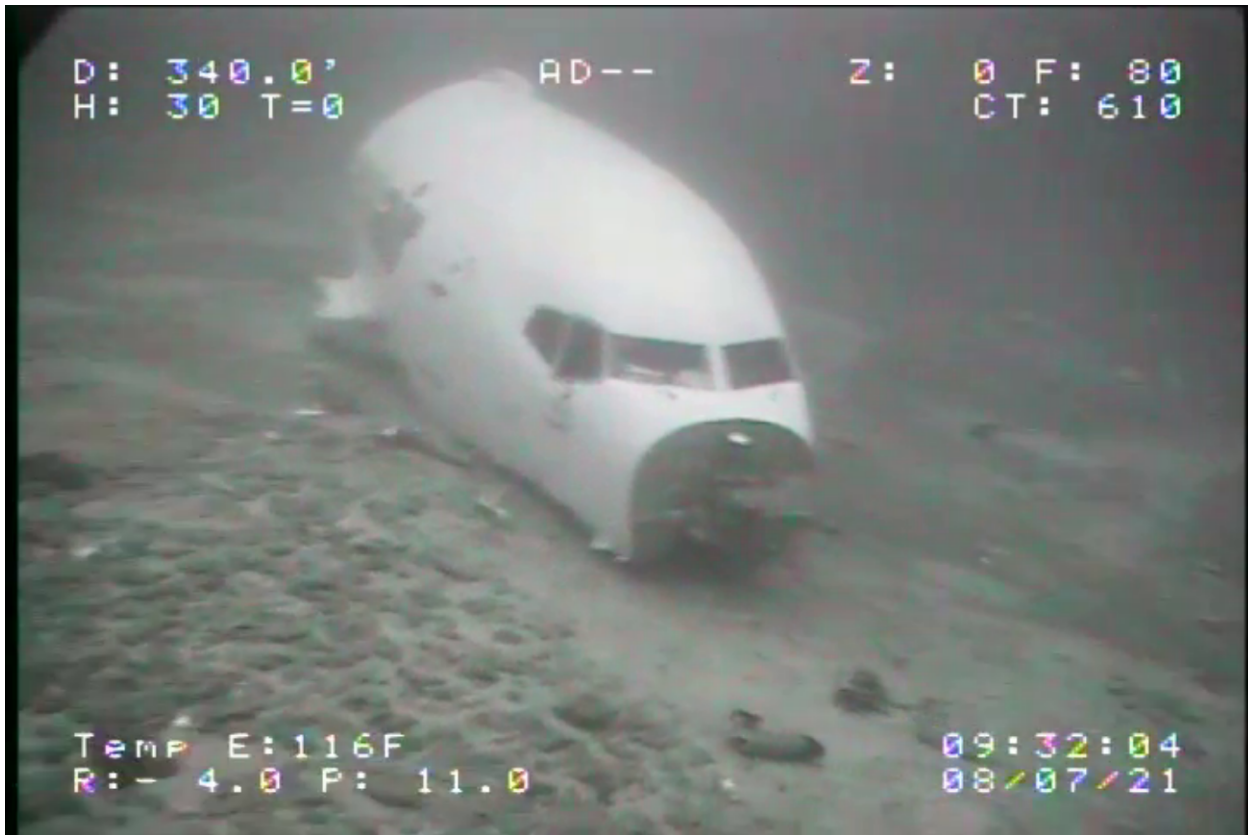
Figure 6. Forward fuselage (Source: Sea Engineering Inc.).
