Aviation Investigation Final Report

Location:	Angwin, California	Accident Number:	WPR21FA273
Date & Time:	July 16, 2021, 08:40 Local	Registration:	N112TW
Aircraft:	Beech V35	Aircraft Damage:	Destroyed
Defining Event:	Abnormal runway contact	Injuries:	3 Fatal
Flight Conducted Under:	Part 91: General aviation - Personal

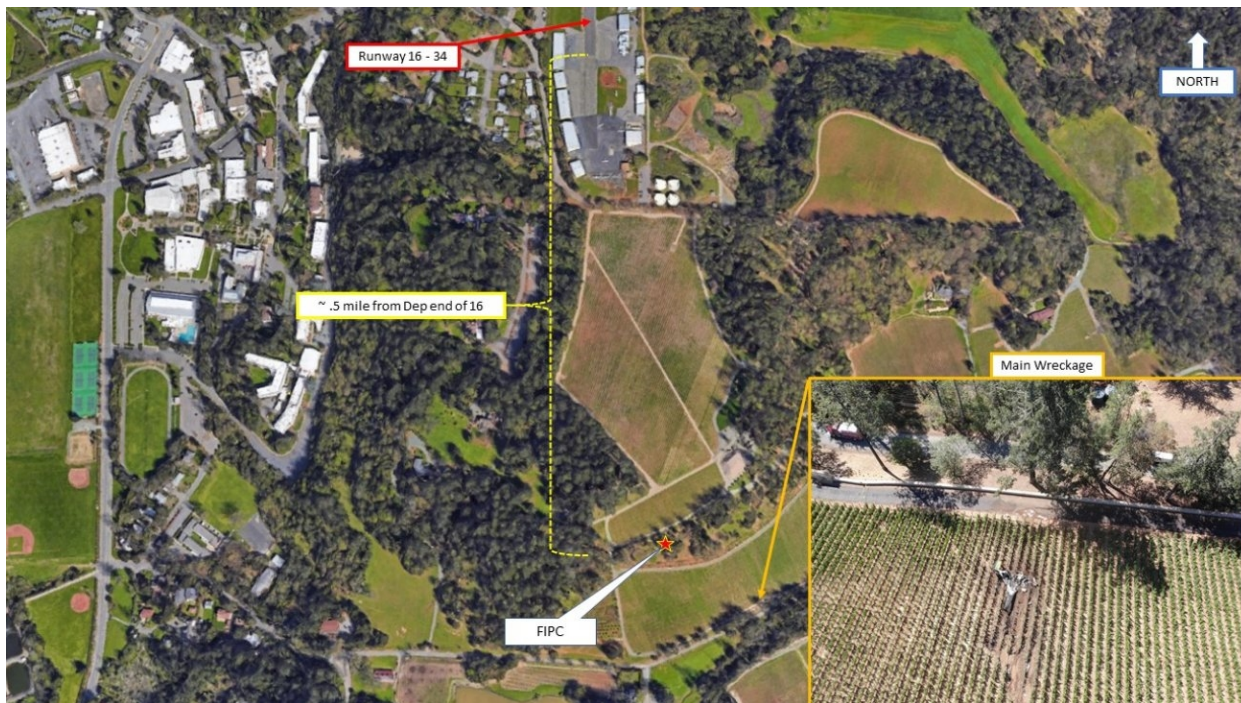
Figure 3. Accident site (Source: Napa County Sheriff's Department.)

Examination of the accident site (see figure 3) revealed that the departure end of runway 16 was about 0.5 miles from the first identified point of contact, a 50-ft-tall tree. The airport was not visible from the wreckage site. A portion of wing skin was found in the tree, and the left aileron was found a few feet away on the ground. The main wreckage came to rest about 500 ft downslope of the tree in a vineyard. The left-wing tip tank was found 150 ft west of the main wreckage.

All four corners of the airplane were accounted for at the accident site. The airframe came to rest on a westerly heading with the engine separated from the firewall. The three-bladed propeller, its spinner, and its hub separated from the engine crankshaft and were located uphill and adjacent to the engine. Flight control continuity was established from the tail to the cockpit and right wing. Continuity could not be established to the left wing because it was destroyed by impact forces and postaccident fire. Numerous separations were noted within the flight control system with signatures consistent with overload separation or thermal damage.
