Aviation Investigation Final Report

| Location: | Anchorage, Alaska | Accident Number: | ANC21LA064 |
| Date & Time: | July 23, 2021, 15:10 Local | Registration: | N4206H |
| Aircraft: | Piper PA-14 | Aircraft Damage: | Substantial |

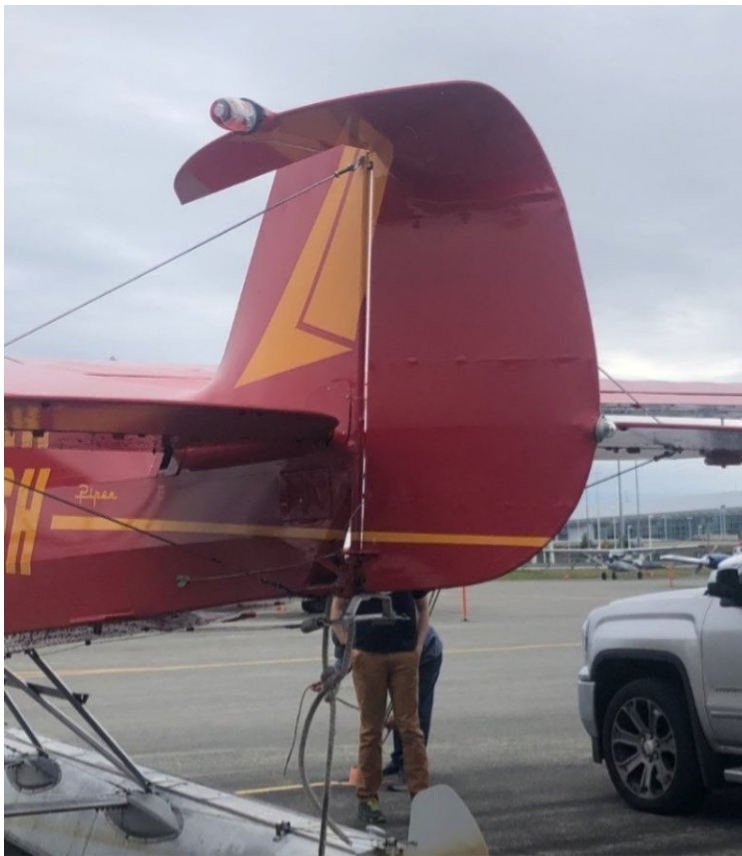
Thus, the rudder failure on the accident airplane was due to the fatigue fracture of the AISI 1025 carbon steel rudder post. Contributing to the fatigue failure was the post's susceptibility to fatigue cracking under normal service conditions.

Figure - Photo of the damaged rudder. Photo provided by FAA.

An initial examination of the rudder revealed that the vertical spar tube separated above the upper hinge point and the top portion of the rudder folded over the horizontal stabilizer tail brace wires. (See figure).

When the accident airplane's rudder was examined, radial features with crack arrest lines were observed, consistent with fatigue from multiple origins at the outer diameter. The piece of post from the upper side of the fracture was further examined using a scanning electron microscope (SEM). Multiple fatigue origins were identified on the right side that originated from corrosion pits on the exterior surface. Fatigue fracture features were identified around approximately $\frac{1}{4}$ of the circumference on the right side, but the total extent of fatigue cracking could not be determined conclusively due to post-fracture contact damage on the surfaces.
