# Aviation Investigation Final Report

<b>Location:</b>	Truckee, California	<b>Accident Number:</b>	WPR21FA286
<b>Date &amp; Time:</b>	July 26, 2021, 13:18 Local	<b>Registration:</b>	N605TR
<b>Aircraft:</b>	BOMBARDIER INC CL-600-2B16	<b>Aircraft Damage:</b>	Destroyed
<b>Defining Event:</b>	Loss of control in flight	<b>Injuries:</b>	6 Fatal
<b>Flight Conducted Under:</b>	Part 91: General aviation - Personal

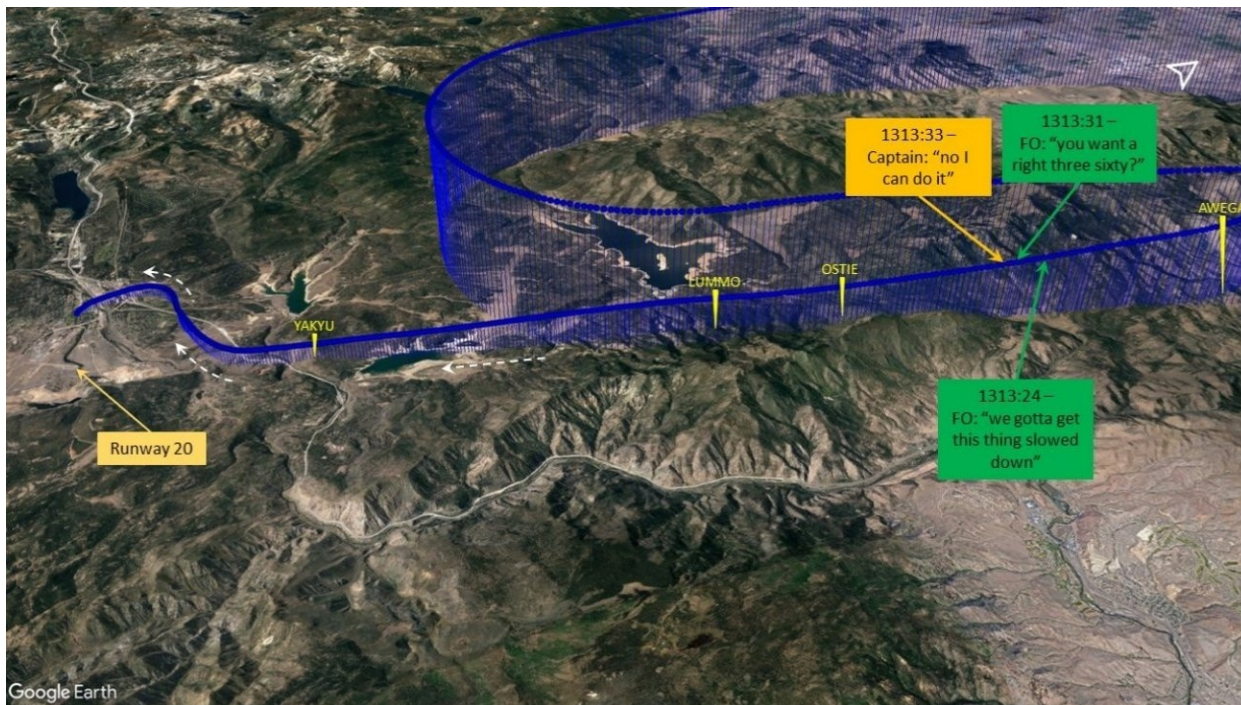
At 1312:39, the FO then stated to the captain, “We’ve got a ways to go,” and added, “You got plenty of time.” About this time, FDR data showed the airplane’s indicated airspeed was at 241 kts. At 1313:24 the FO said, “We gotta get this thing slowed down,” then asked if the captain wanted “a right three sixty [degree turn],” but the captain declined. The airplane was about 3 nm south of AWEGA, heading toward OSTIE waypoint at an airspeed of about 252 kts (OSTIE is about 2 nm north of LUMMO, the final approach fix [FAF]) (see the locations of flight crew comments and waypoints in figure 1 below).

Figure 1. Airplane flightpath and crew discussion on runway 20 approach

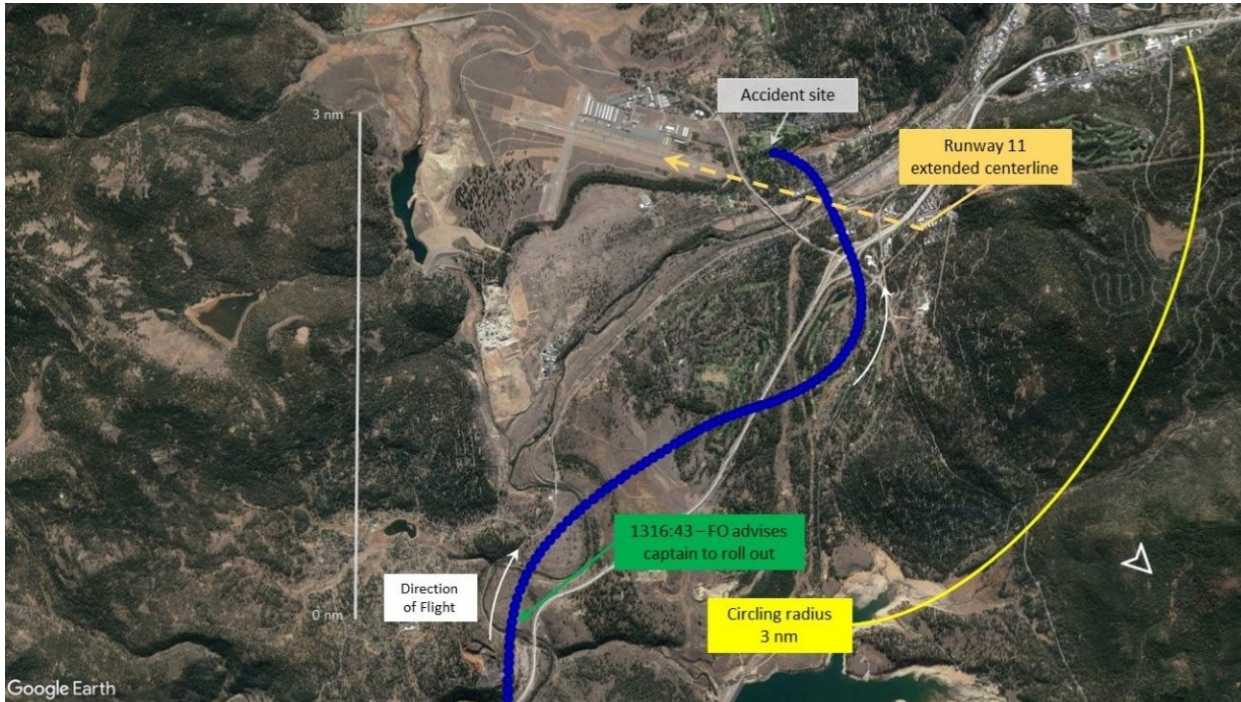
At 1316:20, the FO deployed full flaps (45°) after confirming with the captain. A second later (near YAKYU waypoint), the FO said, “There’s the airport,” told the captain to make a 90° right turn, and contacted Truckee tower, which cleared the airplane to land. The FO attempted to point out the airport to the captain, and the captain asked “where?” twice. At 1316:43, the FO told the captain to roll out (level the wings, stopping the turn) and turn the autopilot off. The airplane was at the beginning of the downwind leg turn (about 213° magnetic) when the FO told the captain to roll out, and the airplane rolled out on a heading of about 233°. Figure 2 depicts the turns taken by the airplane in the approach and the maximum circling radius of 3 nm allowed for category C aircraft at TRK in the airport’s approach charts (the airplane was at least 1.3 nm from that maximum circling radius).

Figure 2. The airplane’s downwind leg and allowed circling radius.

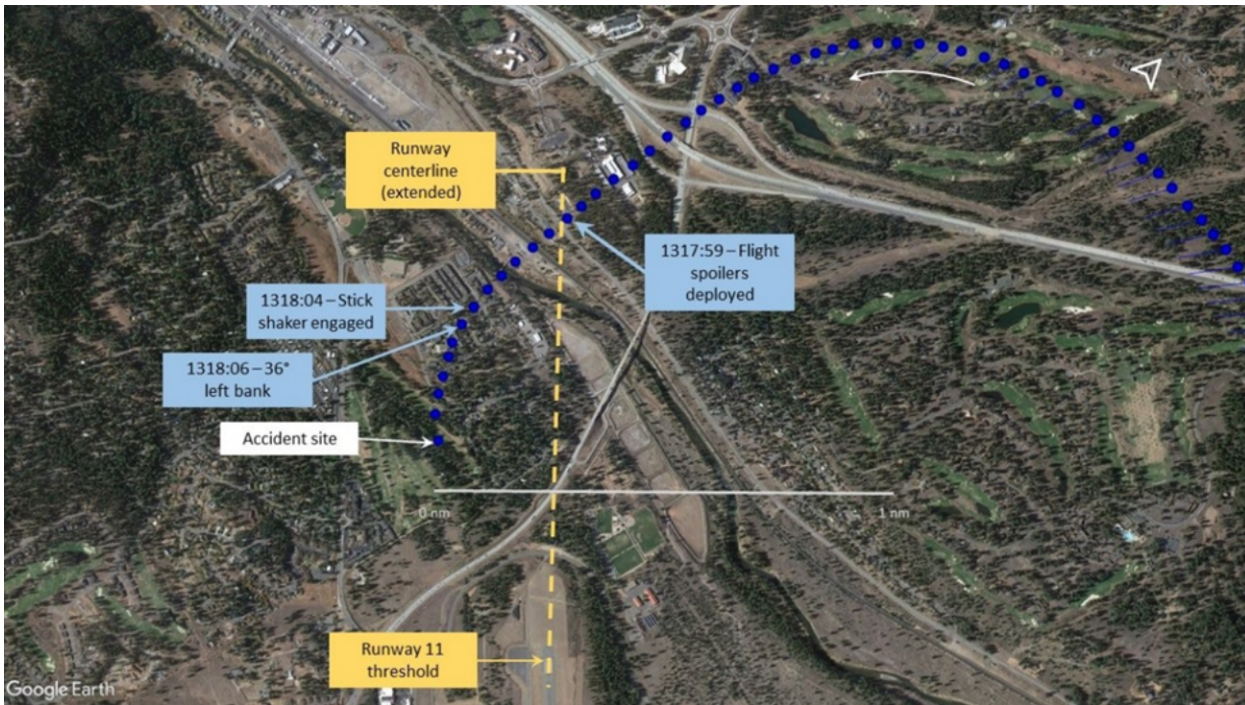
At 1317:59, the airplane began a left turn that reached a bank angle of 36° about 4 seconds later. According to the CVR data, the stick shaker engaged at 1318:04, then the captain asked, “What are you doing,” which was followed by a stall warning sound. The airplane was on a south heading about 0.75 nm from the runway threshold as it continued to turn back toward the extended runway centerline (see figure 3). The stick pusher engaged about 1318:05. (For more information about the stick shaker and stick pusher, see the section below about the SPS.) The captain again asked the FO, “What are you doing?” and the FO then asked the captain three times over 2 seconds to “let me have the airplane.” The stick pusher disengaged at 1318:07 followed immediately by the stick shaker disengaging. At 1318:09, the stick shaker engaged again followed immediately by the stick pusher engaging, and the airplane was about 6,075 ft msl on a southeasterly heading when it entered a rapid left roll. The airplane was in a 111° left-wing-low bank angle at 1318:11 and 1 second later it was in a 146° right-wing-low bank angle and an approximate 30° nose-low attitude, just before the airplane impacted terrain and a postcrash fire ensued.

Figure 3. Accident airplane's flightpath during final approach after crossing the runway centerline.
