Aviation Investigation Final Report

Location:	Truckee, California	Accident Number:	WPR21FA286
Date & Time:	July 26, 2021, 13:18 Local	Registration:	N605TR
Aircraft:	BOMBARDIER INC CL-600-2B16	Aircraft Damage:	Destroyed
Defining Event:	Loss of control in flight	Injuries:	6 Fatal
Flight Conducted Under:	Part 91: General aviation - Personal

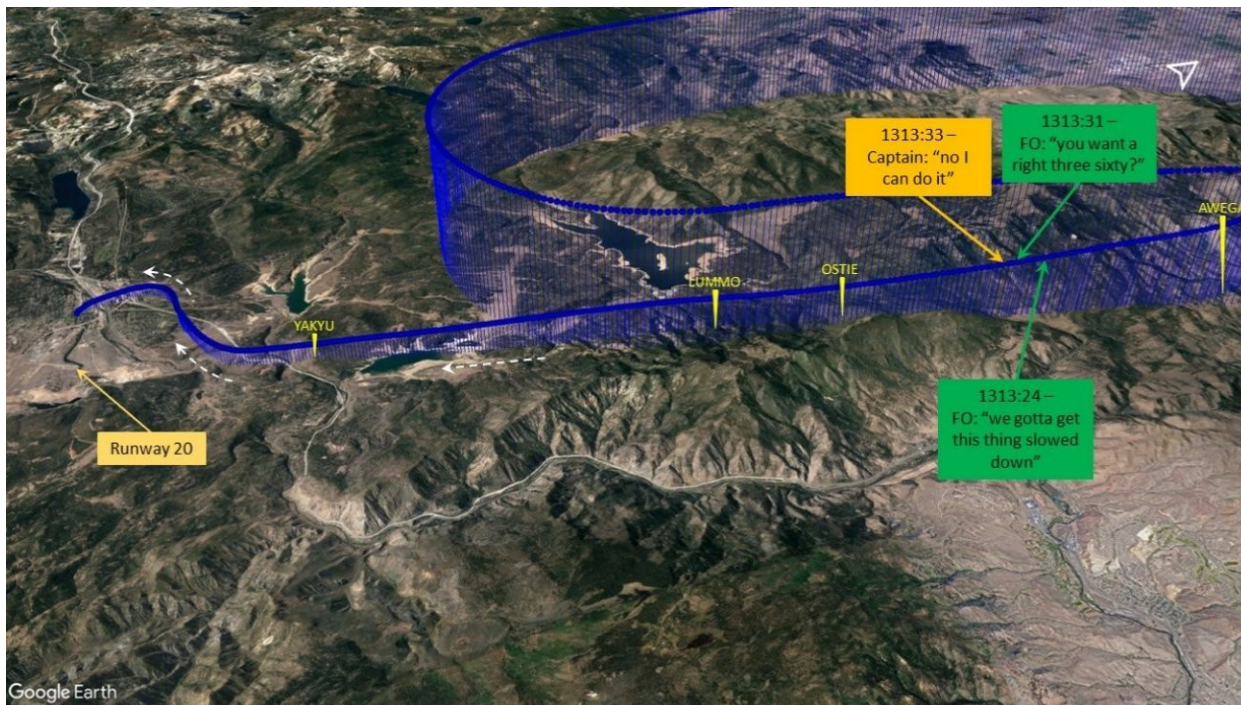
At 1312:39, the FO then stated to the captain, “We’ve got a ways to go,” and added, “You got plenty of time.” About this time, FDR data showed the airplane’s indicated airspeed was at 241 kts. At 1313:24 the FO said, “We gotta get this thing slowed down,” then asked if the captain wanted “a right three sixty [degree turn],” but the captain declined. The airplane was about 3 nm south of AWEGA, heading toward OSTIE waypoint at an airspeed of about 252 kts (OSTIE is about 2 nm north of LUMMO, the final approach fix [FAF]) (see the locations of flight crew comments and waypoints in figure 1 below).

Figure 1. Airplane flightpath and crew discussion on runway 20 approach

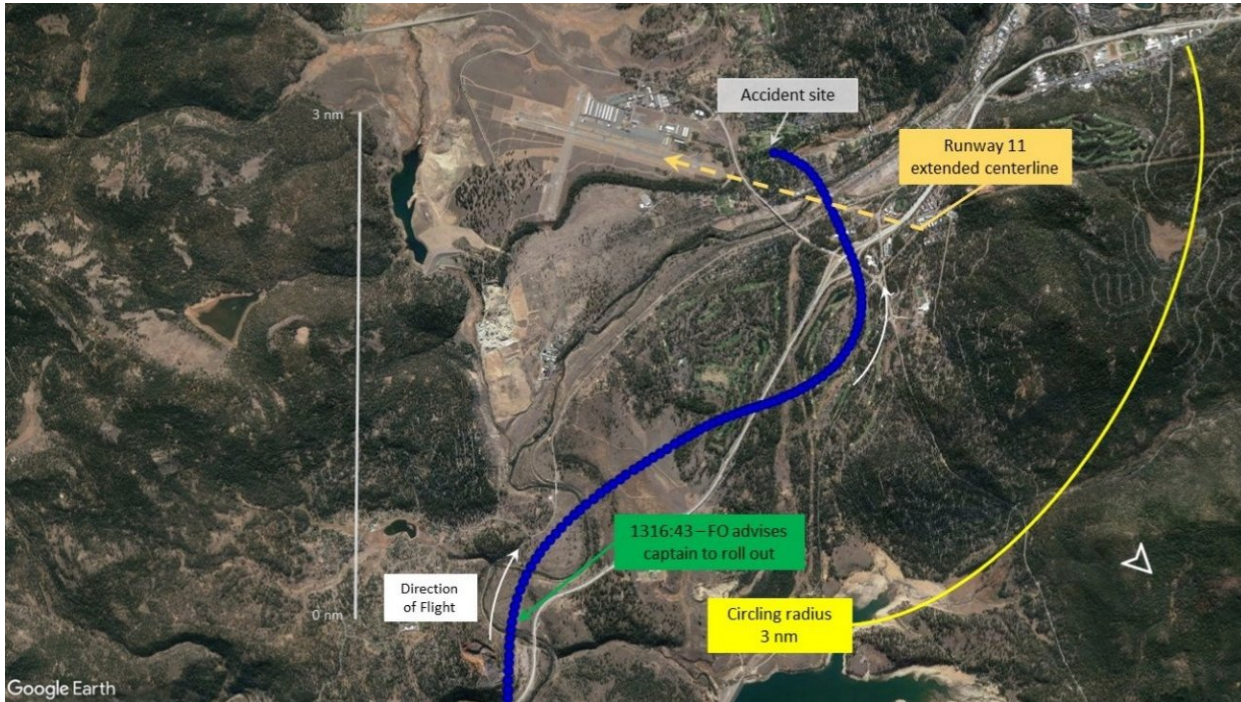
At 1316:20, the FO deployed full flaps (45°) after confirming with the captain. A second later (near YAKYU waypoint), the FO said, “There’s the airport,” told the captain to make a 90° right turn, and contacted Truckee tower, which cleared the airplane to land. The FO attempted to point out the airport to the captain, and the captain asked “where?” twice. At 1316:43, the FO told the captain to roll out (level the wings, stopping the turn) and turn the autopilot off. The airplane was at the beginning of the downwind leg turn (about 213° magnetic) when the FO told the captain to roll out, and the airplane rolled out on a heading of about 233°. Figure 2 depicts the turns taken by the airplane in the approach and the maximum circling radius of 3 nm allowed for category C aircraft at TRK in the airport’s approach charts (the airplane was at least 1.3 nm from that maximum circling radius).

Figure 2. The airplane’s downwind leg and allowed circling radius.
