Aviation Investigation Final Report

Location:	Briggs, Texas	Accident Number:	CEN21LA346
Date & Time:	July 30, 2021, 14:40 Local	Registration:	N304AB
Aircraft:	HpH, Spol. S.R.O. Glasflügel 304S	Aircraft Damage:	Substantial
Defining Event:	Flight control sys malf/fail	Injuries:	1 Serious
Flight Conducted Under:	Part 91: General aviation - Personal

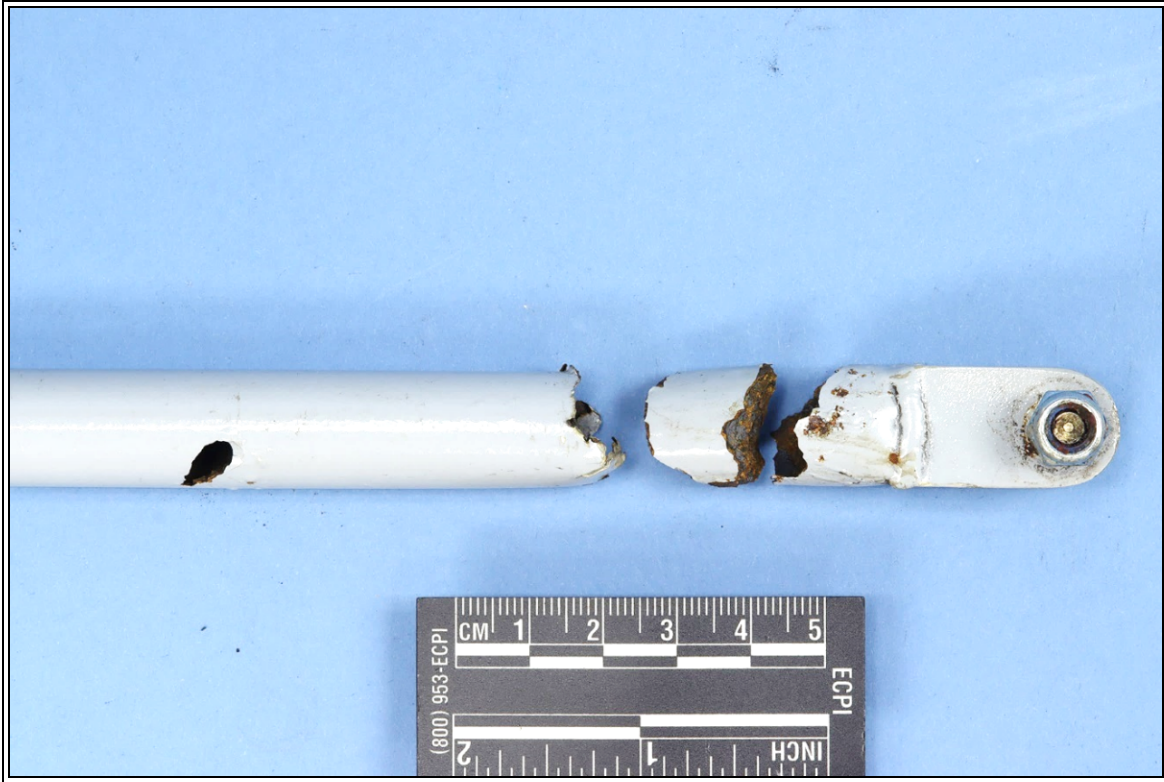
The elevator control tube was further examined by the National Transportation Safety Board Materials Laboratory, Washington, D.C. The control tube fractured in the circumferential direction at two locations at the lower end adjacent to the clevis fitting, as shown in figure 1 and figure 2. The fractures were coplanar with the upper and lower faces of a plug of corrosion product that had filled most of the inner cavity and measured between 0.35 inch and 0.60 inch in length. The fracture surfaces exhibited features consistent with overstress and loss of wall thickness due to corrosion. There was no evidence of a drain hole in the clevis fitting at the lower end of the control tube, as shown in figure 3.

Figure. Fracture of elevator control tube near the clevis fitting.

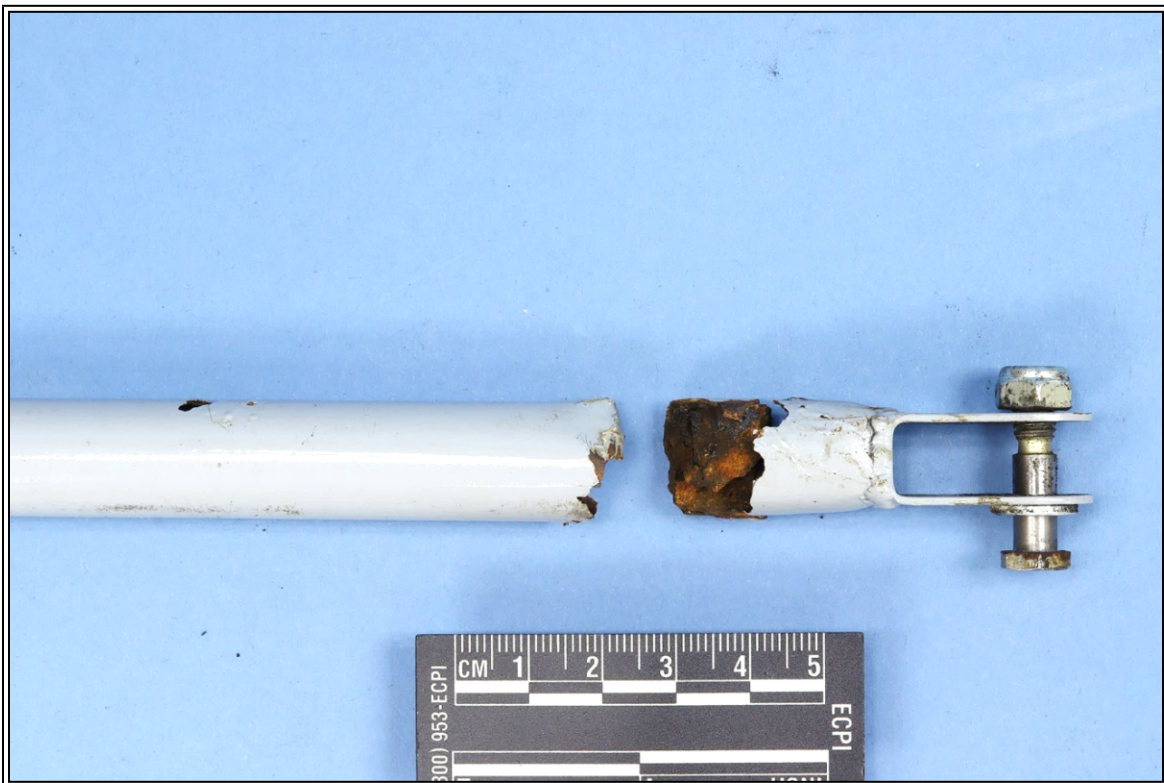
Figure 2. Fracture of elevator control tube near the clevis fitting.

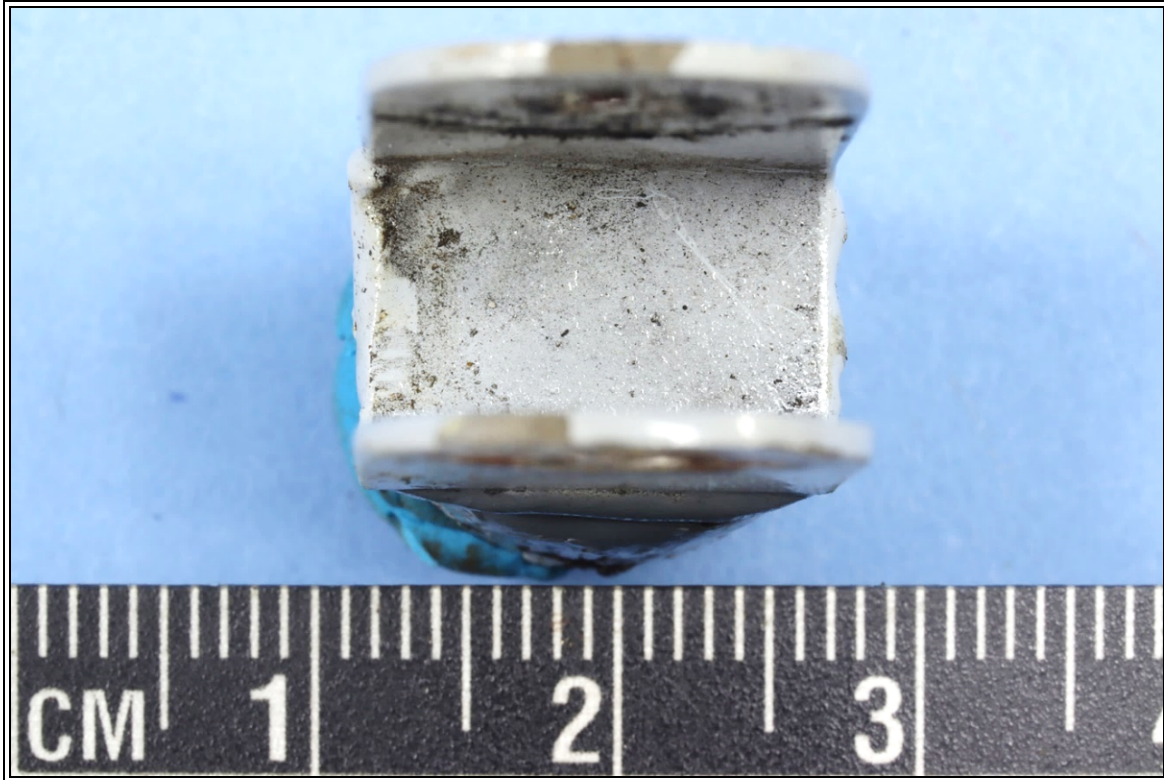
The overstress fracture of the elevator control tube due to reduced wall thickness from water intrusion and subsequent corrosion. Contributing to the accident was the lack of a drain hole at the bottom of the elevator control tube, which allowed the tube to collect water, and the mechanic's inadequate inspection of the elevator control system during the recent condition inspection.

Figure 3. Clevis fitting without drain hole.

Additionally, Service Bulletin No. G304S-12b required a surface sealing and corrosion prevention compound be inserted inside the control tube when installing a new control tube with a drainage hole at the clevis fitting or when an existing control tube is modified with a drainage hole, the installation of shrink tubing to cover the witness hole at the upper end of the control tube, and to trim the rubber sealing boot to prevent water accumulation.

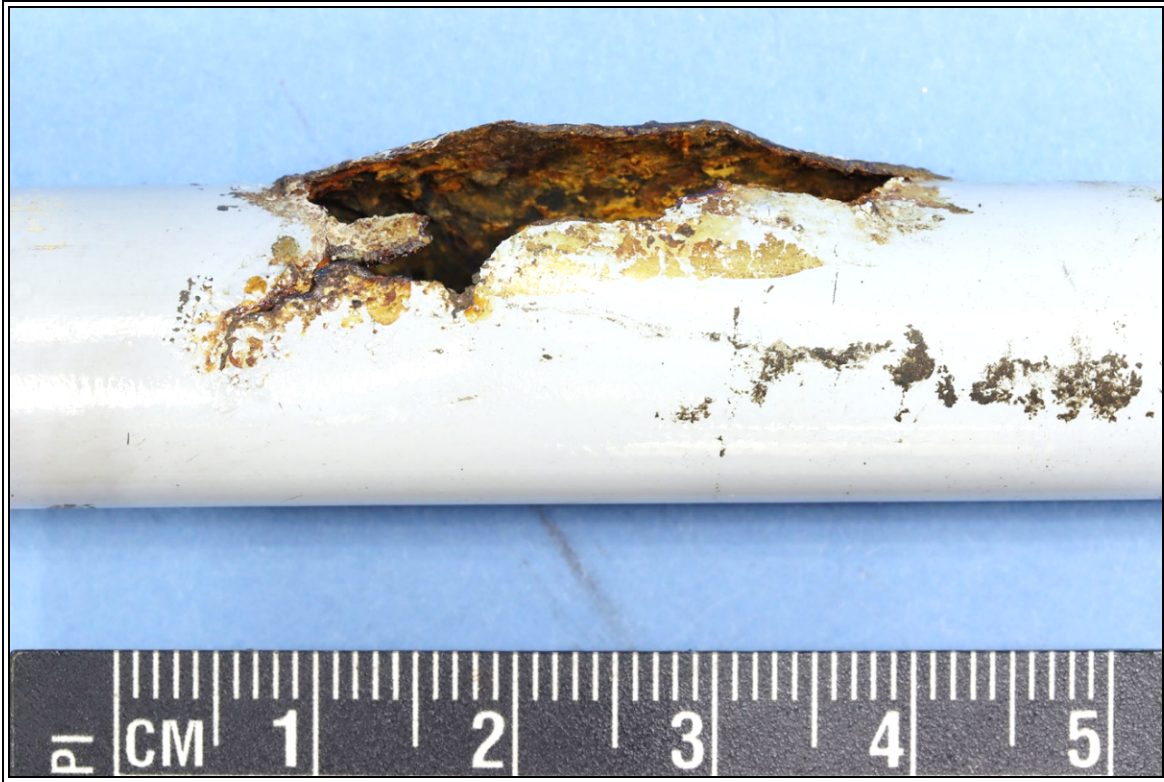
The wall thickness eventually thinned sufficiently to cause the tube to burst in the longitudinal direction near its upper end. After the control tube burst, the resulting hole on the side of the tube allowed for the easy ingress of water that made its way past the boot seal. The corrosion product and standing water at the base of the tube eventually reduced the tube wall thickness to a point where it could no longer withstand the typical operational loads and subsequently fractured in overstress near the clevis fitting during the accident flight. The overstress failure of the control tube prevented the pilot's control of the elevator during the accident flight.

The control tube was also fractured in the longitudinal direction near the upper end of the rod, as shown in figure 4 and figure 5. The midpoint of the fracture was about 2.2 inch from the upper end of the tube and it extended about 1.6 inch in the longitudinal direction. The fracture surfaces were corroded as was the inner surface of the tube and the surrounding paint was bubbled and stained. The tube material bulged outward on either side of the fracture. The fracture features were consistent with internal corrosion and an overstress fracture. The outside of the tube above the longitudinal fracture exhibited a dark stain over a length of about 0.87 inch, as shown in figure 6, consistent with contact with the collar of the rubber sealing boot. The stain extended just above the level of the witness hole. Internal corrosion was observed along the entire length of the rod, as shown in figure 7 and figure 8.

Figure 4. Fracture of control tube near the upper end.

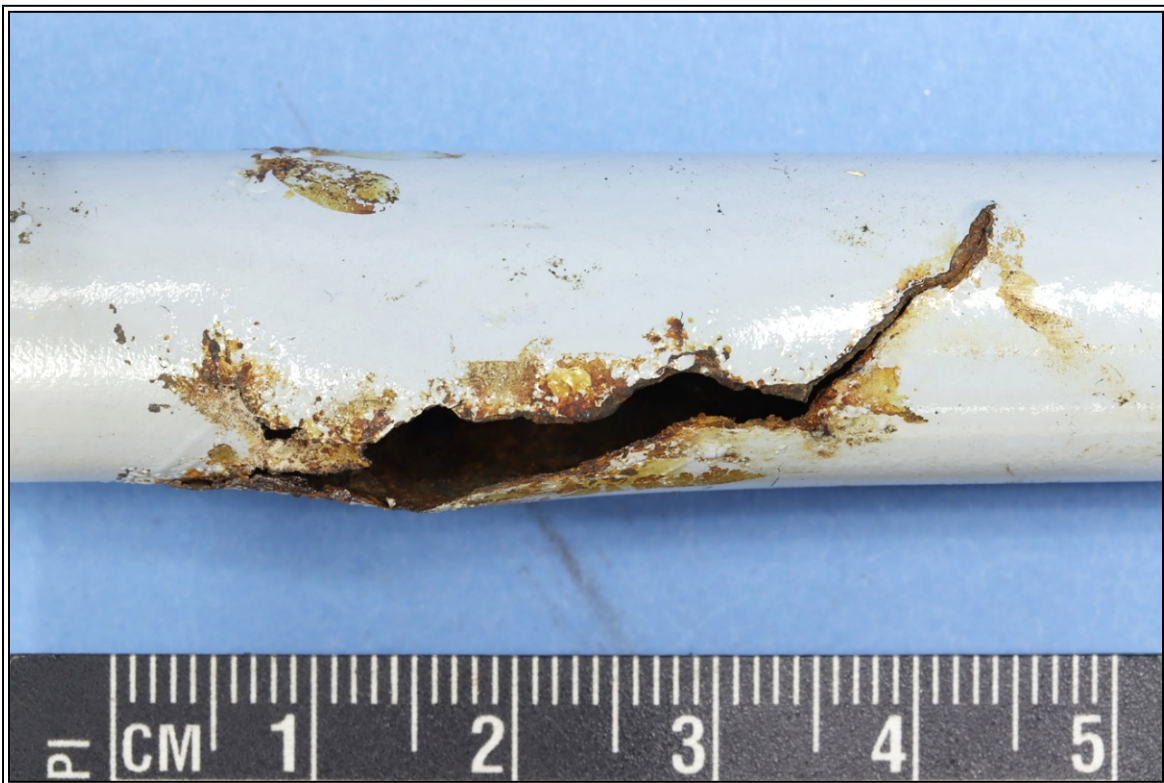
Figure 5. Fracture of control tube near the upper end.

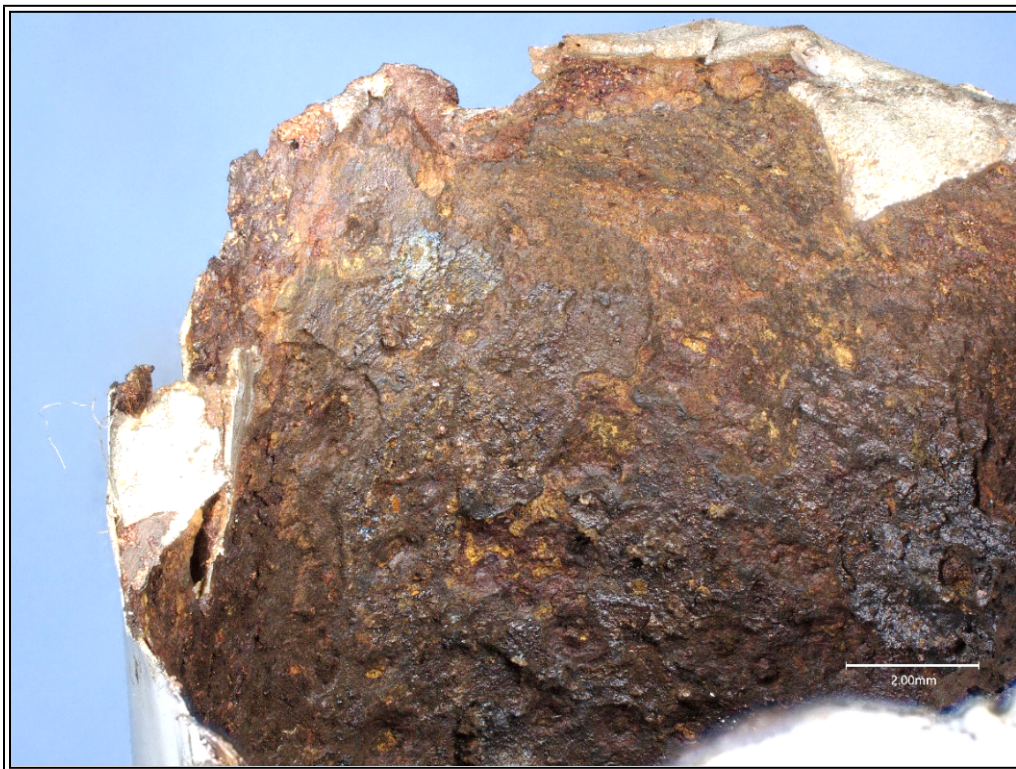
Postaccident examination determined that the elevator control tube installed in the vertical stabilizer was corroded along the entire length of its inner surface, reducing its wall thickness. Water likely entered the control rod, either through a witness hole near the upper end of the control tube or as moisture carried in by humid air. There was no drain hole at the bottom end of the control tube and, as a result, there was no way for liquid water to drain out of the control tube.

Figure 7. Inner surface of control tube near the clevis fitting fracture.

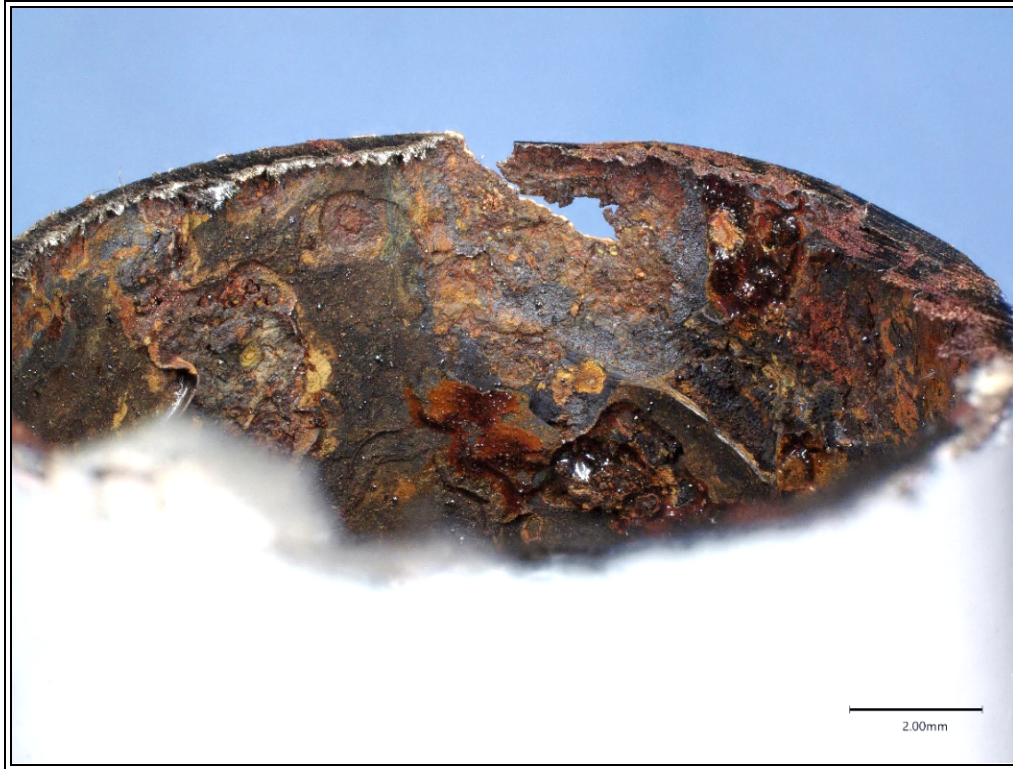
Figure 8. Inner surface of control tube about midspan.
