Aviation Investigation Final Report

Location:	Victoria, Minnesota	Accident Number:	CEN21FA360
Date & Time:	August 7, 2021, 17:40 Local	Registration:	N9156Z
Aircraft:	Mooney M20M	Aircraft Damage:	Destroyed
Defining Event:	Loss of control in flight	Injuries:	3 Fatal
Flight Conducted Under:	Part 91: General aviation - Personal

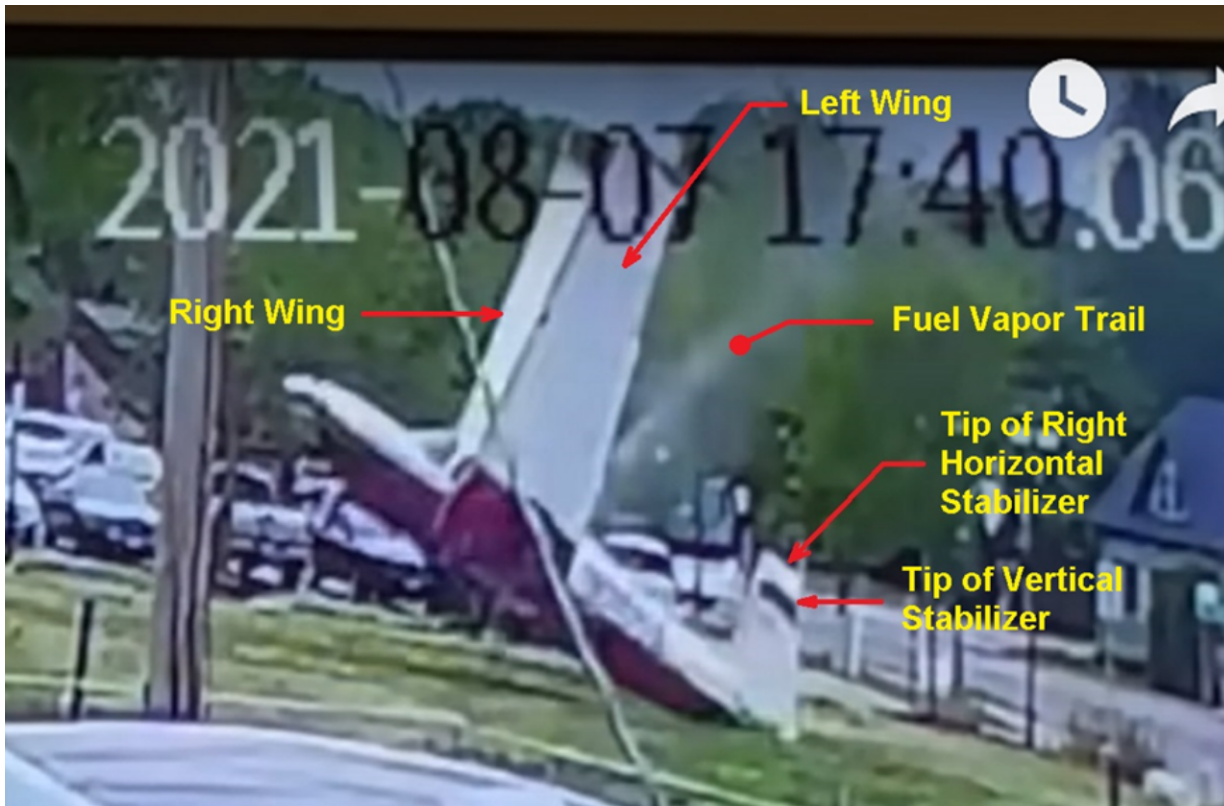
Several witnesses heard a loud popping noise and observed the airplane in a rapid descent with at least one of the wings "folded up." Review of a doorbell security video near the accident site revealed that the airplane was upright and in a nose-high attitude at ground impact and that both wings and the right stabilizer were deflected upward in a vertical position (see figure 1). A King Air pilot who heard the accident pilot's communications with the controller stated that the pilot sounded "stressed" and "confused."

Figure 1. Screen capture of airplane just before impact (Source: doorbell security video).

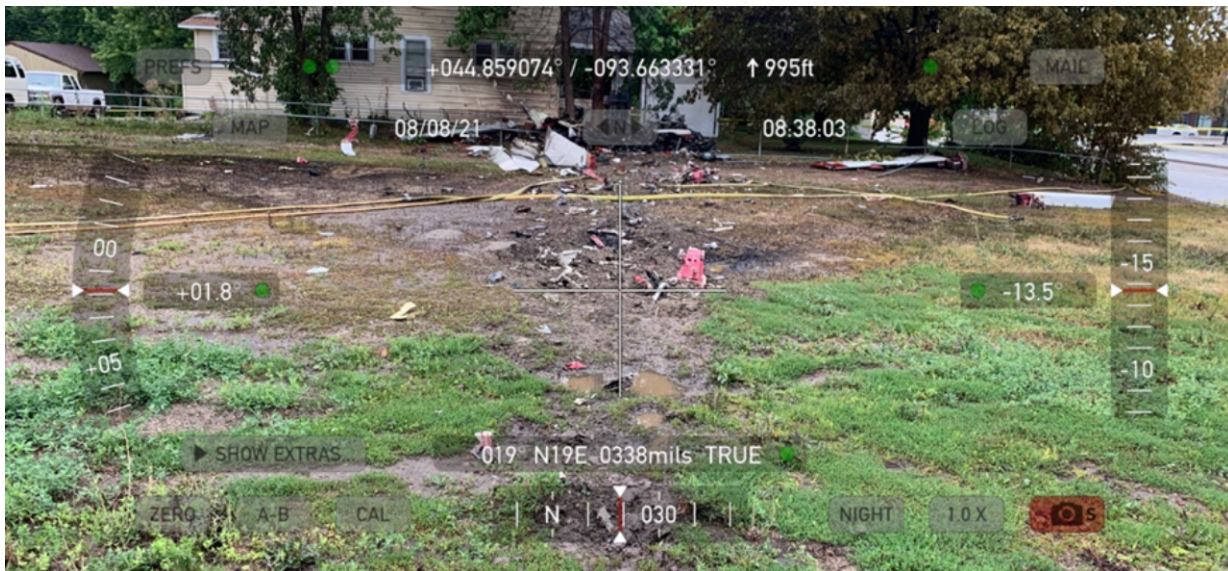
The airplane impacted the ground on a northerly heading (see figure 2). The left horizontal stabilizer and left elevator were found about 720 and 800 ft southwest of the accident site, respectively. A 6-inch section of the main wing spar upper cap splice plate was found about 300 ft southwest of the accident site.

Figure 2. Airplane at accident site with parametric data overlaid.

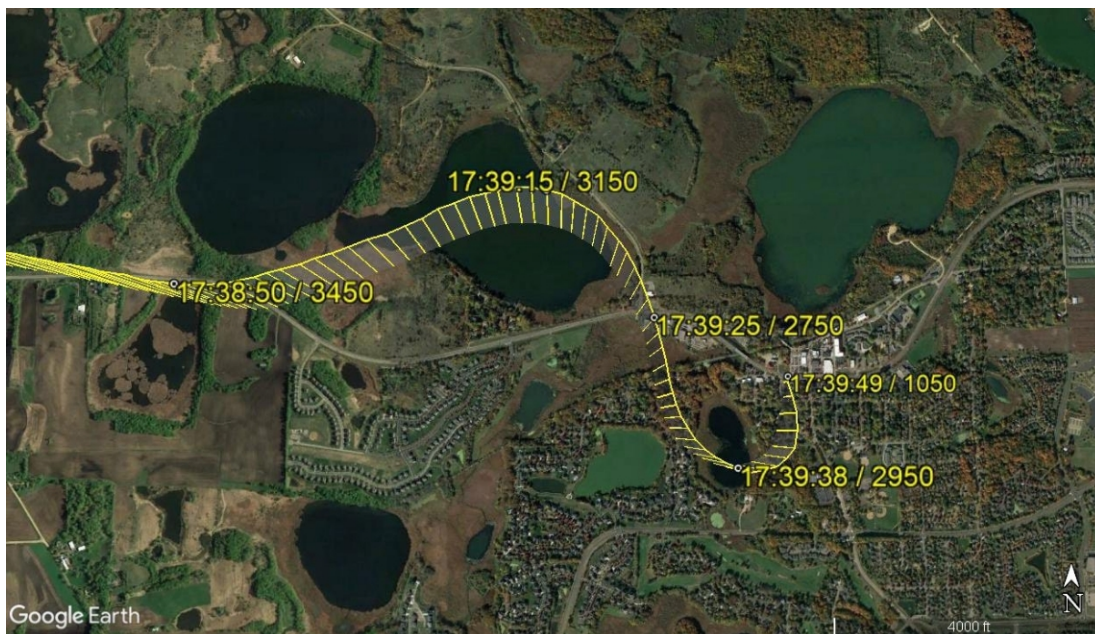
The NTSB conducted a performance study for this accident based on ADS-B data. The study found that, after 1739:00, the airplane made increasingly tight turns at speeds above V_A (see figure 3).

Figure 3. Flightpath showing increasingly tight turns with times and altitudes (in msl).

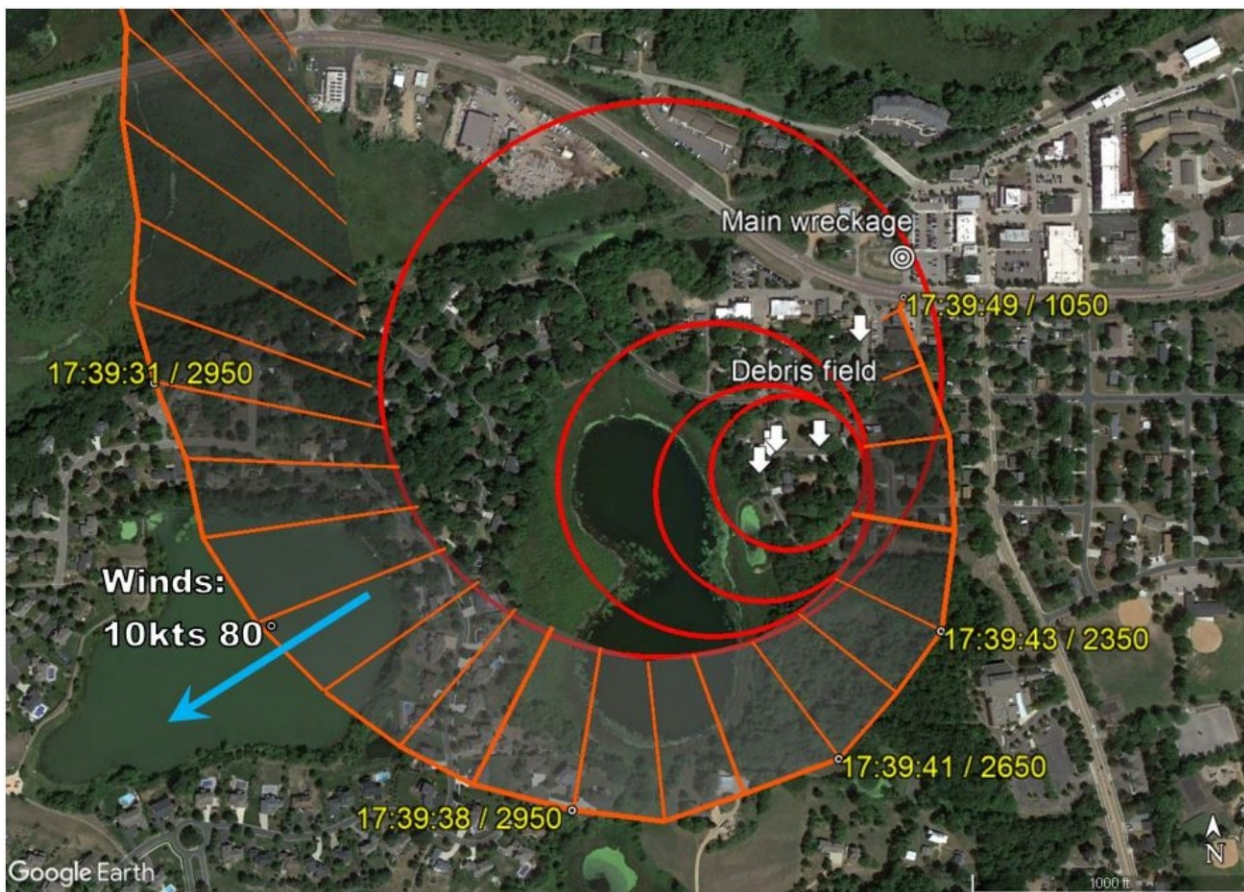
About 1739:25, the airplane began its final left turn. About 13 seconds later, the left-turn radius tightened markedly (see figure 4). The airplane began to descend at more than 7,000 ft per minute, and its airspeed increased to more than 180 knots. As the airplane's left turn tightened and airspeed increased, the resulting bank angle and load factor increased.

Figure 4. Final turn with time and altitudes (in msl). The red circles near the center of the figure depict the radius of the airplane's final left turn at four different points.

By 1739:43, the 4.8-G estimated load factor exceeded the manufacturer's maximum positive load factor for the airplane. About 1 second later, the increased speed and tighter turn resulted in a load factor that was more than 8 Gs. From 1739:43 to 1739:45, the airplane's groundspeed increased about 40 knots, and the left turn rate accelerated with a 046° heading change.
