# Aviation Investigation Final Report

<b>Location:</b>	Fort Lauderdale, Florida	<b>Accident Number:</b>	ERA21LA336
<b>Date &amp; Time:</b>	August 21, 2021, 13:40 Local	<b>Registration:</b>	N277GM
<b>Aircraft:</b>	GULFSTREAM AEROSPACE G-IV	<b>Aircraft Damage:</b>	Substantial
<b>Defining Event:</b>	Preflight or dispatch event	<b>Injuries:</b>	14 None
<b>Flight Conducted Under:</b>	Part 91: General aviation - Personal

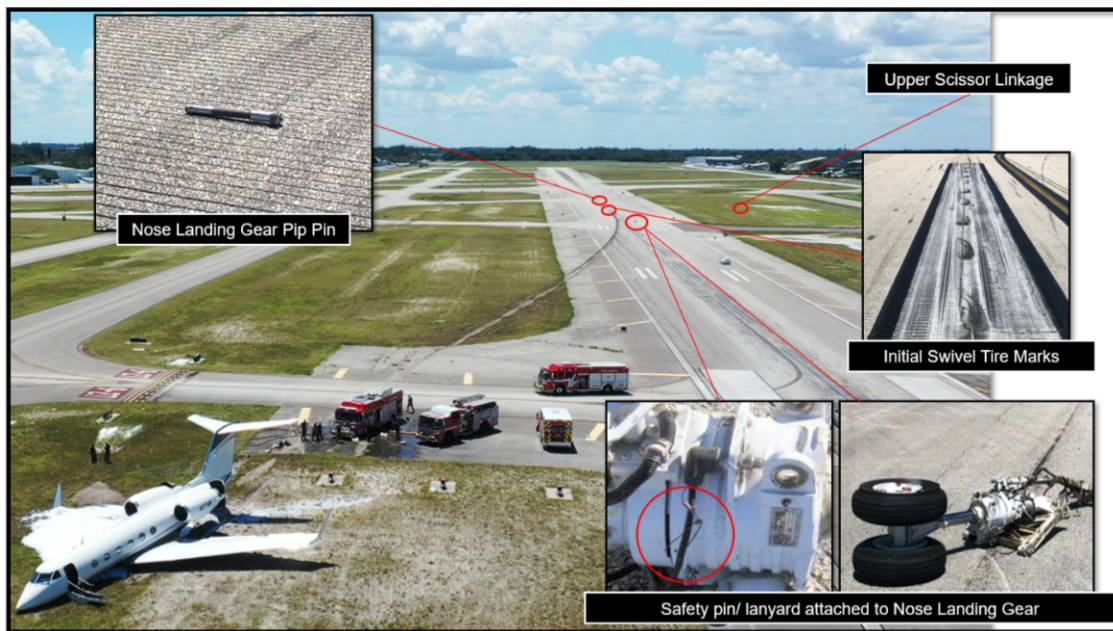
Figure 1: Overview of the main wreckage and runway environment (Source: FXE Airport Authority)

Examination of the runway environment revealed that the first item of debris located on the runway was the pip pin. Shortly after this location, tire swivel marks were located near the runway centerline, which were followed by large scrape and tire marks, leading to the separated NLG. The safety pin remained attached to the NLG via its lanyard and was undamaged.

Examination of the runway environment and accident site revealed that the airplane came to rest in a sandy grass area about 200 ft to the right of the runway 9 centerline. The left main landing gear did not collapse; however, the right main landing gear had punctured upward into the inboard aft section of the right wing, which resulted in substantial damage.

All major components of the nose landing gear (NLG), which had sheared from the airplane, were located on or near runway 9. The first item located on the runway, farthest from the main wreckage, was the NLG pip pin (upper torque link pin). It was found about 2,215 ft from the main wreckage. The bulk of the NLG came to rest near the runway centerline about 900 ft

farther down the runway from the pip pin. The safety pin that was normally installed through the pip pin was found intact still attached to the separated NLG by its lanyard cord.

Figure 1 shows a still image captured by the FXE Airport Authority drone shortly after the accident. Additional photographs have been added to the drone image to show the location of swivel tire marks and where components were located on the runway as noted with the red circles.

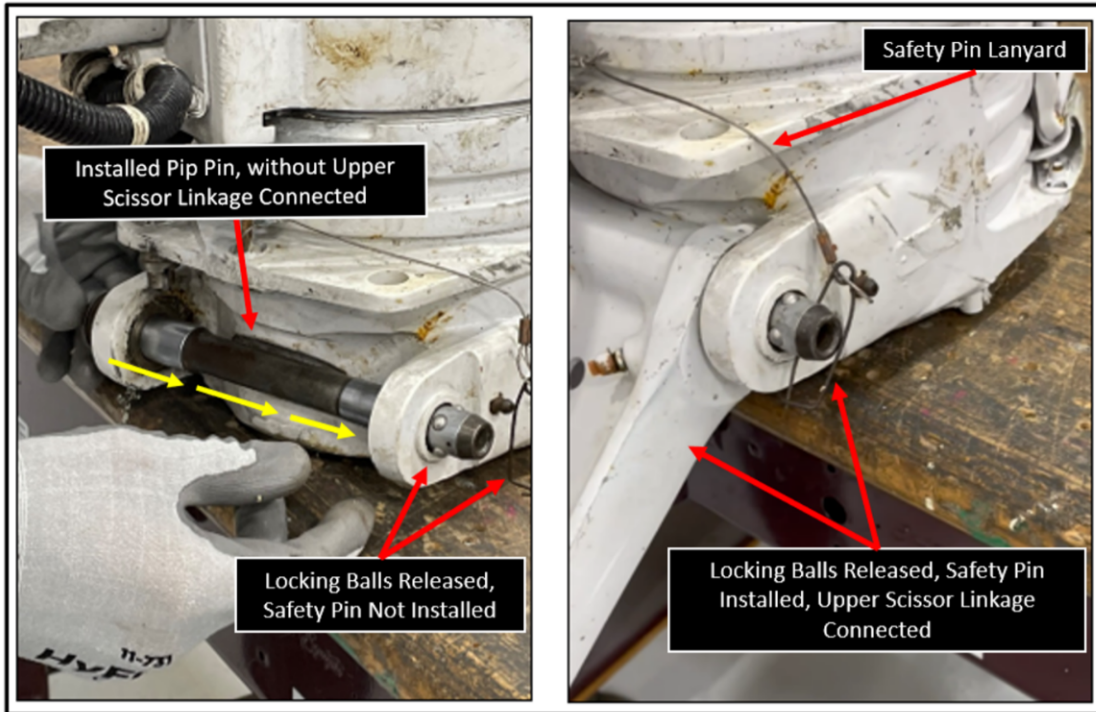
Figure 2: View of the NLG and pip pin installed during postaccident examination testing

Postaccident examination and testing of the NLG and its pins revealed no evidence of preimpact mechanical malfunctions or failures. The sticking of the pip pin plunger button that the ground crew reported experiencing could not be duplicated during postaccident testing. When installed on the NLG, the locking ball mechanism worked as intended, and the pip pin could not be removed by hand.

Figure 2 shows the accident NLG, the pip pin, and the safety pin installed during postaccident examination and testing. The NLG and pip pin as found did not possess the second lanyard, safety clip, or handle that was called for in the Gulfstream Technical Publications.

Postaccident examination and testing of the separated NLG and its pins revealed no anomalies. The pip pin displayed some exterior damage due to its impact with the runway. It

could be inserted into position and the plunger and locking balls operated without issue. With the plunger and locking balls released, the safety pin was inserted into the pip pin without issue. Attempts were made to remove the pip pin by hand, with the locking balls released, but as designed, the balls prevented the pin from being removed from the upper torque link arm; the pip pin could not be removed either with or without the safety pin installed. The NLG and pip pin as found did not possess the second lanyard, safety clip, or handle that is normally attached.
