Aviation Investigation Final Report

Location:	Fort Lauderdale, Florida	Accident Number:	ERA21LA336
Date & Time:	August 21, 2021, 13:40 Local	Registration:	N277GM
Aircraft:	GULFSTREAM AEROSPACE G-IV	Aircraft Damage:	Substantial
Defining Event:	Preflight or dispatch event	Injuries:	14 None
Flight Conducted Under:	Part 91: General aviation - Personal

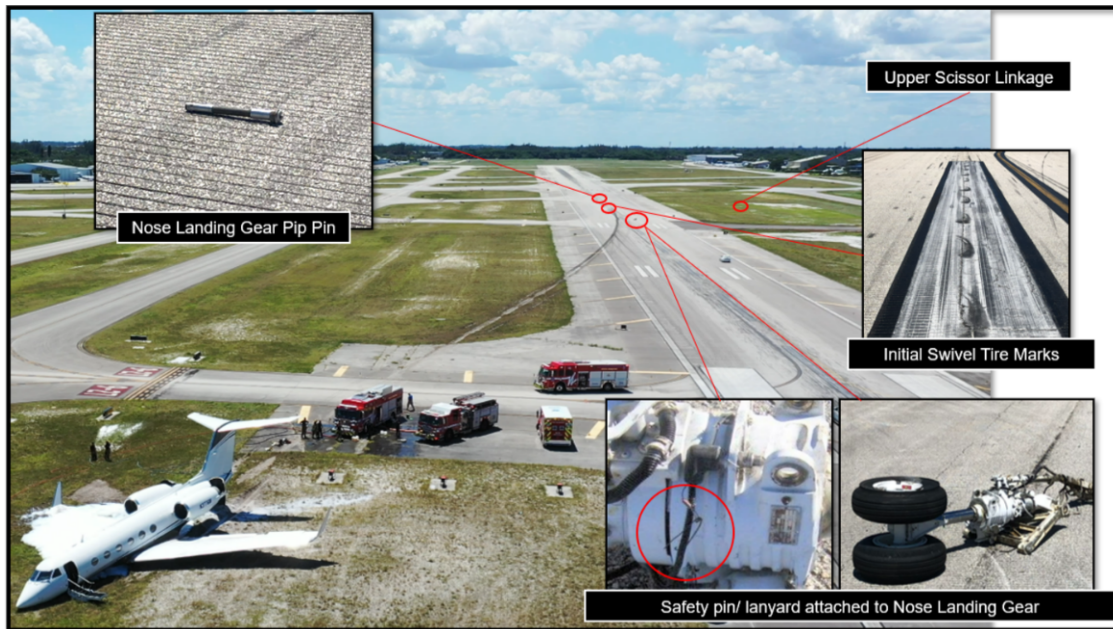
Examination of the runway environment revealed that the first item of debris located on the runway was the pip pin. Shortly after this location, tire swivel marks were located near the runway centerline, which were followed by large scrape and tire marks, leading to the separated NLG. The safety pin remained attached to the NLG via its lanyard and was undamaged.

All major components of the nose landing gear (NLG), which had sheared from the airplane, were located on or near runway 9. The first item located on the runway, farthest from the main wreckage, was the NLG pip pin (upper torque link pin). It was found about 2,215 ft from the main wreckage. The bulk of the NLG came to rest near the runway centerline about 900 ft

farther down the runway from the pip pin. The safety pin that was normally installed through the pip pin was found intact still attached to the separated NLG by its lanyard cord.

Figure 1 shows a still image captured by the FXE Airport Authority drone shortly after the accident. Additional photographs have been added to the drone image to show the location of swivel tire marks and where components were located on the runway as noted with the red circles.

Figure 1: Overview of the main wreckage and runway environment (Source: FXE Airport Authority)
