Aviation Investigation Final Report

Location:	Farmington, Connecticut	Accident Number:	ERA21FA346
Date & Time:	September 2, 2021, 09:51 Local	Registration:	N560AR
Aircraft:	Cessna 560	Aircraft Damage:	Destroyed
Defining Event:	Collision with terr/obj (non-CFIT)	Injuries:	4 Fatal, 1 Serious, 3 Minor
Flight Conducted Under:	Part 91: General aviation - Personal

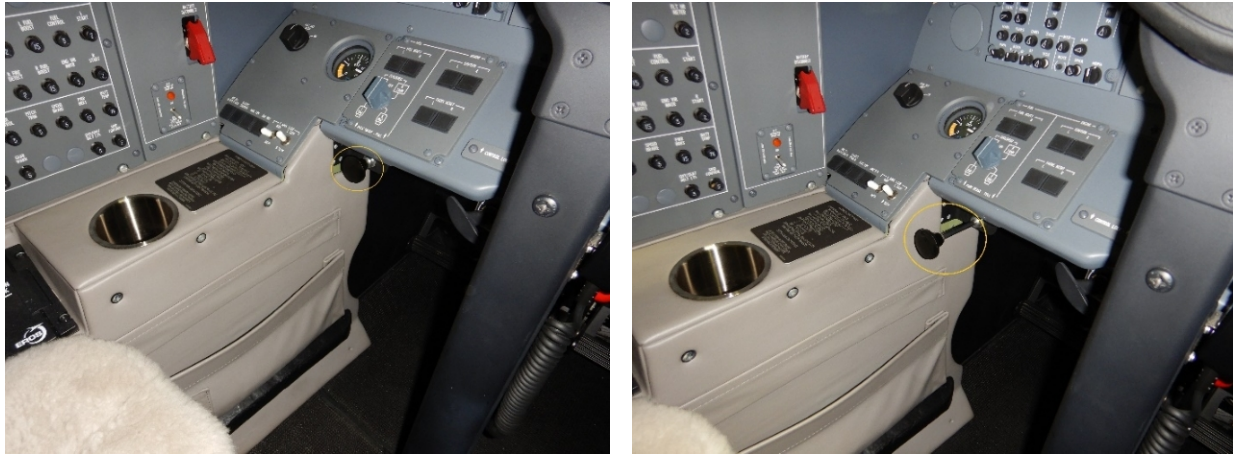
The parking brake knob was located on the tilt panel forward of the left seat pilot's seat adjacent to the occupant's knee and was not visible to the right seat occupant.

Per the airplane operating manual, the parking brake is set by depressing the toe brakes in the normal manner, then pulling out the parking brake pull knob on the left lower side of the tilt panel. That action mechanically actuates the parking brake valve, trapping fluid in the brakes. The parking brake is released by pushing in the parking brake pull knob.

Figure 1. Pictures from an exemplar 560 XLS+ showing the parking brake off (left) and set (right).

The airplane was equipped with a crew alerting system (CAS) that did not incorporate parking brake valve position as part of its activation logic, nor was there an indication or annunciation in the cockpit when the parking brake was not fully released. A red NO TAKEOFF warning CAS message would display a NO TAKEOFF aural warning for some conditions that would impede a safe takeoff, such as if the throttles were advanced beyond the climb setting or the flaps were not configured for takeoff.
