# Aviation Investigation Final Report

| <b>Location:</b> | Provincetown, Massachusetts | <b>Accident Number:</b> | ERA21FA354 |
| <b>Date &amp; Time:</b> | September 9, 2021, 15:27 Local | <b>Registration:</b> | N88833 |
| <b>Aircraft:</b> | Cessna 402C | <b>Aircraft Damage:</b> | Substantial |

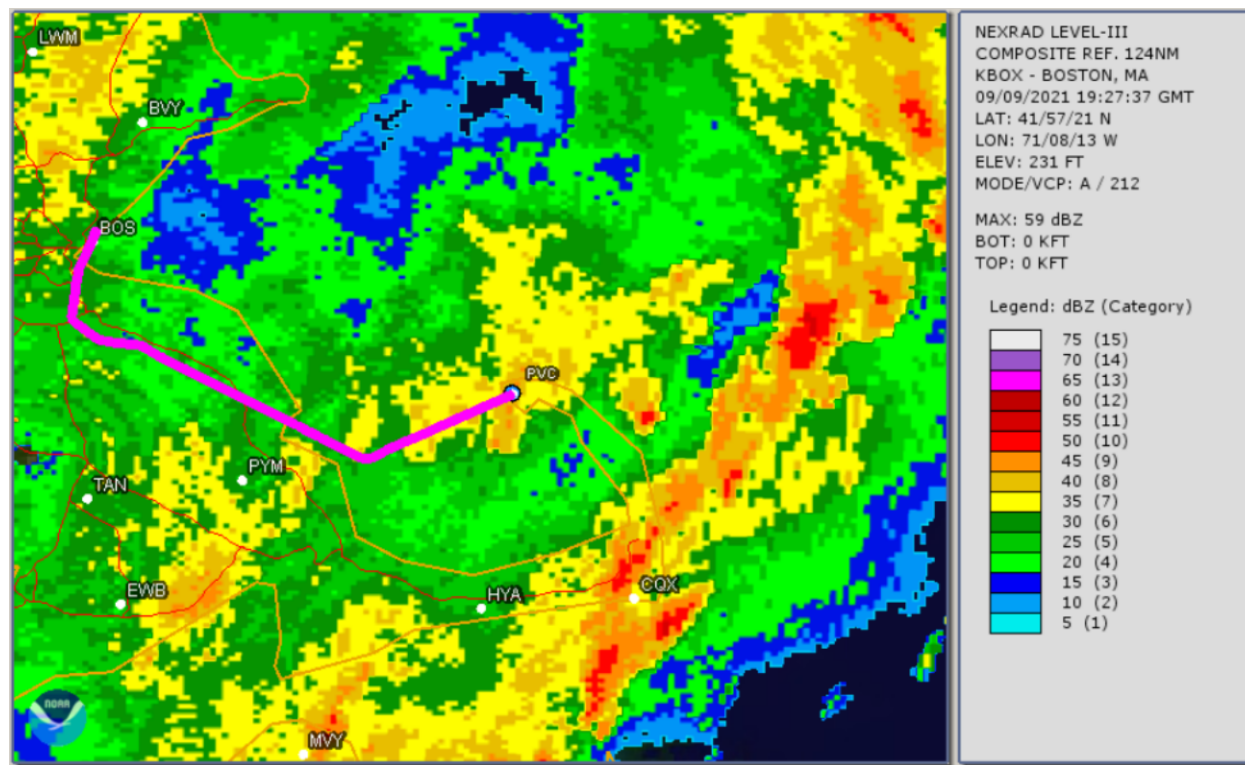
Figure 1 – Boston WSR-88D Composite reflectivity image and flight track at 1527 EDT

The High Resolution Rapid-Refresh (HRRR) sounding indicated an unstable atmosphere favorable for convection, with a low potential for any non-convective low-level wind shear at the time of the accident. The sounding (and satellite imagery) did not indicate any microburst potential over the accident site at the time of the accident. Furthermore, WSR-88D weather radar imagery did not detect any outflow boundaries or microburst at the time of the accident.
