Aviation Investigation Final Report

Location:	Lake Havasu City, Arizona	Accident Number:	WPR21FA340
Date & Time:	September 12, 2021, 16:09 Local	Registration:	N2085Q
Aircraft:	Cessna 177RG	Aircraft Damage:	Substantial
Defining Event:	Loss of engine power (partial)	Injuries:	1 Fatal
Flight Conducted Under:	Part 91: General aviation - Personal

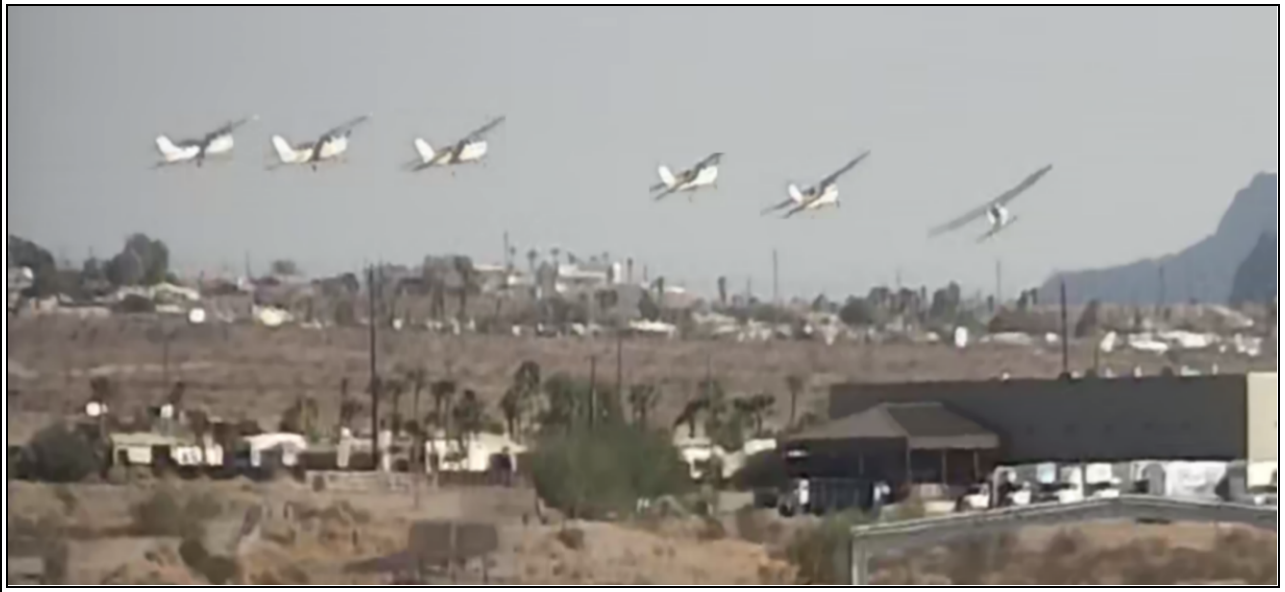
Video and audio recordings and Federal Aviation Administration (FAA) automatic dependent surveillance-broadcast (ADS-B) data showed that the pilot taxied the airplane to runway 14, performed a run-up, and departed about 1608. Witnesses reported that the airplane traveled down the runway at a slow groundspeed and noted that the engine sounded abnormal, as if it were producing partial power. The airplane veered to the right of the centerline and ascended 100 to 150 ft above ground level (see figure 1). ADS-B data showed that the airplane accelerated down the runway at airspeeds up to 65 knots.

Figure 1: Security camera video showing initial right veer

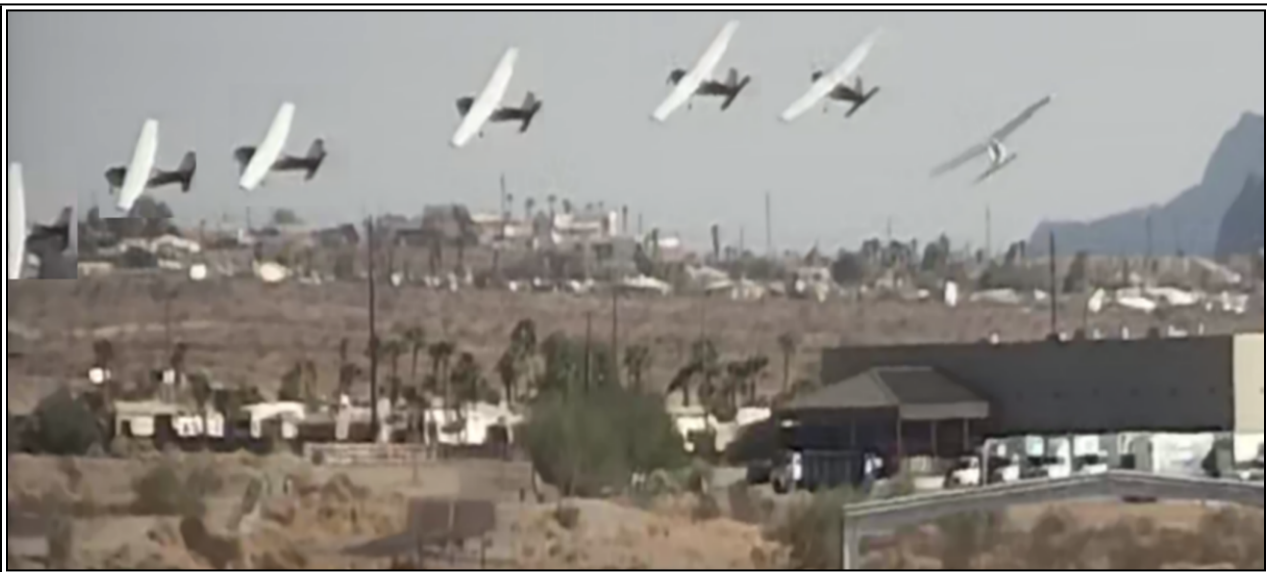
The video showed the airplane pitch to a nose-high attitude and banked to the left (see figure 2). Witnesses observed the airplane's wingspan turn nearly perpendicular to the horizon and then stall with the left wing dropping toward terrain.

Figure 2: Security camera video of left bank

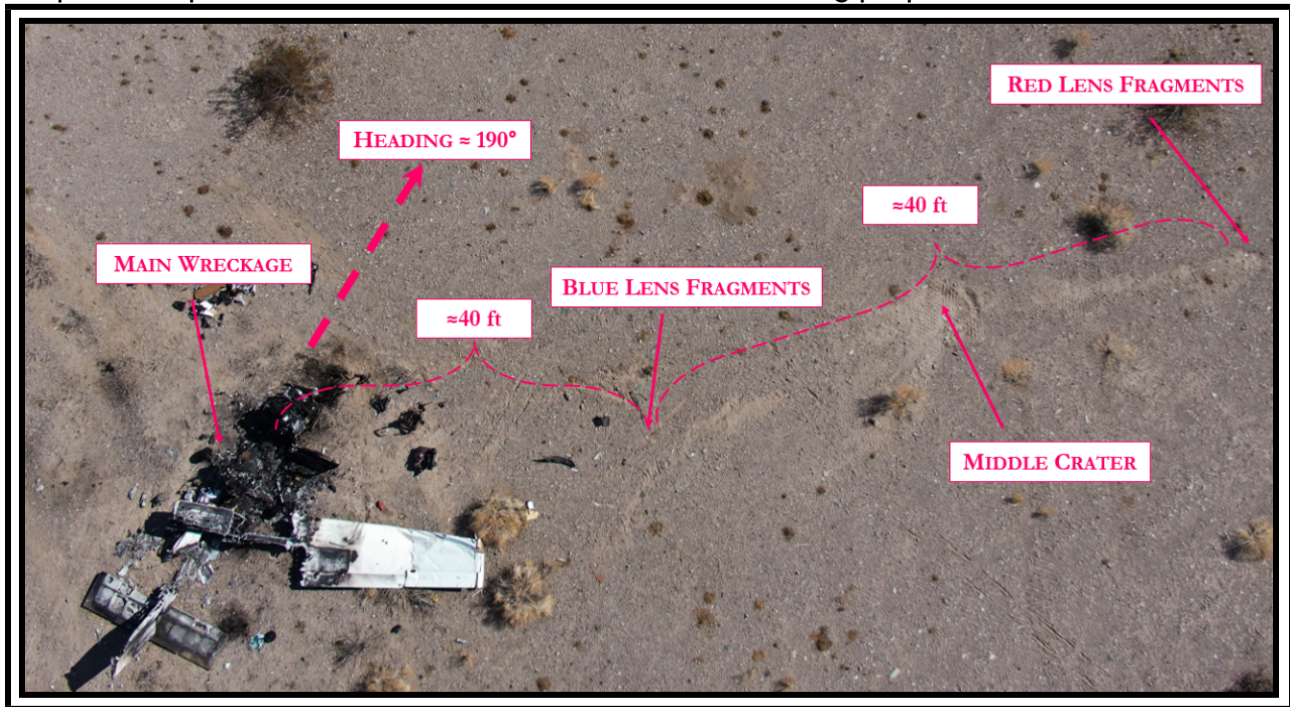
disrupted dirt on the flat desert terrain at the far east-southeast end of the debris field. The markings started as a dirt indentation with shards of red fragments imbedded within the soil, consistent with the left wingtip impacting the ground first. The crater was continuous toward the main wreckage, and the end of the crater had blue/green fragments imbedded (see figure 4). A larger center indentation (referred to in the figure as the middle crater) was found in between the red fragments and the green/blue fragments; this indentation had a large arc-shaped disruption of dirt that was consistent with a rotating propeller blade.

Figure 4: Main wreckage in reference to first identified point of impact.

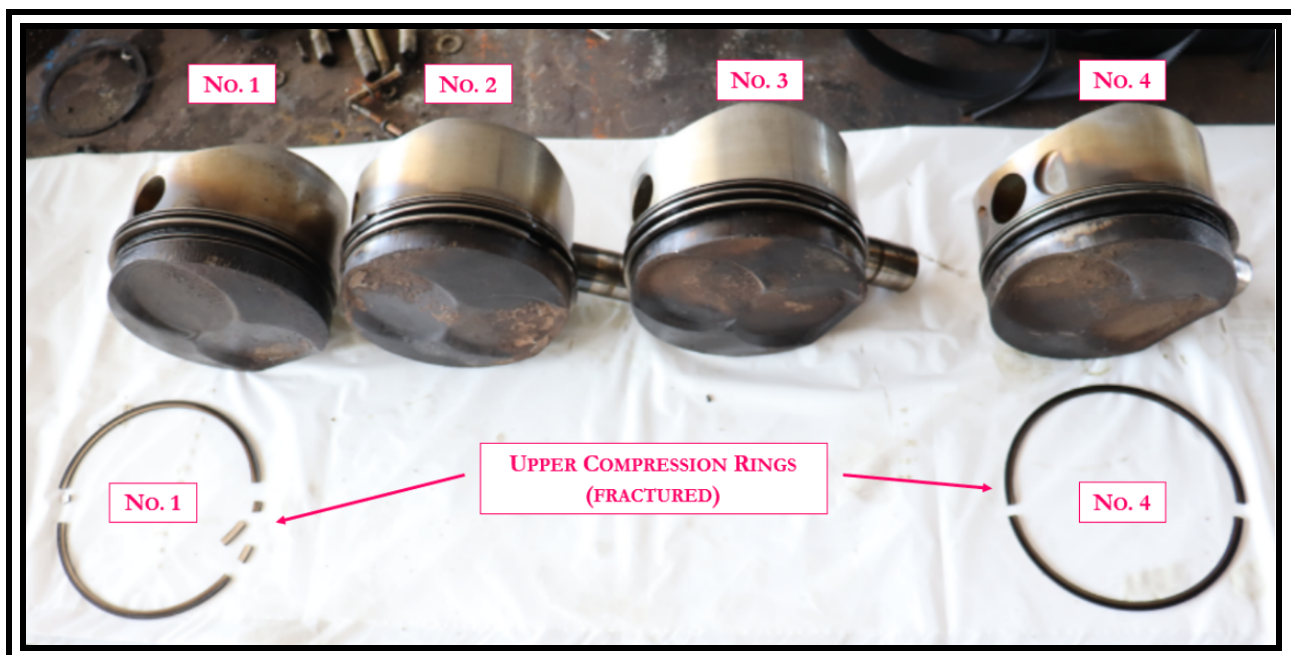
As part of the postaccident examination, most of the engine and its components were disassembled. The Nos. 1 and 4 top compression piston rings had fractured in multiple locations (see figure 5). All the piston skirts showed evidence of corrosion and wear with light scuffs/grooves oriented from the base to the crowns. Additionally, the piston skirts on all cylinders showed evidence of blow-by, with the No. 3 cylinder exhibiting the least amount of damage.

Figure 5: Fractured rings from the Nos. 1 and 4 pistons.

The National Transportation Safety Board Materials Laboratory examined the No. 1 and No. 4 fractured piston rings. The upper compression piston ring from the No. 1 cylinder had fractured in four locations. All fracture and parting surfaces exhibited iron oxides with high amounts of carbon, lead, and bromine, consistent with exposure to combustion gases from airplane fuel. Extensive wear and smoothing were observed on the fracture and parting surfaces, consistent with the fractures occurring before the accident and continuing to wear during the repetitive actuation of the pistons inside the cylinders. Fracture and wear of the rings could allow blowby of combustion gasses past the piston and oil leakage into the combustion chamber.

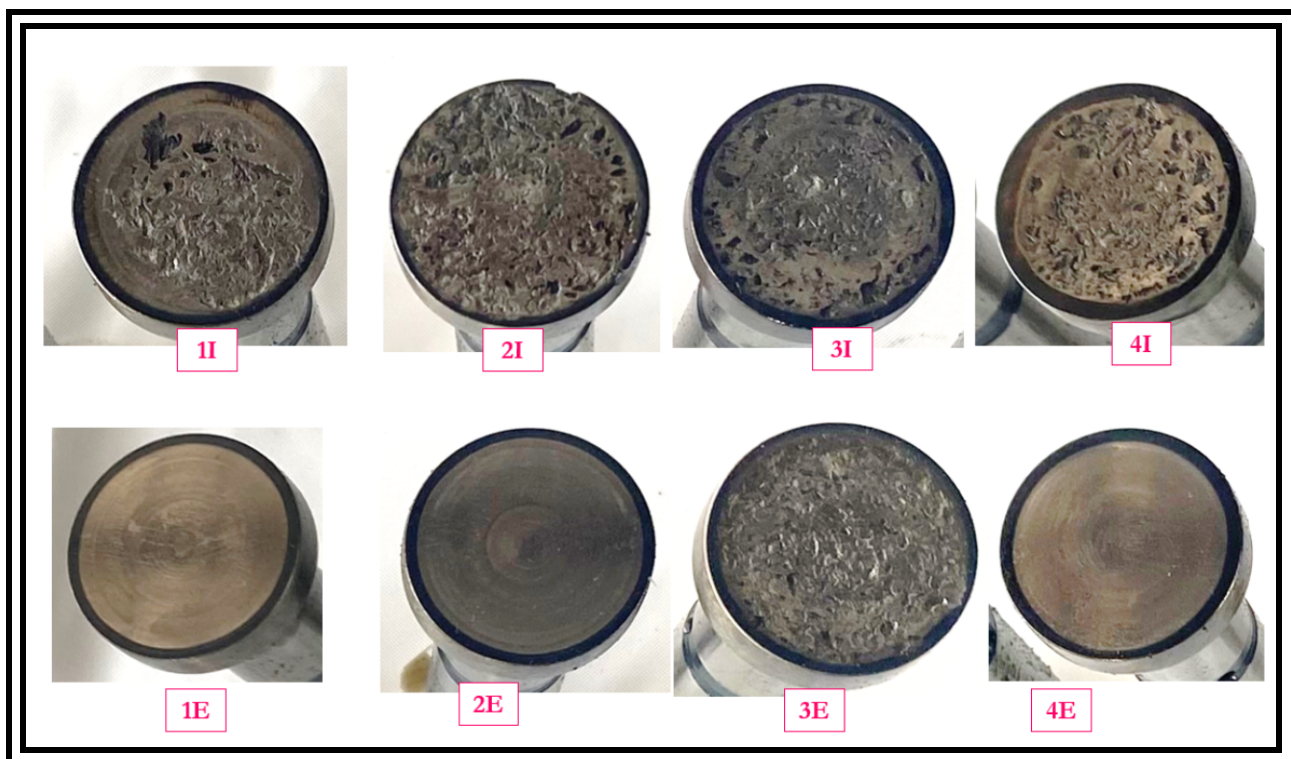
Separation of the crankcase halves revealed severe spalling on the faces of all the intake lifters and the No. 3 exhaust lifter; evidence of galling was also noted. The remaining lifters showed evidence of wear with a circular pattern and pitting (see figure 6). The camshaft revealed signatures of excessive wear on the cam lobes, including rounding of the lobes, pitting, and material deformation on the lobes.

Figure 6: Wear signatures on intake lifter faces (top row) and exhaust lifter faces (bottom row).
