Aviation Investigation Final Report

| Location: | Wadsworth, Ohio | Accident Number: | CEN21FA426 |
| Date & Time: | September 18, 2021, 18:45 Local | Registration: | N6915G |
| Aircraft: | RANS S20 | Aircraft Damage: | Destroyed |

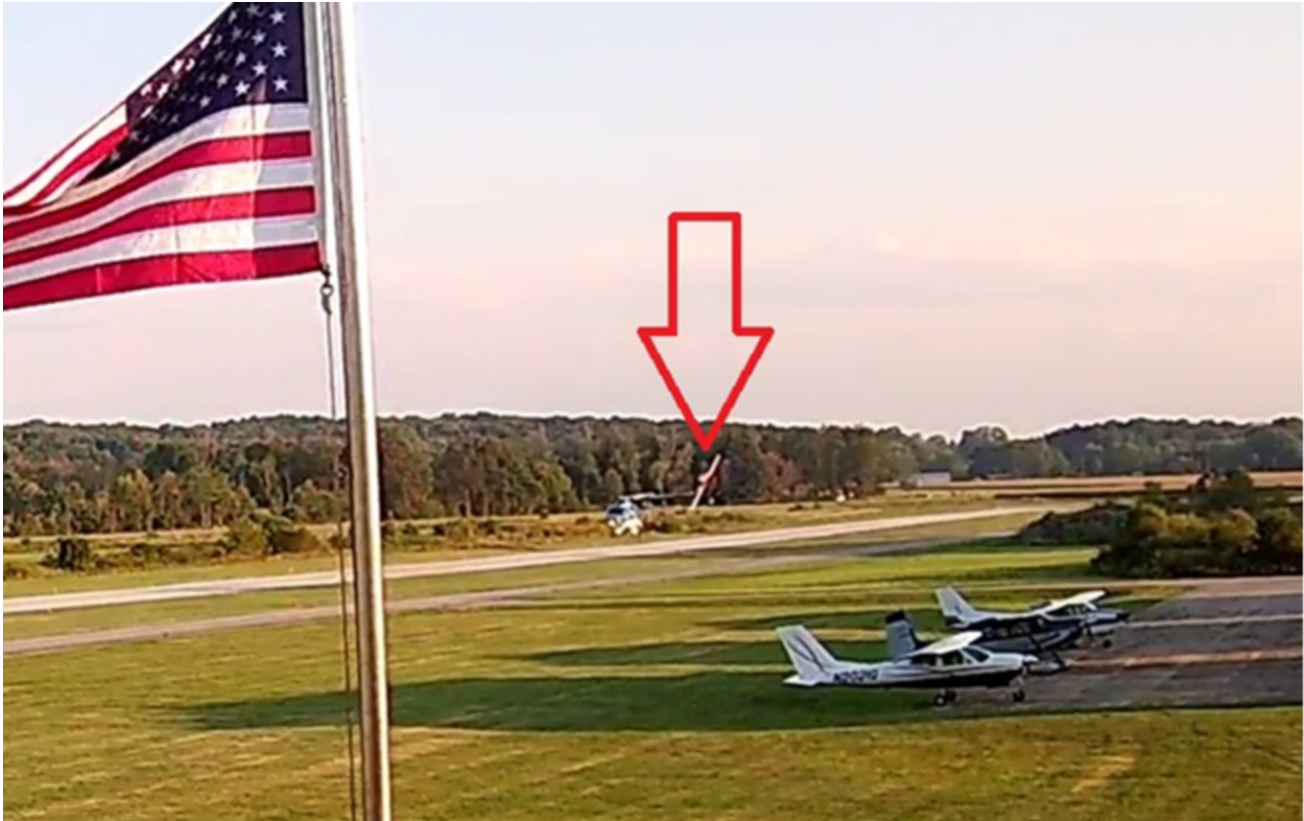
A few seconds after the helicopter flew over the approach end of runway 2, the accident pilot taxied onto the runway and started the takeoff roll. Soon after liftoff, the airplane entered a steep roll, descended, and impacted the runway (see figure 1). A postimpact fire ensued.

Figure 1. Screenshot of airport surveillance video. Red arrow points to accident airplane.

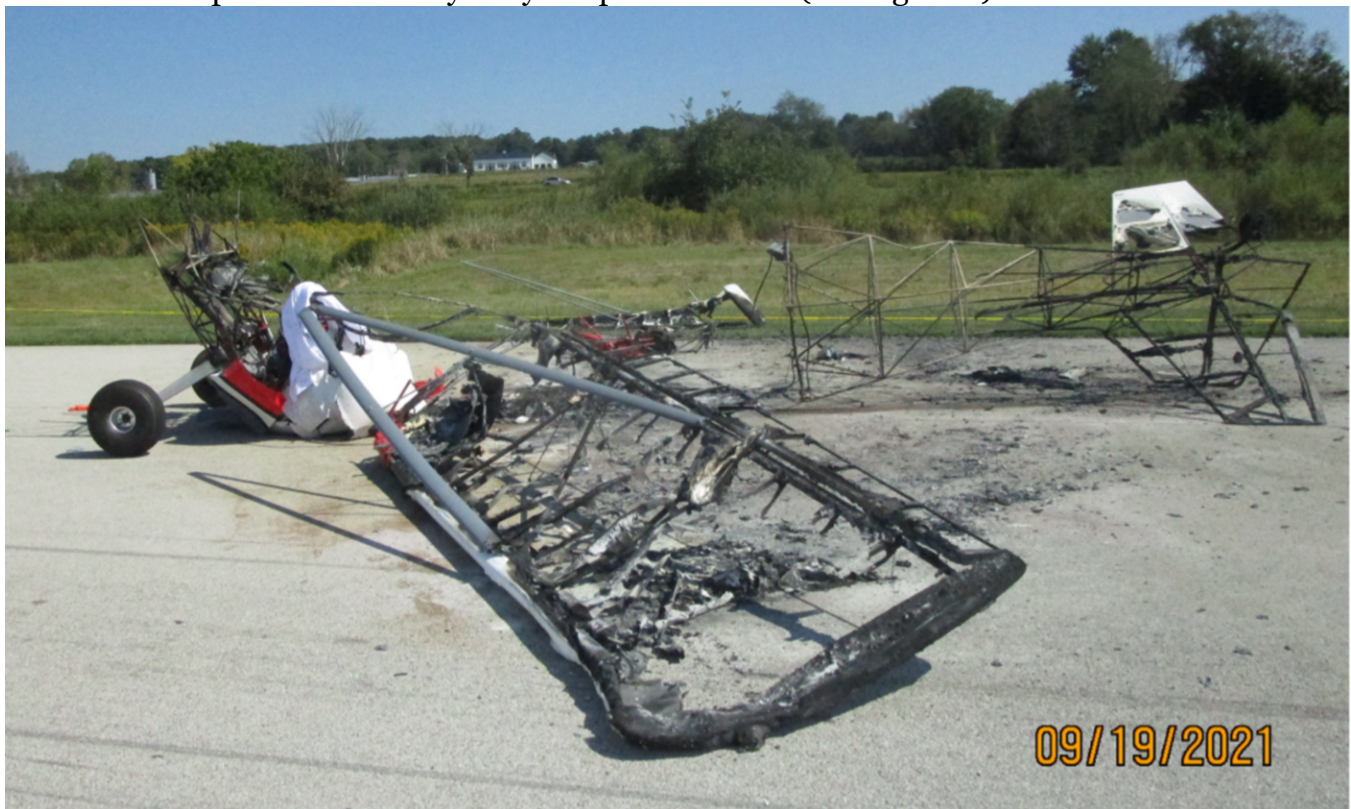
Most of the airplane was destroyed by the postcrash fire (see Figure 2).

Figure 2 – Airplane at Accident Site

Examination of the wreckage did not identify any pre-impact anomalies that would have precluded normal operation.
