Aviation Investigation Final Report

Location:	Wadsworth, Ohio	Accident Number:	CEN21FA426
Date & Time:	September 18, 2021, 18:45 Local	Registration:	N6915G
Aircraft:	RANS S20	Aircraft Damage:	Destroyed
Defining Event:	Aircraft wake turb encounter	Injuries:	1 Fatal
Flight Conducted Under:	Part 91: General aviation - Personal

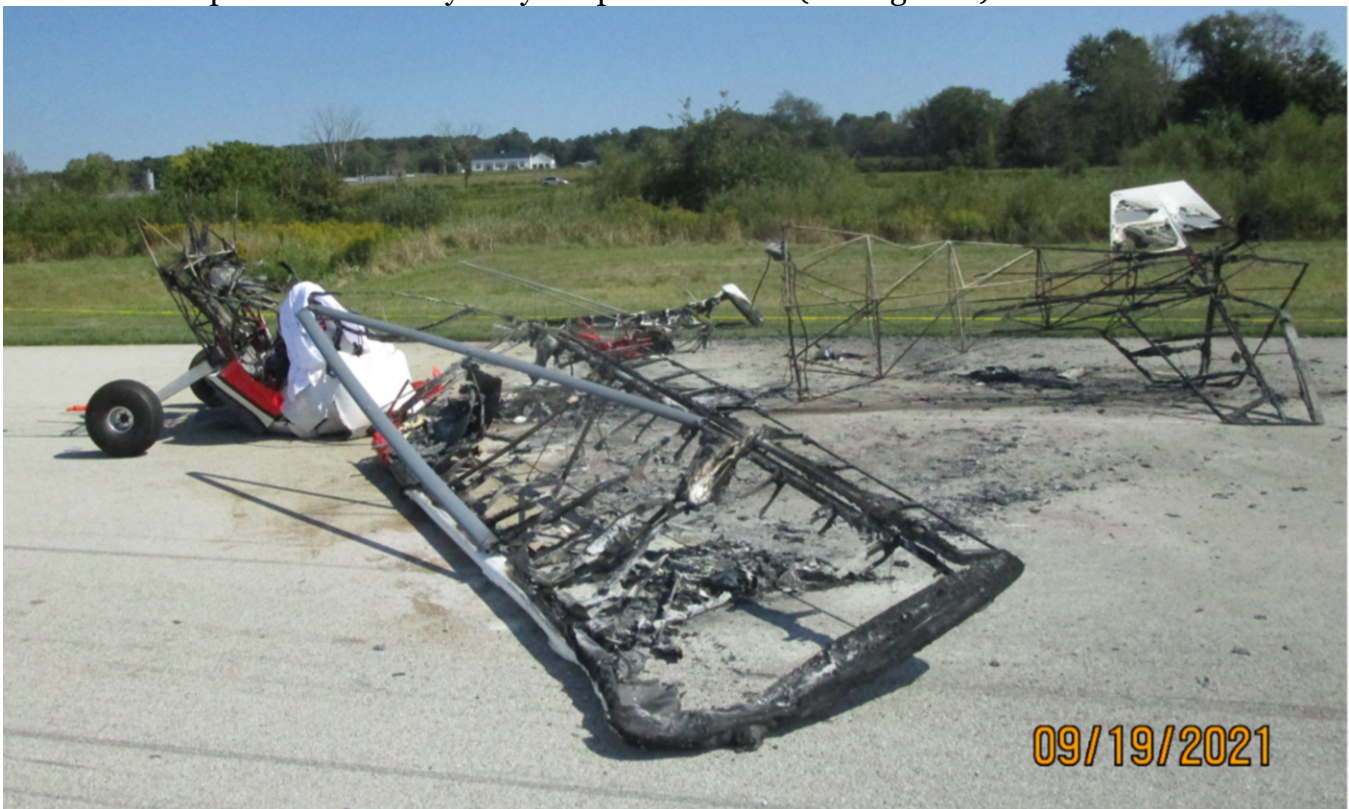
Most of the airplane was destroyed by the postcrash fire (see Figure 2).

Figure 2 – Airplane at Accident Site

Examination of the wreckage did not identify any pre-impact anomalies that would have precluded normal operation.
