Aviation Investigation Final Report

Location:	Page, Arizona	Accident Number:	WPR21FA352
Date & Time:	September 22, 2021, 16:24 Local	Registration:	N3906X
Aircraft:	Piper PA-28R-200	Aircraft Damage:	Substantial
Defining Event:	Fuel exhaustion	Injuries:	1 Fatal, 1 Serious
Flight Conducted Under:	Part 91: General aviation - Personal

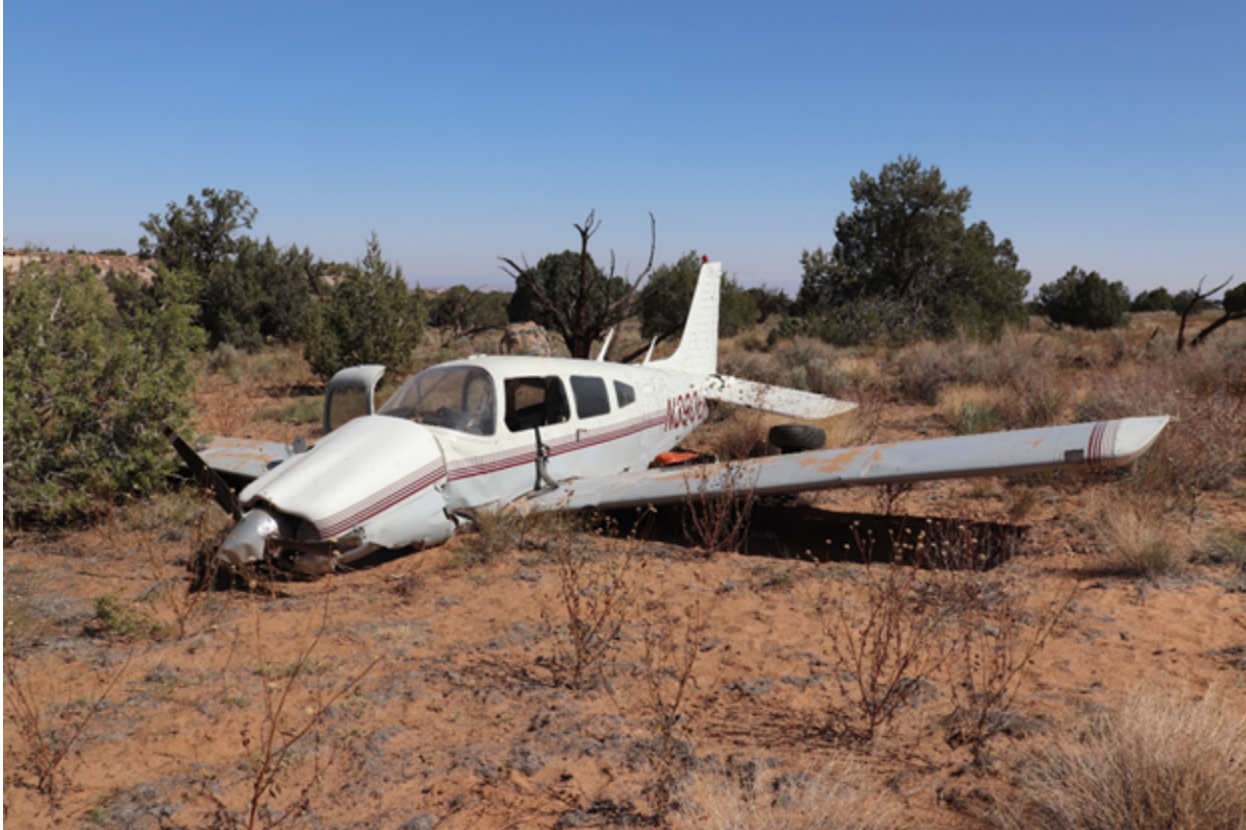
Figure. Accident site.

The airplane was located about 11 nm west of PGA on a mesa at a field elevation of about 6,150 ft msl. The airplane came to rest at a level attitude on a magnetic heading of 227°, as shown in the figure below.

The first point of impact was identified by a 12-foot-tall tree with several broken branches. A debris path was marked by parallel ground scars that began about 20 ft forward of the first point of impact and was oriented on a magnetic heading of 155°. The outboard right stabilator was located on the left side of the debris path.
