# Aviation Investigation Final Report

<b>Location:</b>	Lansing, West Virginia	<b>Accident Number:</b>	ERA21FA377
<b>Date &amp; Time:</b>	September 26, 2021, 10:09 Local	<b>Registration:</b>	N3342L
<b>Aircraft:</b>	Beech C23	<b>Aircraft Damage:</b>	Substantial
<b>Defining Event:</b>	Aerodynamic stall/spin	<b>Injuries:</b>	3 Fatal
<b>Flight Conducted Under:</b>	Part 91: General aviation - Personal

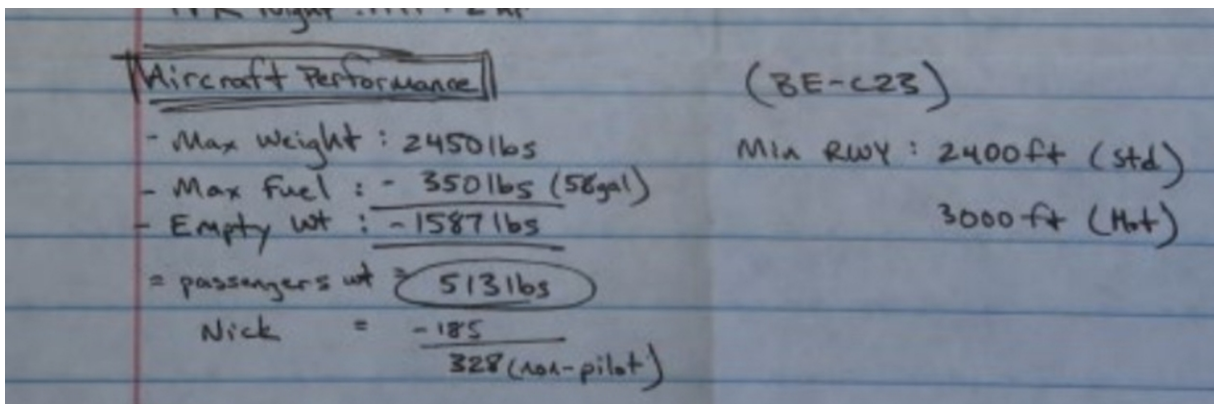
A piece of notebook paper titled, "1/25/2021 New Personal Minimums" was found inside the back cover of the pilot's personal logbook. The paper included a section titled, "Aircraft Performance," which listed the maximum gross weight of the airplane, empty weight, and maximum fuel capacity. The list included a 328-lb "non-pilot" weight, which was consistent with the airplane's payload capacity given full fuel tanks and the weight of the accident pilot.

The section also listed, "Min rwy: 2400 ft (std); 3000 ft (hot)." (see figure.)

Figure. Excerpt from "Personal Minimums" document found in pilot's logbook
