Aviation Investigation Final Report

Location:	Hiles, Wisconsin	Accident Number:	CEN21FA459
Date & Time:	September 28, 2021, 09:00 Local	Registration:	N690LS
Aircraft:	ROCKWELL INTERNATIONAL 690B	Aircraft Damage:	Destroyed
Defining Event:	Loss of control in flight	Injuries:	3 Fatal
Flight Conducted Under:	Part 91: General aviation - Aerial observation

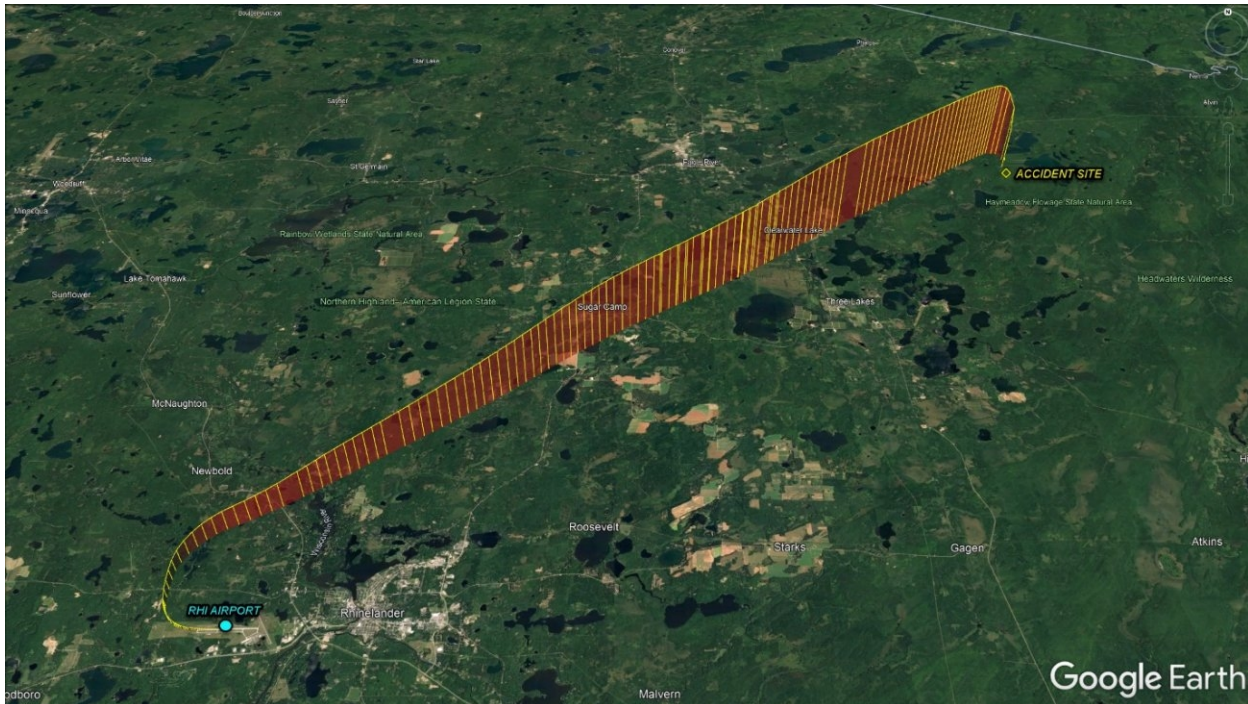
Figure 1. Airplane flightpath and accident site location.

The airplane subsequently made a right turn with a rapid descent (see figure 1), and the ADS-B data ended at 0900:56. According to ATC audio, transmissions indicating “mayday, mayday, mayday” and “we’re in a spin” were broadcast while the accident airplane was in flight.

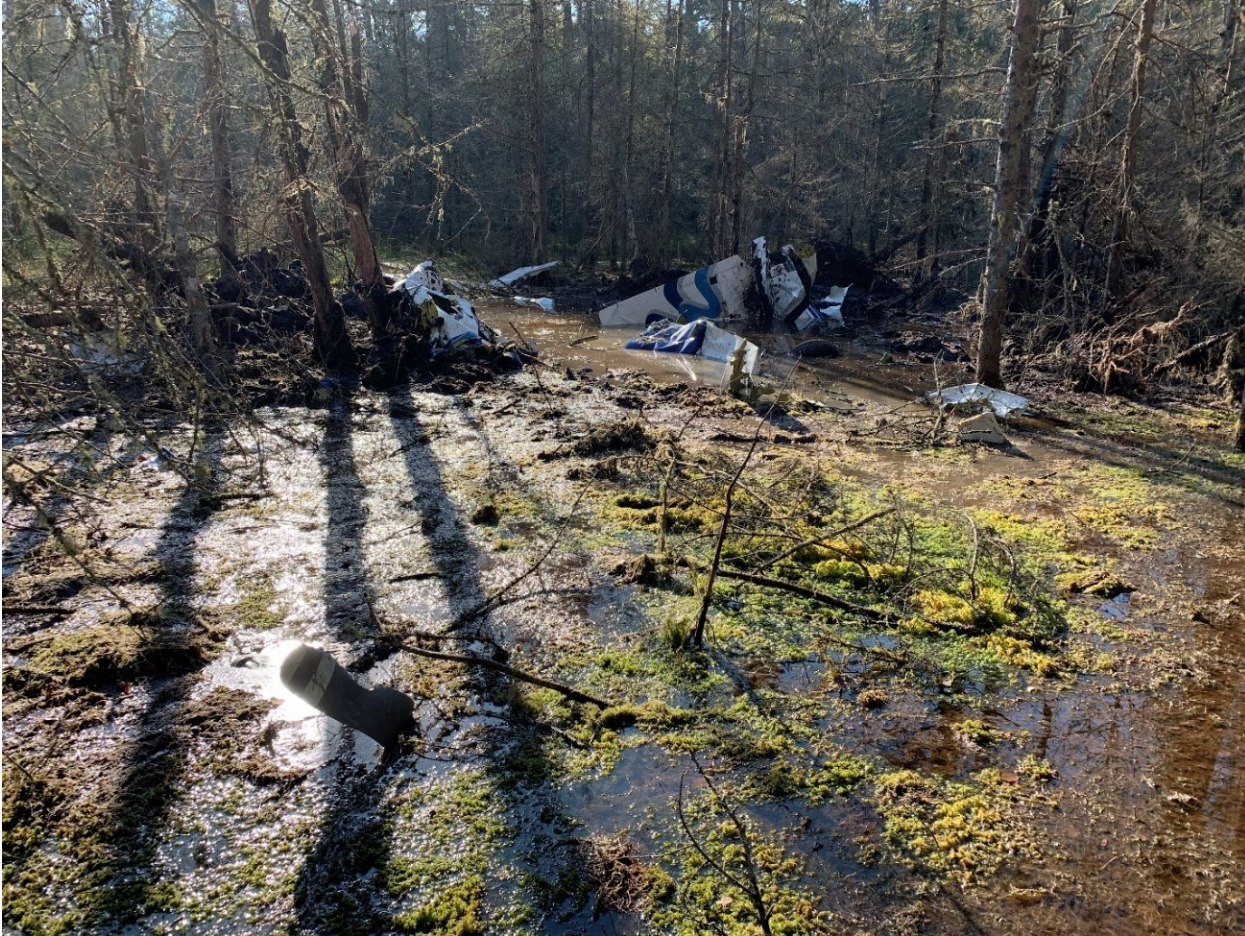
Figure 2. Accident site and main wreckage.

The airplane wreckage was located in remote wetlands and wooded terrain (see figure 2). The wreckage was distributed in an area with a diameter of about 150 ft.

Most of the main wreckage was highly fragmented and submerged beneath the water surface; other debris was located in the adjacent trees. The forward fuselage, fragmented sections of the wings, and a portion of the rear fuselage were submerged in the wetlands. A smell of Jet A aviation fuel and sheen on the wetlands were noted at the accident site.

The cockpit and fuselage were crushed aft and fragmented by impact forces. Flight control cable continuity could not be established due to the fragmentation of the airplane. All flight control cable connections exhibited tensile overload fractures. The primary and secondary control surfaces were found fragmented within the debris field.

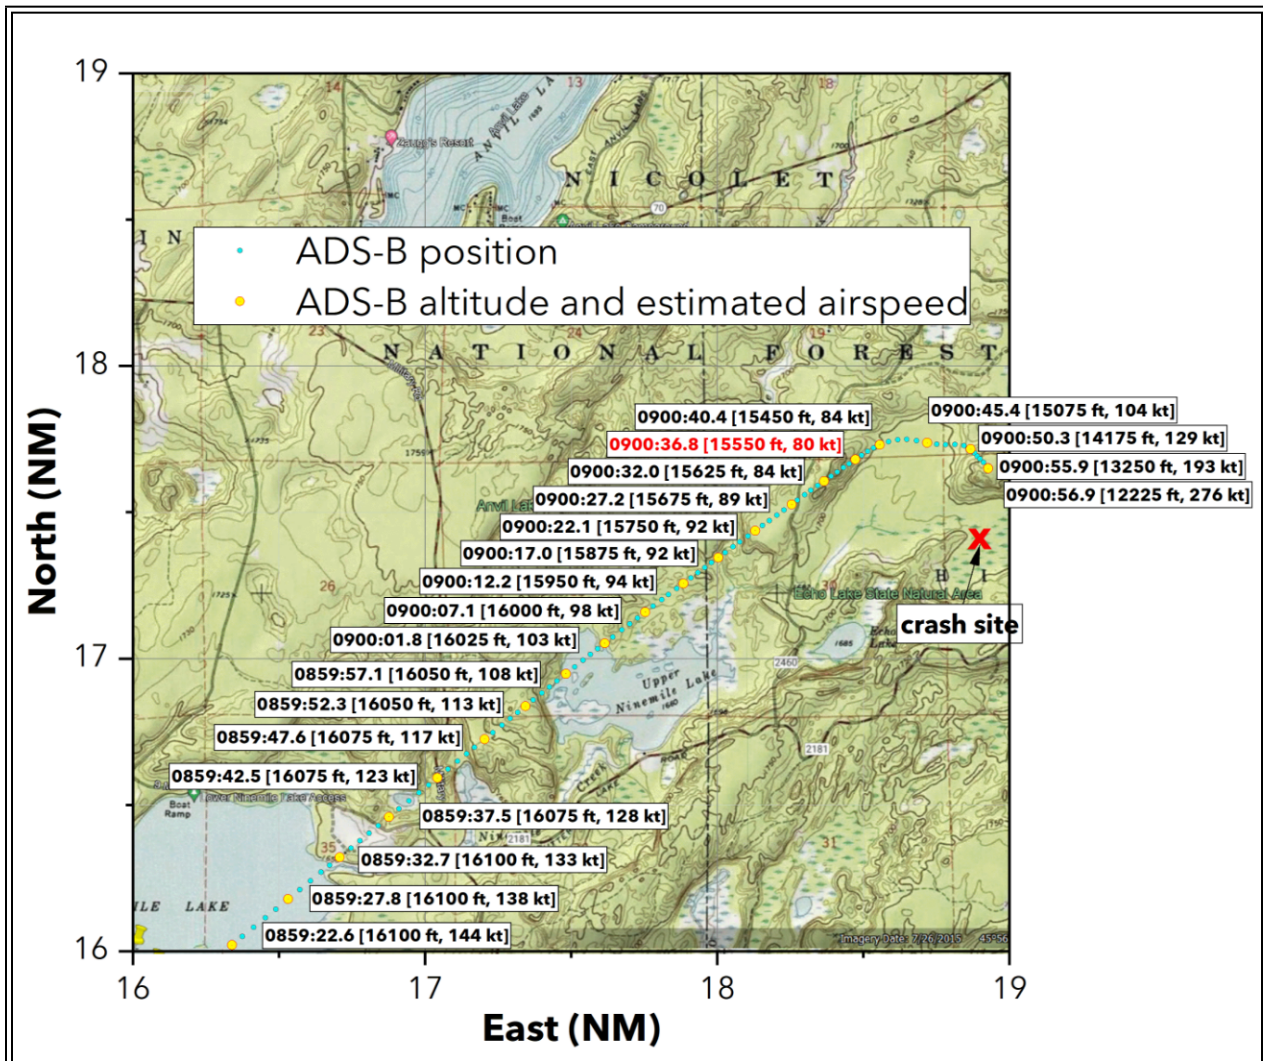
Figure 3. ADS-B altitudes and airspeeds for the accident flight.

An aircraft performance study was conducted for this investigation. The study was largely based on ADS-B data. Figure 3 shows the ADS-B altitude and estimated airspeed for the 11-minute flight in an overhead view. The airplane's airspeed was estimated to be at the stall speed at the altitude, airspeed, and time marked in red in the figure.

At 0900:38.7, the airplane pitched down in excess of 30° and descended at a rate that reached 20,000 ft per minute. About the time that the airplane pitched down, the estimated normal load factor decreased from about 1.6 Gs to less than 1 G.

The study stated that a decrease in normal load factor is consistent a stall when the wing reaches its critical angle of attack, at which time the air flow becomes separated at the wing and the wing can no longer generate the necessary lift. The study also stated that a spin could result if an airplane were in uncoordinated flight at the time of a stall.
