Aviation Investigation Final Report

Location:	Chandler, Arizona	Accident Number:	WPR22FA001
Date & Time:	October 1, 2021, 07:40 Local	Registration:	N412TL (A1); N2868H (A2)
Aircraft:	ROBINSON HELICOPTER COMPANY R22 (A1); Piper PA-28-181 (A2)	Aircraft Damage:	Substantial (A1); Minor (A2)
Defining Event:	Midair collision	Injuries:	2 Fatal (A1); 2 None (A2)
Flight Conducted Under:	Part 91: General aviation - Instructional (A1); Part 91: General aviation - Instructional (A2)

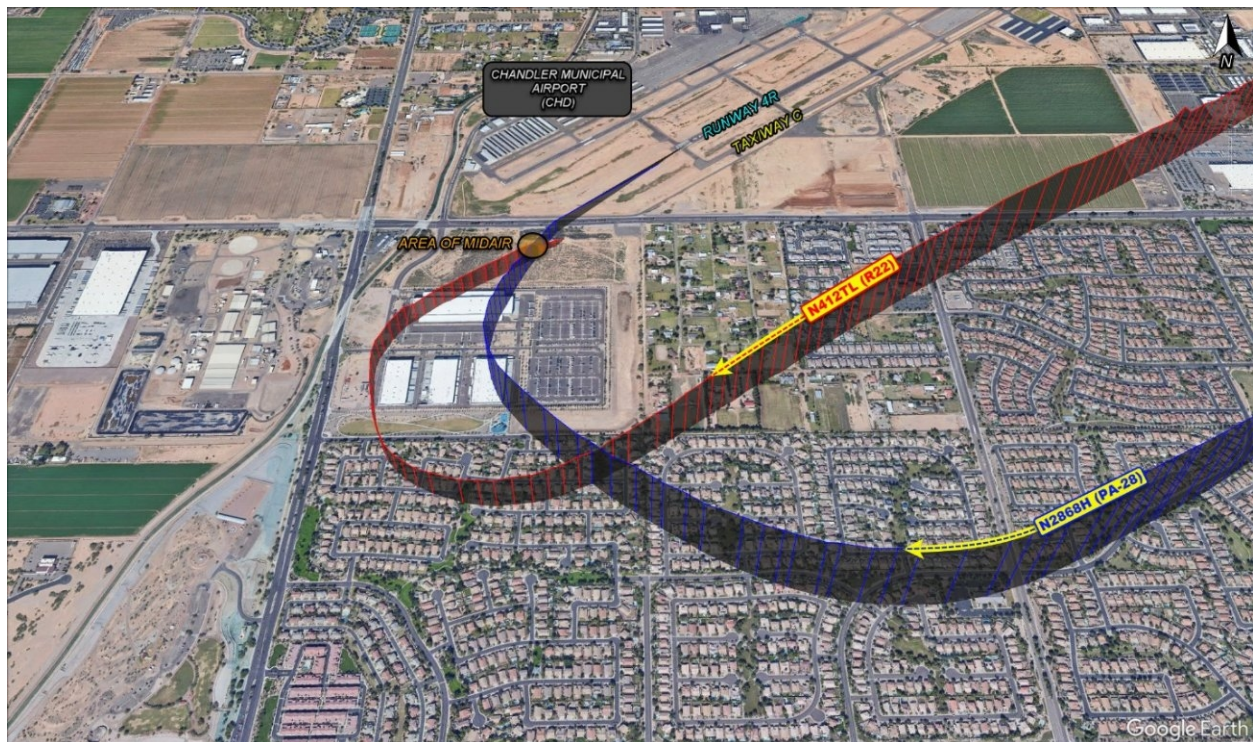
Figure 1. View of helicopter and airplane ADS-B flight track data

Flight track information, witness statements, and damage to the airplane indicated that the airplane descended into the helicopter while both aircraft were on final approach for landing. Review of tower control communications indicated that the accident airplane had been advised and was aware of helicopters operating to the parallel taxiway. The tower controller cleared the airplane to land behind a twin-engine airplane, and advised of a helicopter low and to the airplane's right (the accident helicopter). The circumstances of the accident are consistent with the failure of the pilots onboard the airplane to see and avoid the helicopter

Recorded Automatic Dependent Surveillance-Broadcast (ADS-B) data provided by the Federal Aviation Administration (FAA) showed that both aircraft appeared to be on a base to final turn, with the airplane on the approach to runway 04R and the helicopter on the approach to taxiway C (parallel to and to the right of runway 04R). The data showed that the flight paths of the aircraft intersected about 0740:15 at an altitude of about 1,400 ft mean sea level (msl), as seen in Figure 1.

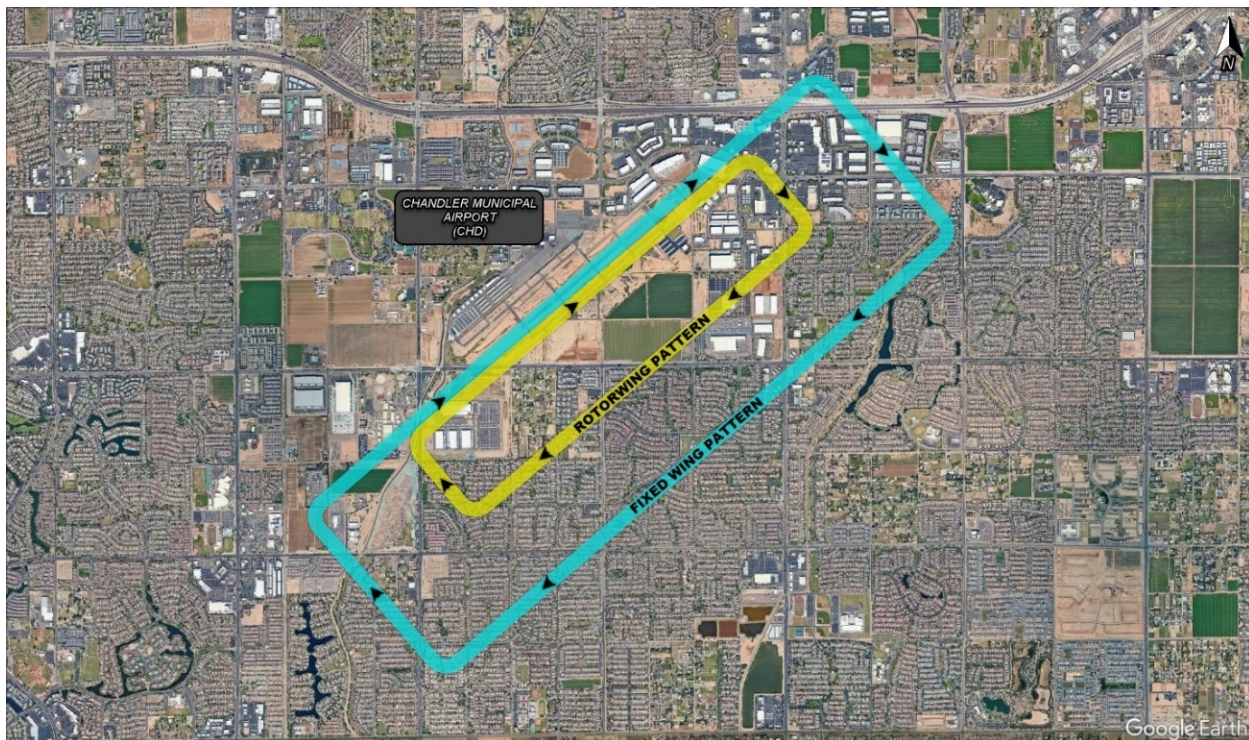
Figure 2. View of helicopter and airplane traffic pattern

The Chandler Municipal Airport (CHD) FAA contract tower (FCT) had a Letter of Agreement (LOA), dated August 2020, with the helicopter operator that specified responsibilities, defined terms, and established the procedures for operations of helicopters within the CHD class D airspace. The provision of the letter applied only to helicopters conducting operations by persons authorized by the helicopter operator and only when CHD control tower was in operation. The LOA established a helicopter traffic pattern to taxiway C. (see Figure 2.) The helicopter traffic pattern altitude was 1,900 ft msl and the fixed wing traffic pattern altitude was 2,300 ft msl.
