Aviation Investigation Final Report

Location:	Thomson, Georgia	Accident Number:	ERA22FA004
Date & Time:	October 5, 2021, 05:44 Local	Registration:	N283SA
Aircraft:	Dassault Falcon 20	Aircraft Damage:	Destroyed
Defining Event:	Miscellaneous/other	Injuries:	2 Fatal
Flight Conducted Under:	Part 135: Air taxi & commuter - Non-scheduled

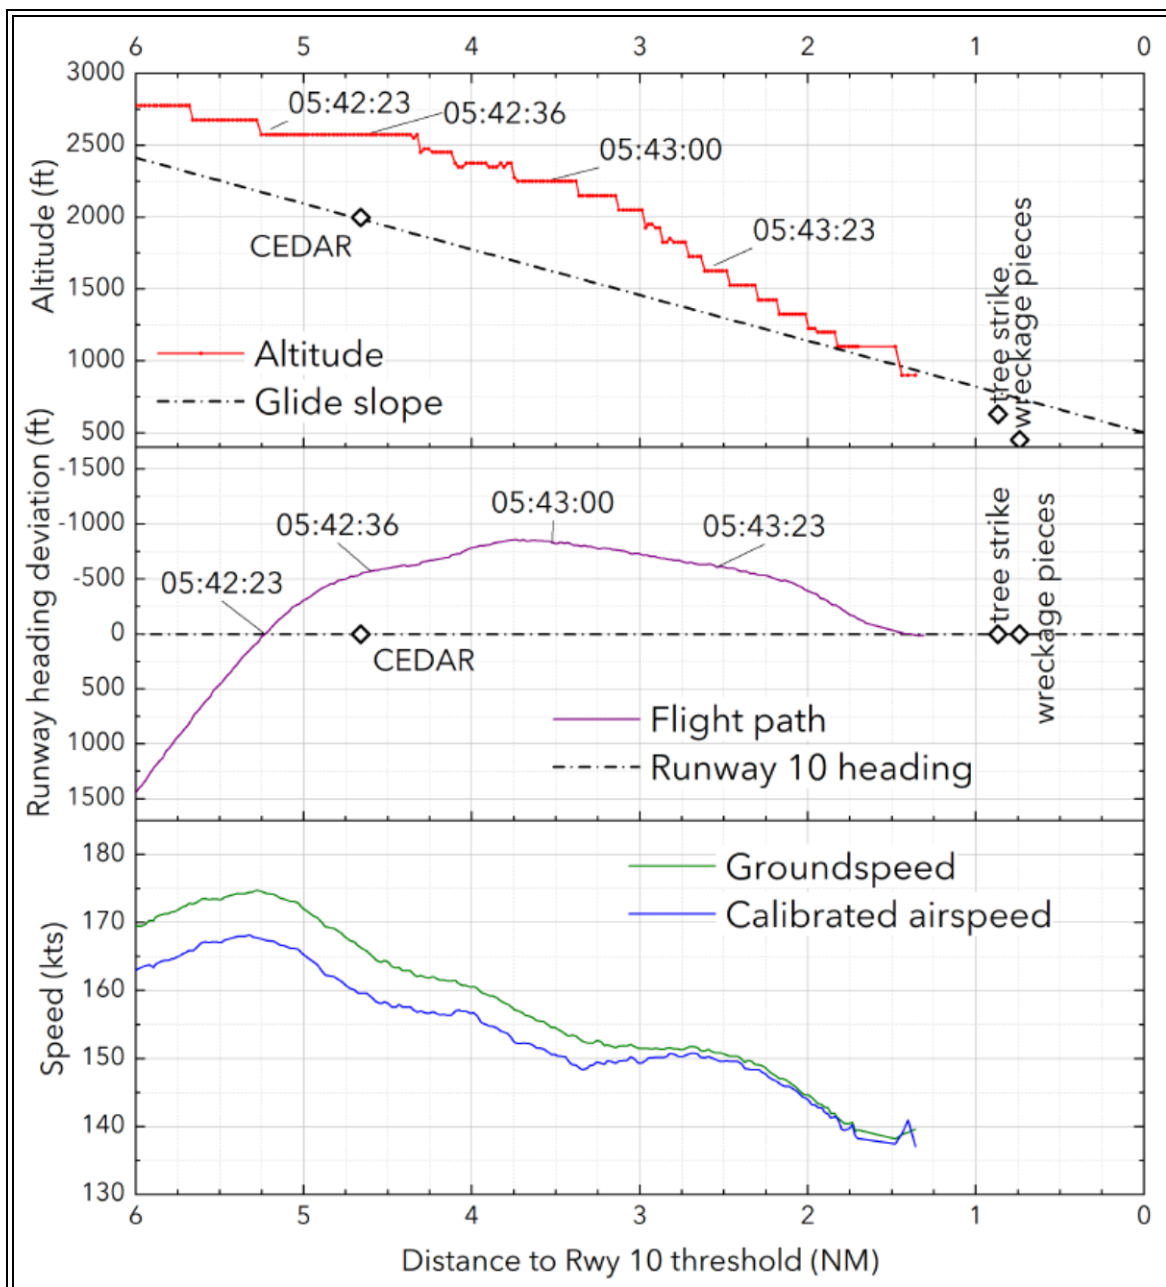
An automatic dependent surveillance – broadcast (ADS-B) performance study conducted by the National Transportation Safety Board's (NTSB) Vehicle Performance Division found that the airplane crossed CEDAR (the final approach fix) at 2,600 ft mean sea level (msl) and 500 ft to the left of the extended runway centerline. After CEDAR, the flight track continued toward the runway and continued to be about 600 ft above the 3° visual glide path and further deviated to the left of the runway heading until about 3 nautical miles from the threshold, when the descent rate increased. The airplane's airspeed at that time was about 150 kts. ADS-B coverage ended at 05:43:54, about 3,000 ft short of the first recorded tree strike. The final recorded altitude was 900 ft msl (400 ft above ground level [agl]) and the calculated airspeed was 137 kts. Figures 1 and 2 provide an overview of the flight track data, expected approach path, and summary CVR comments related to the approach.

Figure 1: Altitude compared to 3° visual glide slope, flight path compared to runway heading, and calculated ground and airspeeds for final 6 NM of the approach.

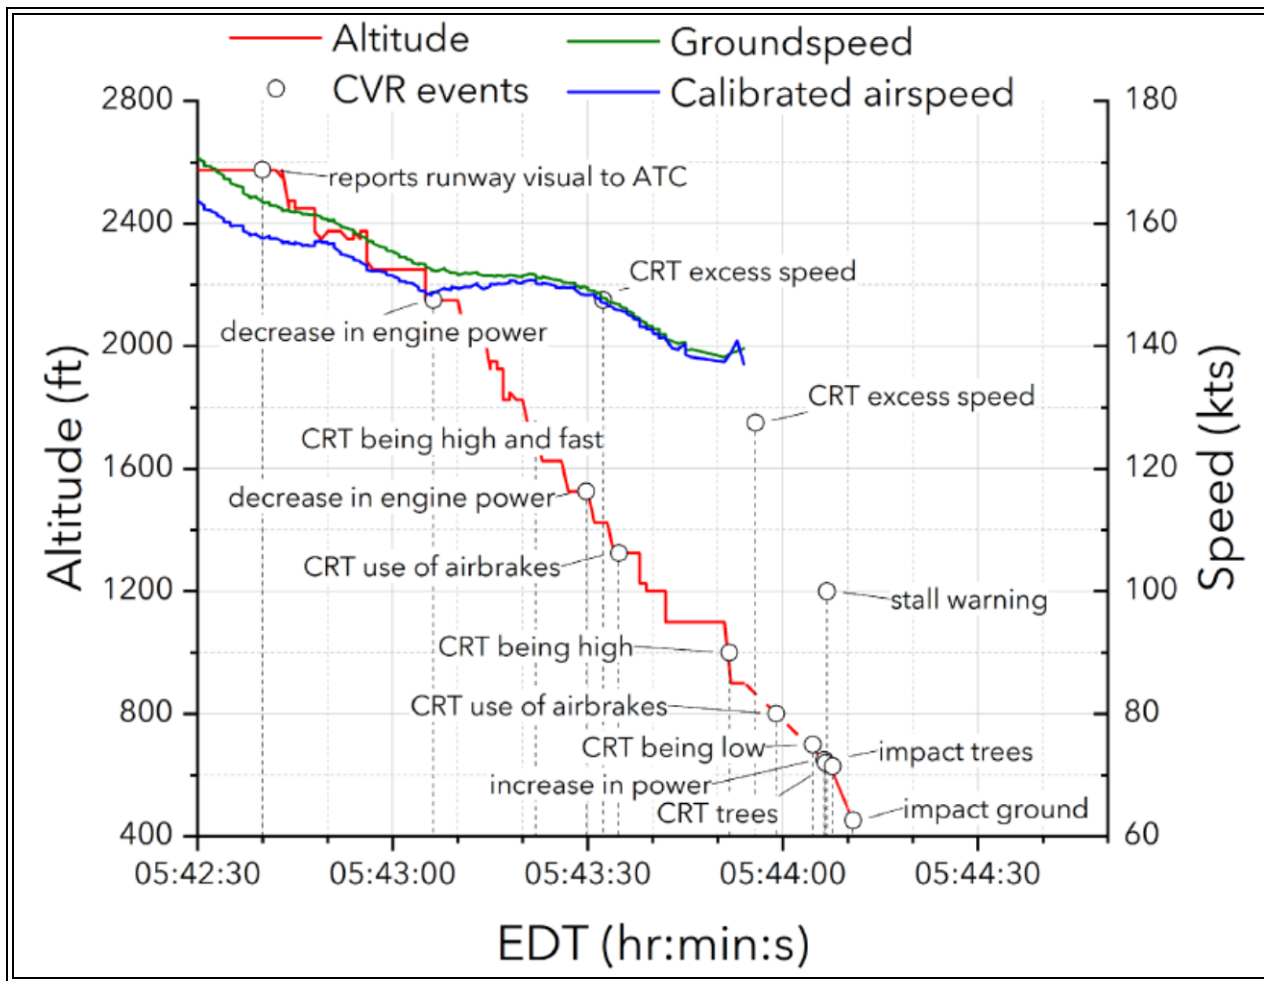
At 0543:22, the captain made repeated comments that they were high and fast and that they needed to lose 20 kts. A few seconds later, the captain stated, "let's use your air brakes again." At 0543:51, the captain stated, "you're way high," and the first officer responded, "no I'm not." The captain responded with "look" and "you're fifteen knots fast we got a short runway." About 0544, the captain again stated, "use your air brake" and about 4 seconds later, the captain stated, "now you're low." About 6 seconds later, the captain stated in an elevated voice, "you got trees." Power was heard to increase rapidly, the audible electronic pulsating stall warning activated, and at 0544:07, the sound of impact was heard.

Figure 2: Altitude, calibrated airspeed, and groundspeed with selected end of flight CVR events. "CRT" is "Comment related to -". Red dotted line shows estimated altitude trend. ADS-B data ended at 05:43:54.

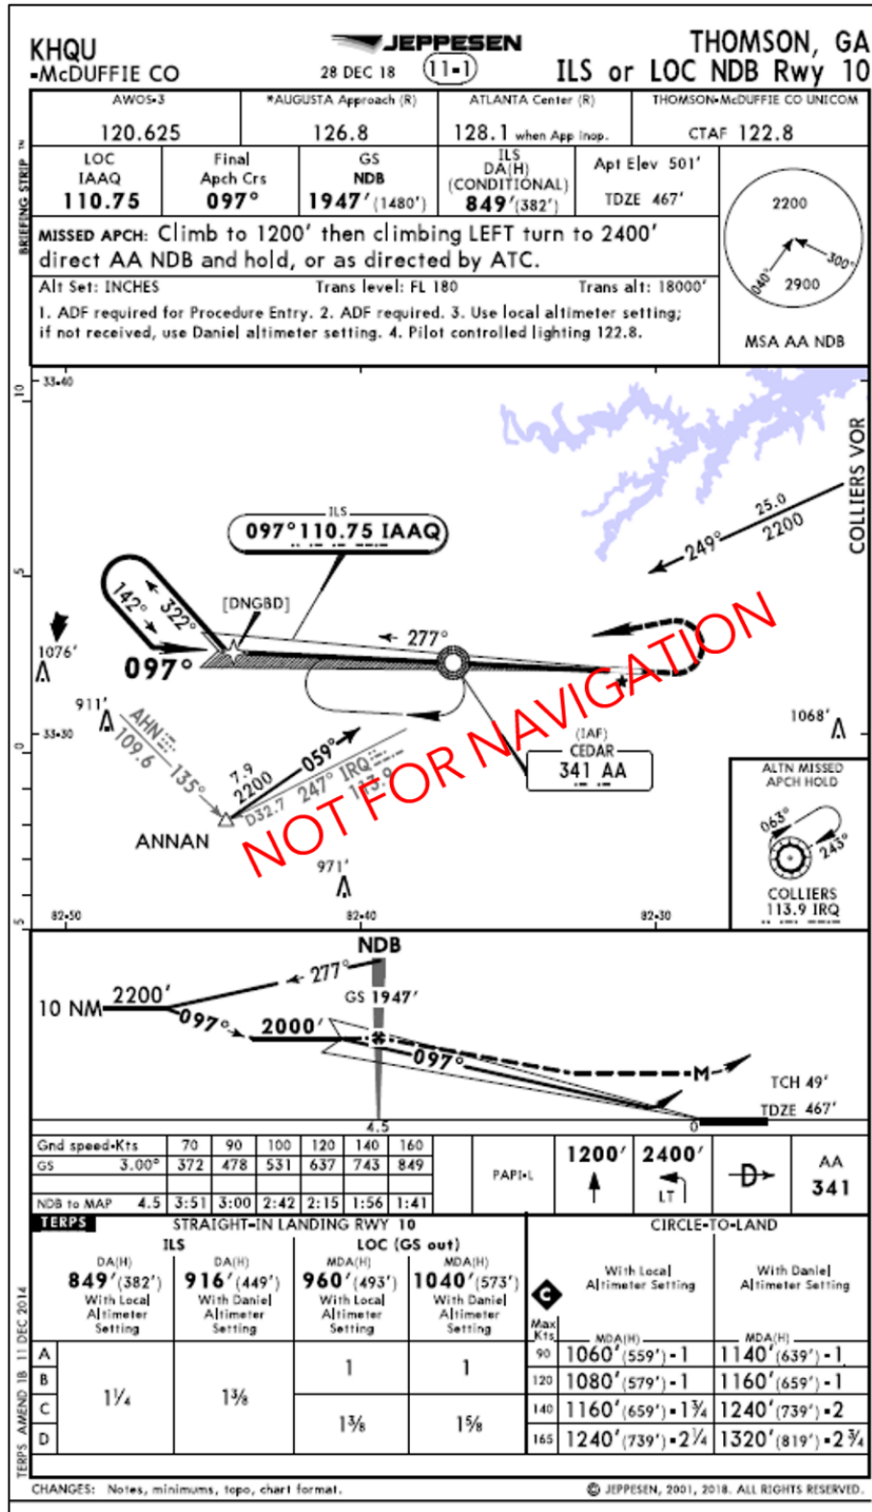
The only ILS or localizer approach to HQU was to runway 10. The approach required automatic direction finding (ADF) equipment for the procedure entry. The approach published a minimum altitude of 2,000 ft msl at the final approach fix CEDAR. The published procedure entry required that the airplane fly outbound on a 277° heading and complete a procedure turn back to the final approach course of 097°. The minimum descent altitude was 960 ft msl (492 ft agl), with the glideslope out of service and the local altimeter setting. The approach plate stated that a precision approach path indicator (PAPI) was available on the left side of the runway.

Figure 3: Instrument approach procedure chart for the ILS or LOC NDB Runway 10 Approach

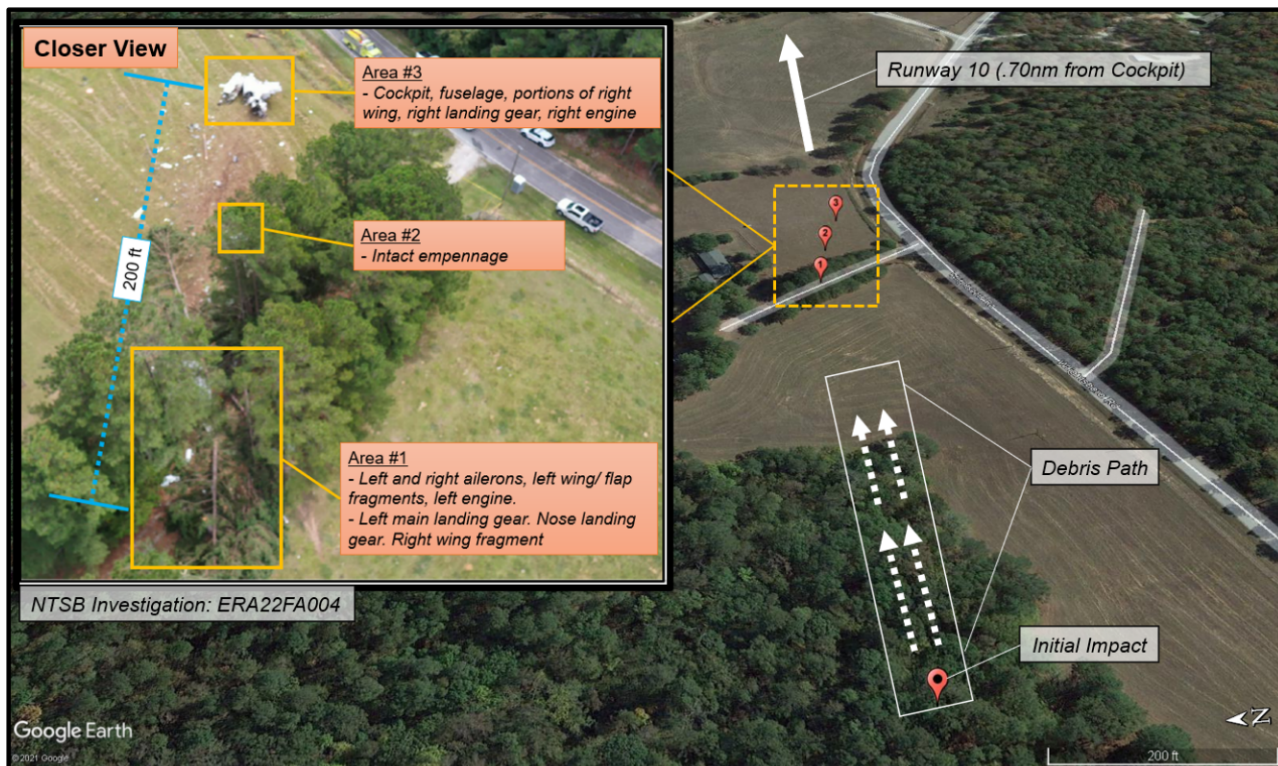
The initial impact point coincided with broken pine tree branches among a forest where the trees were about 150 ft tall. The debris path was oriented on a heading of about 100° and spanned about 880 ft from the initial impact to the main wreckage area. The airplane was heavily fragmented; however, there was no evidence of fire. The largest fragments of wreckage were concentrated in three primary areas overviewed in Figure 4. The figure shows the initial impact point and a pop-out drone image that describes the three areas.

Figure 4: Overview of the wreckage path and concentrated areas of wreckage (Drone image courtesy of Georgia Bureau of Investigations)
