# Aviation Investigation Final Report

<b>Location:</b>	Santee, California	<b>Accident Number:</b>	WPR22FA004
<b>Date &amp; Time:</b>	October 11, 2021, 12:14 Local	<b>Registration:</b>	N7022G
<b>Aircraft:</b>	Cessna 340A	<b>Aircraft Damage:</b>	Destroyed
<b>Defining Event:</b>	Loss of control in flight	<b>Injuries:</b>	2 Fatal, 2 Serious
<b>Flight Conducted Under:</b>	Part 91: General aviation - Personal

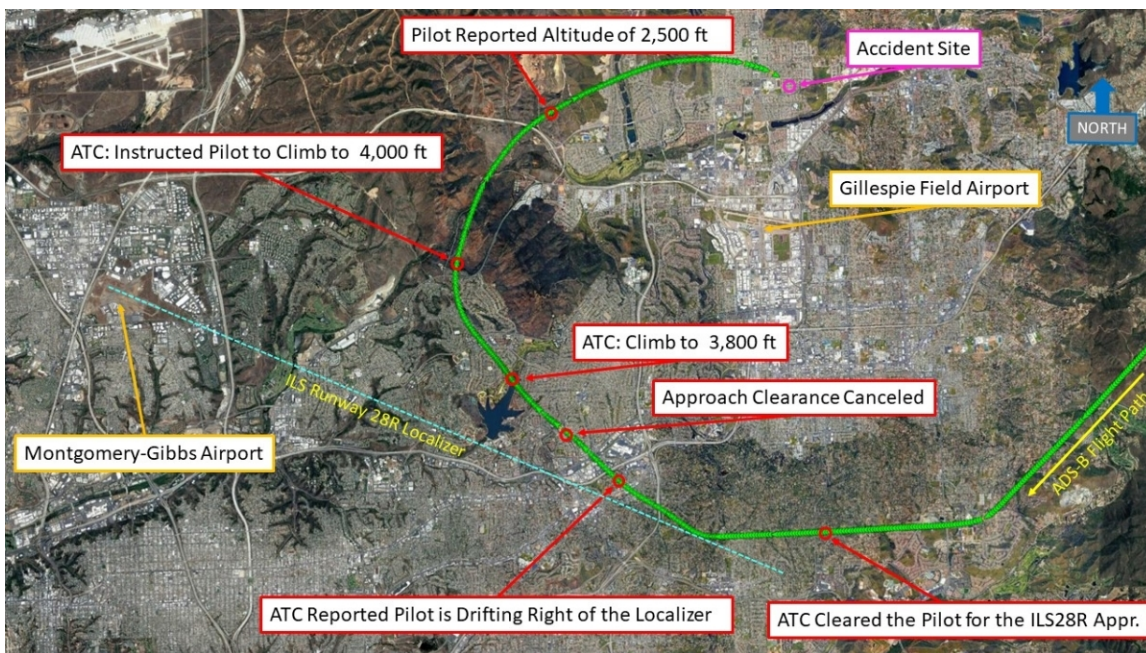
ADS-B data showed that the airplane had begun to climb at 1213:39, from 2,550 ft msl. The airplane continued a climb ascent while turning from a northeasterly-easterly heading and reached a maximum altitude of 3,500 ft msl, where it remained for about 4 seconds before it began a descending right turn. The airplane remained in the right descending turn until the last recorded target at 900 ft msl, located about 1,333 ft northwest of the accident site.

Figure 1: ADS-B data with ATC communication points noted.

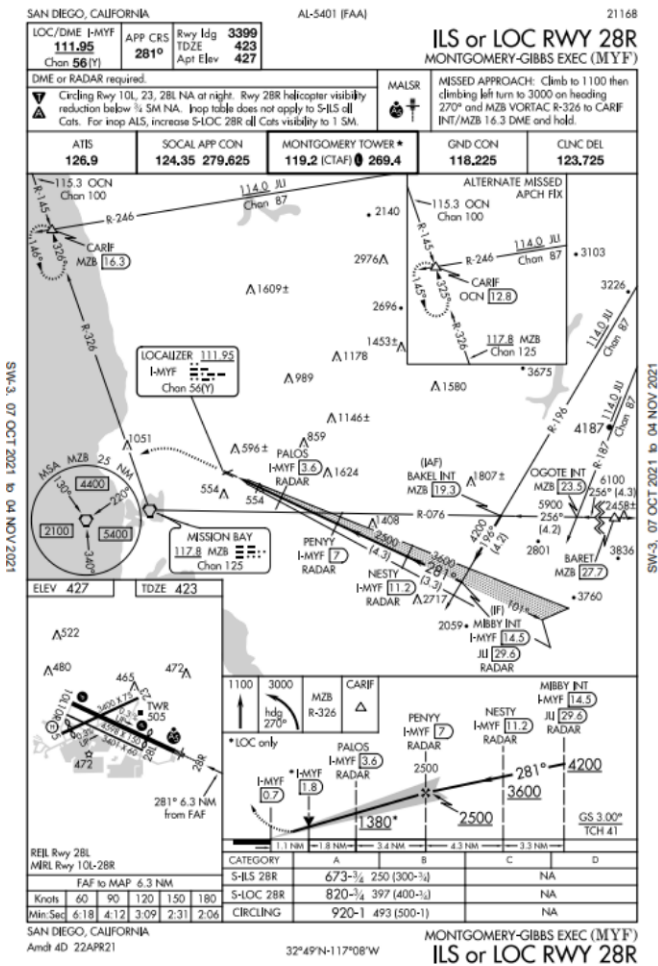
Figure 2: ILS / Localizer approach plate for Runway 28R at Montgomery - Gibbs Executive Airport.

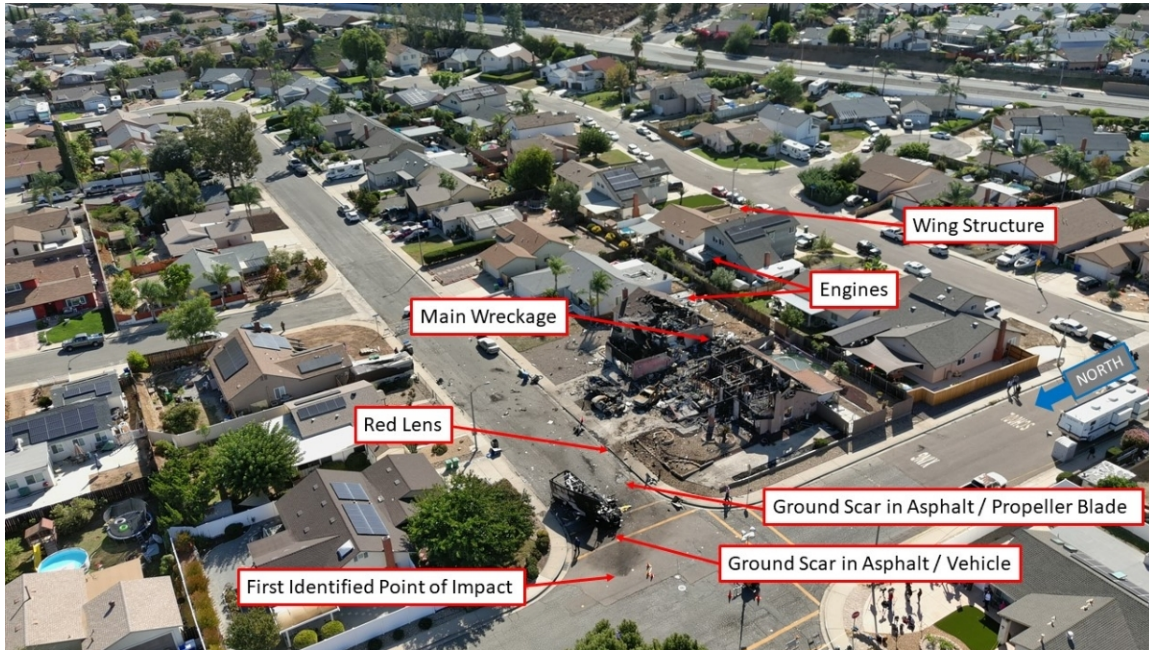
Examination of the accident site revealed that the airplane impacted a residential street on a heading of about 113° magnetic. The debris path, which consisted of various airplane, vehicle, and residential structure debris, was about 475 ft long and 400 ft wide, oriented on a heading of about 132°. Numerous residential structures exhibited impact related damage and or fire damage.

Figure 3: Annotations of wreckage locations. Aerial photo provided by San Diego County Sheriff.

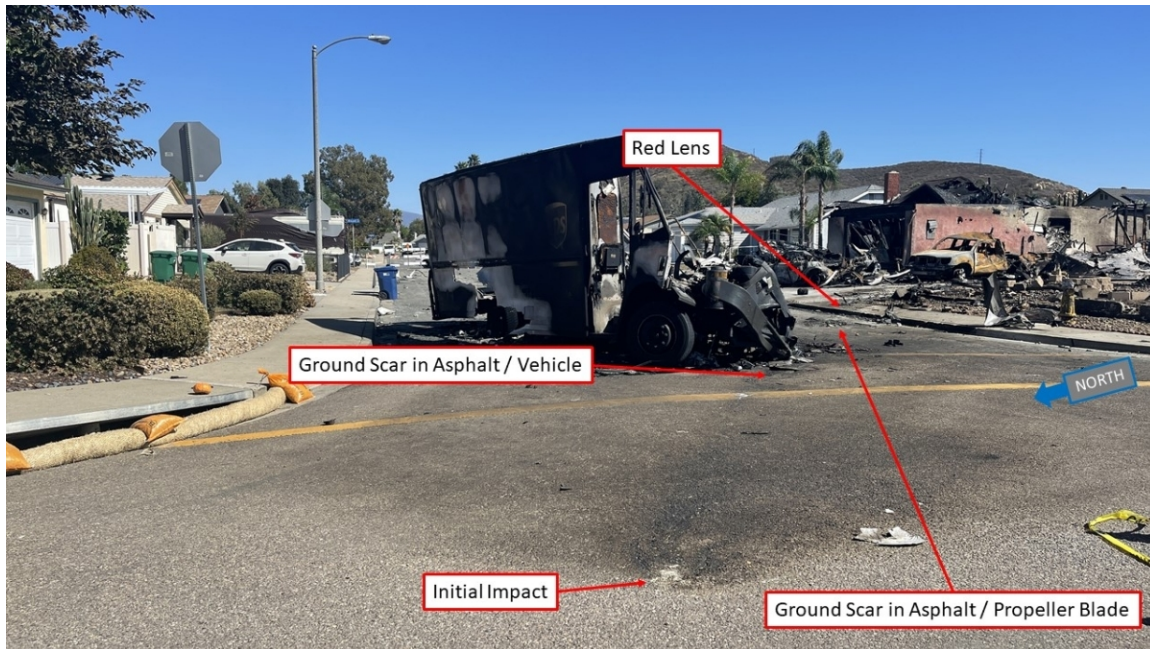
The first identified point of contact (FIPC) was a gouge in the asphalt road about 10 inches long and 5 inches wide. Scrape marks extended from about 18 ft from the FIPC to a second gouge in the asphalt, which was about 2 ft wide and 3 ft long, along with a damaged vehicle. Adjacent to the second scrape mark and vehicle was an additional gouge in the asphalt, about 2 ft long and 4 inches wide. Additional scrape marks extended 28 ft to a large impact crater within the asphalt, which was about 4 ft wide, 3 ft long, and about 6 inches deep, and contained a portion of propeller blade. Additional scratch marks extended another 12 ft to portions of red lens consistent with the left wing navigation lens.

Figure 4: Initial impact area.
