# Aviation Investigation Final Report

<b>Location:</b>	Santee, California	<b>Accident Number:</b>	WPR22FA004
<b>Date &amp; Time:</b>	October 11, 2021, 12:14 Local	<b>Registration:</b>	N7022G
<b>Aircraft:</b>	Cessna 340A	<b>Aircraft Damage:</b>	Destroyed
<b>Defining Event:</b>	Loss of control in flight	<b>Injuries:</b>	2 Fatal, 2 Serious
<b>Flight Conducted Under:</b>	Part 91: General aviation - Personal

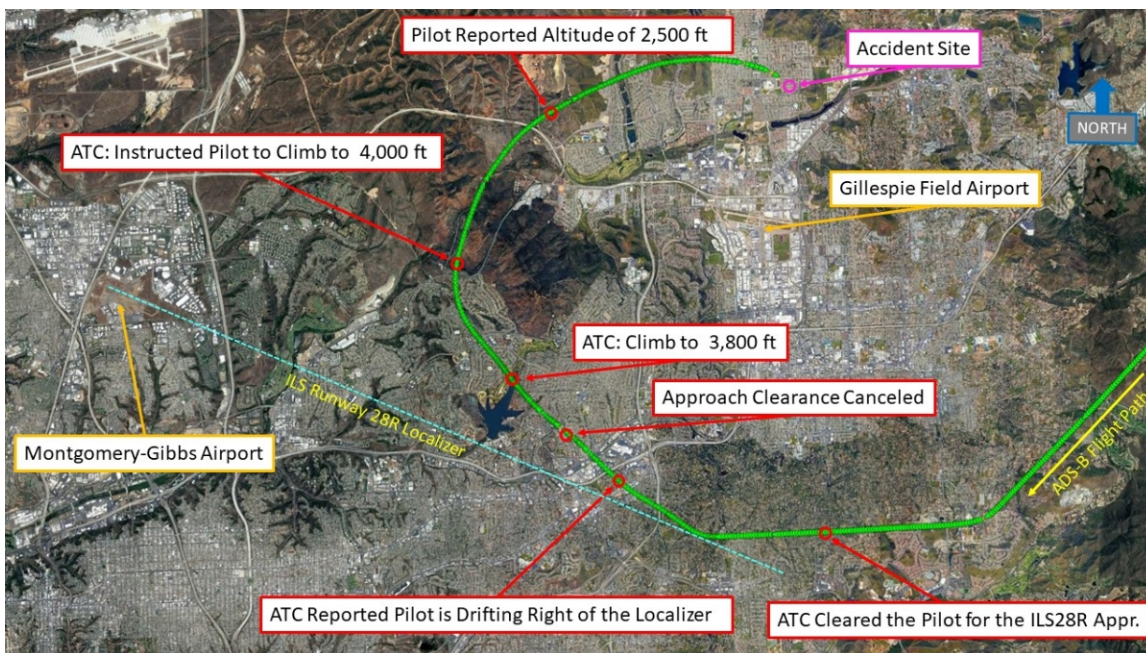
ADS-B data showed that the airplane had begun to climb at 1213:39, from 2,550 ft msl. The airplane continued a climb ascent while turning from a northeasterly-easterly heading and reached a maximum altitude of 3,500 ft msl, where it remained for about 4 seconds before it began a descending right turn. The airplane remained in the right descending turn until the last recorded target at 900 ft msl, located about 1,333 ft northwest of the accident site.

Figure 1: ADS-B data with ATC communication points noted.

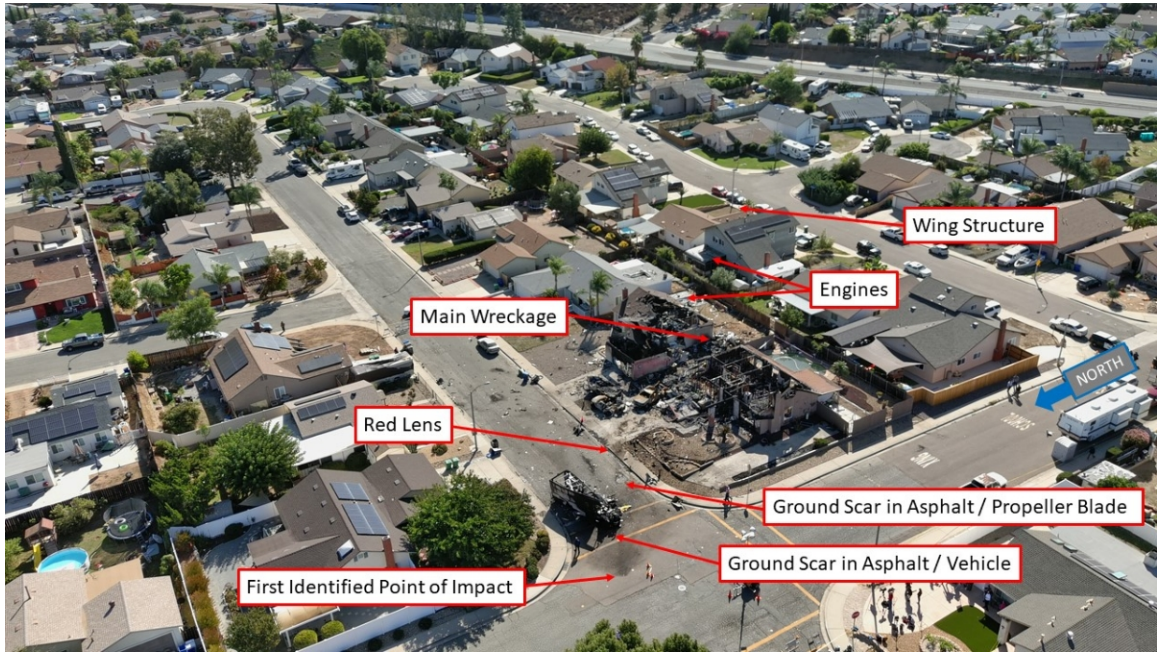
Examination of the accident site revealed that the airplane impacted a residential street on a heading of about 113° magnetic. The debris path, which consisted of various airplane, vehicle,

and residential structure debris, was about 475 ft long and 400 ft wide, oriented on a heading of about 132°. Numerous residential structures exhibited impact related damage and or fire damage.

Figure 3: Annotations of wreckage locations. Aerial photo provided by San Diego County Sheriff.

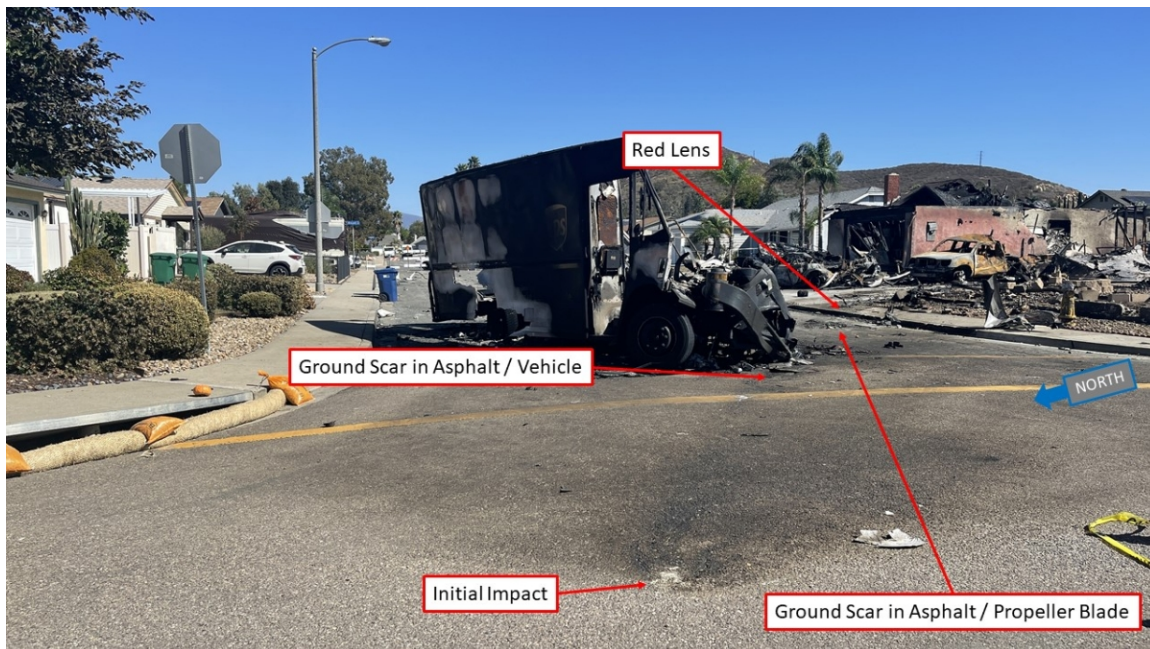
The first identified point of contact (FIPC) was a gouge in the asphalt road about 10 inches long and 5 inches wide. Scrape marks extended from about 18 ft from the FIPC to a second gouge in the asphalt, which was about 2 ft wide and 3 ft long, along with a damaged vehicle. Adjacent to the second scrape mark and vehicle was an additional gouge in the asphalt, about 2 ft long and 4 inches wide. Additional scrape marks extended 28 ft to a large impact crater within the asphalt, which was about 4 ft wide, 3 ft long, and about 6 inches deep, and contained a portion of propeller blade. Additional scratch marks extended another 12 ft to portions of red lens consistent with the left wing navigation lens.

Figure 4: Initial impact area.
