Aviation Investigation Final Report

Location:	Brookshire, Texas	Accident Number:	DCA22MA009
Date & Time:	October 19, 2021, 10:00 Local	Registration:	N987AK
Aircraft:	McDonnell Douglas DC-9-87 (MD-87)	Aircraft Damage:	Destroyed
Defining Event:	Flight control sys malf/fail	Injuries:	2 Serious, 1 Minor, 20 None
Flight Conducted Under:	Part 91: General aviation - Personal

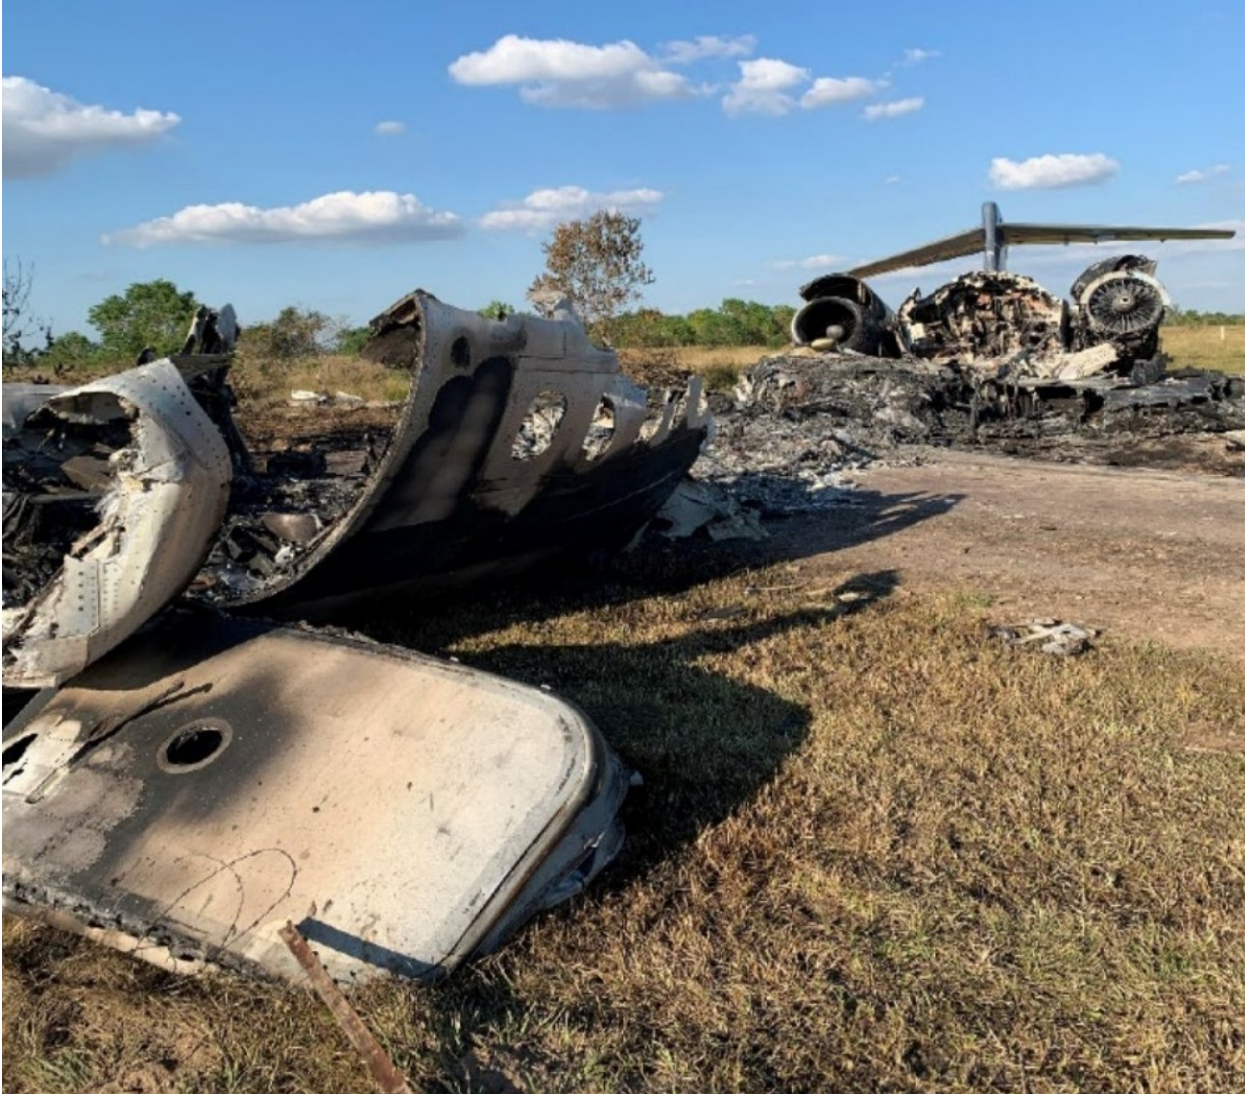
The airplane structure forward of the empennage was heavily damaged by fire. All of the upper fuselage structure (except for a small section of the upper nose structure and empennage) was consumed by fire. An outboard portion of the left wing was found separated due to contact with several trees. The inboard portion of the left wing was attached to the fuselage and showed heavy fire damage. Most of the right wing was partially attached to the fuselage and showed heavy fire damage near the wing root.

Figure 3. View of the wreckage (from front left looking aft) showing heavy fire damage forward of the empennage.

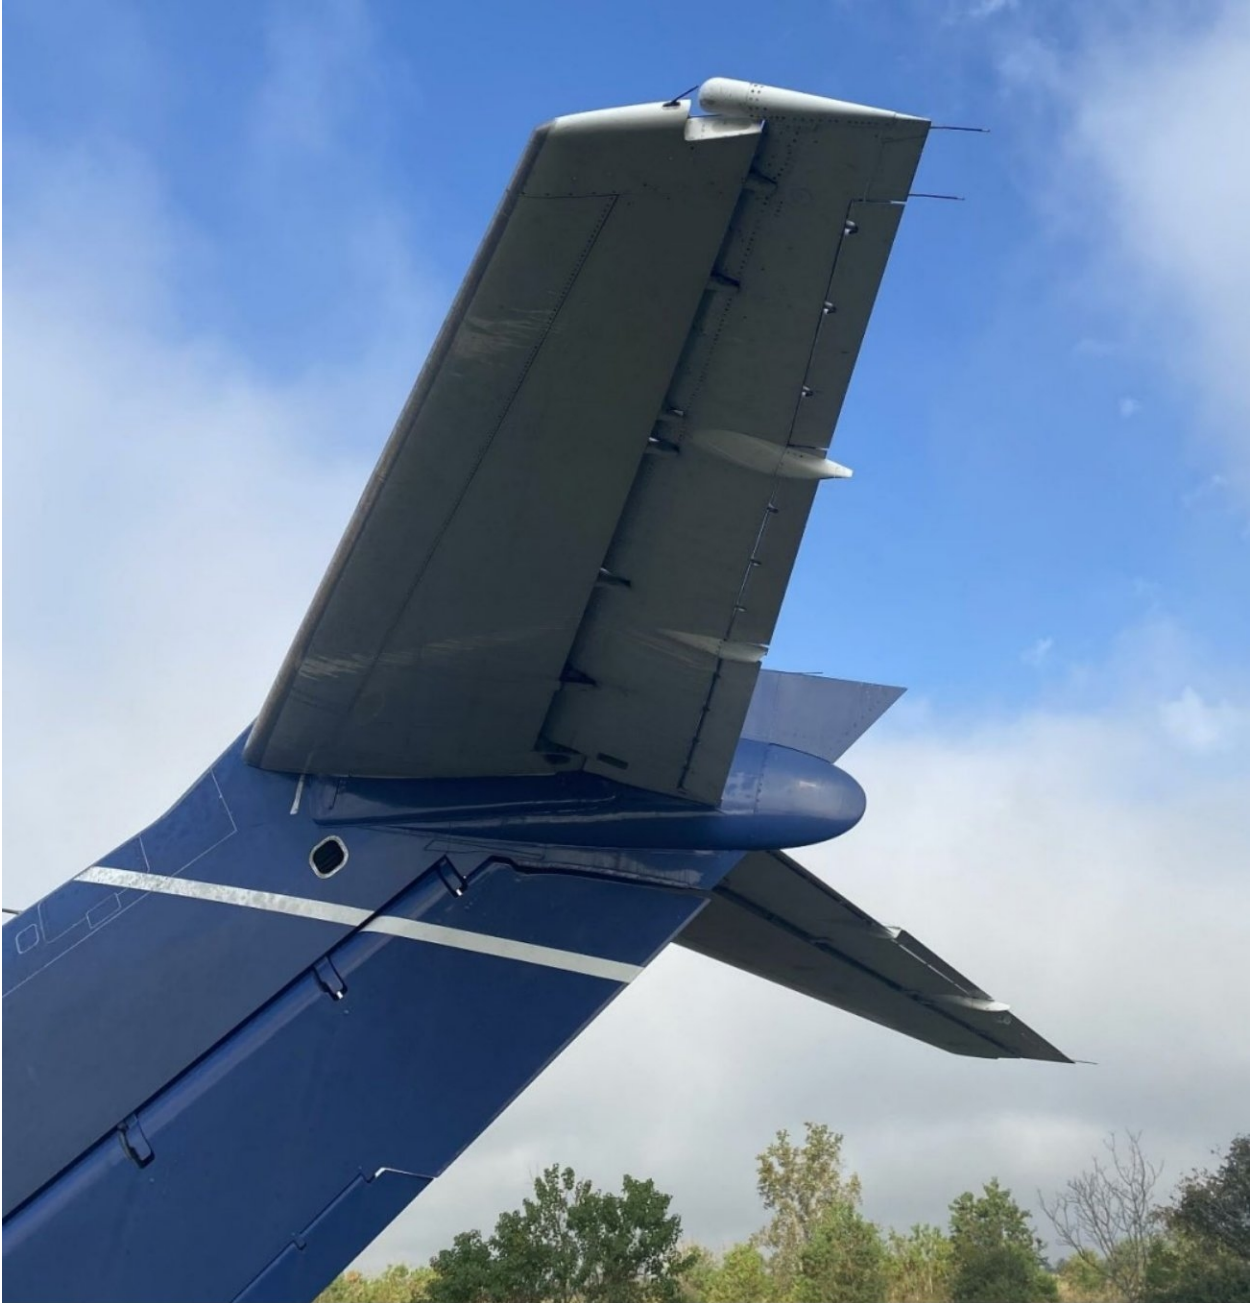
Postaccident examination found both elevators in a trailing-edge-down position, and attempts to move them upward (using hand pressure) were unsuccessful (see figure 4).

Figure 4. Both elevators as found in the trailing-edge down position.

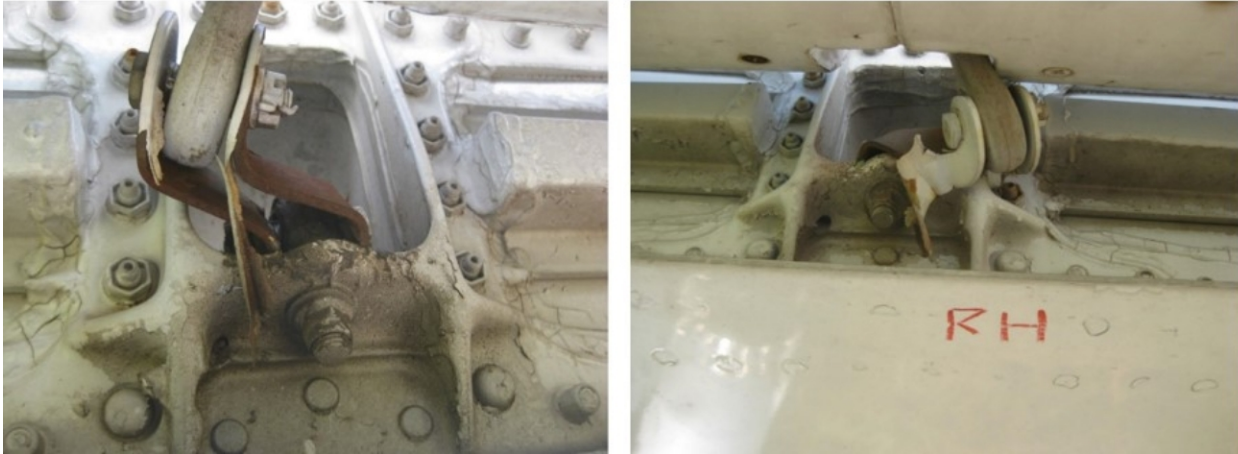
Examination found that the inboard actuating cranks for both elevators' geared tabs were bent, and their respective attachment linkages were bent outboard (see figure 5).

Figure 5. Left and right elevator inboard geared tab linkages (left and right, respectively), viewed from underneath each elevator. Each linkage is bent outboard.

The actuating crank and linkages were found locked overcenter beyond their normal range of travel. Once the actuating cranks were disconnected and the bent linkages removed, the elevators could be moved (using hand pressure) through their normal range of motion. No other elevator or pitch control system component anomalies were identified. Tests and examinations of the components removed from the system revealed no evidence of mechanical failures or damage, or any actions by the flight crew or maintenance personnel, that could have caused the overcenter condition.
