Aviation Investigation Final Report

Location:	Brookshire, Texas	Accident Number:	DCA22MA009
Date & Time:	October 19, 2021, 10:00 Local	Registration:	N987AK
Aircraft:	McDonnell Douglas DC-9-87 (MD-87)	Aircraft Damage:	Destroyed
Defining Event:	Flight control sys malf/fail	Injuries:	2 Serious, 1 Minor, 20 None
Flight Conducted Under:	Part 91: General aviation - Personal

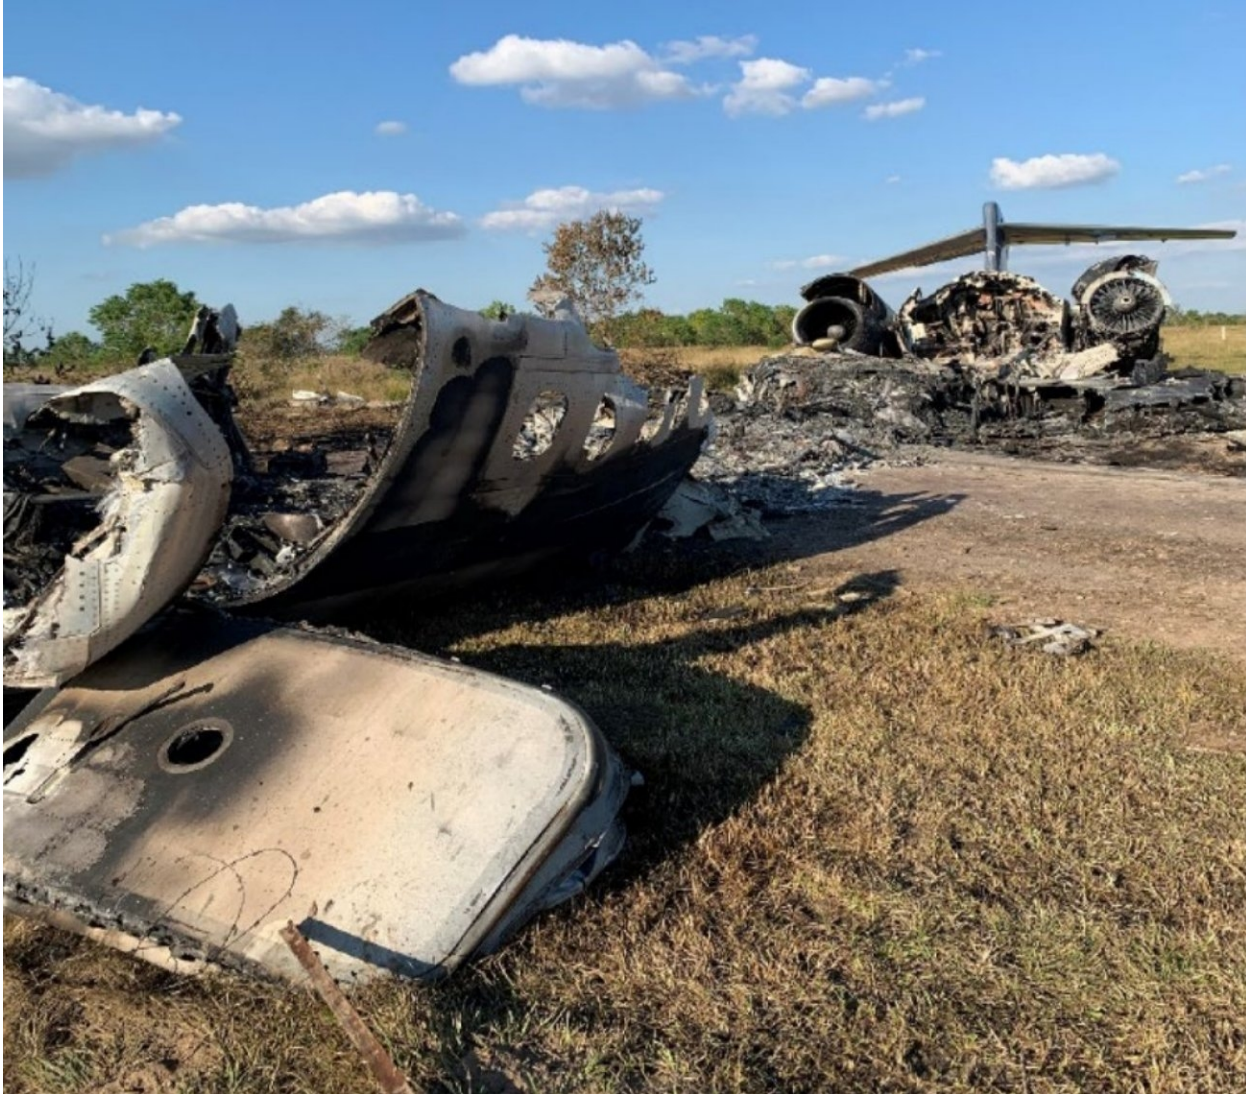
The airplane structure forward of the empennage was heavily damaged by fire. All of the upper fuselage structure (except for a small section of the upper nose structure and empennage) was consumed by fire. An outboard portion of the left wing was found separated due to contact with several trees. The inboard portion of the left wing was attached to the fuselage and showed heavy fire damage. Most of the right wing was partially attached to the fuselage and showed heavy fire damage near the wing root.

The empennage was partially intact with the vertical and horizontal stabilizers, rudder, and elevators attached (see figure 3).

Figure 3. View of the wreckage (from front left looking aft) showing heavy fire damage forward of the empennage.

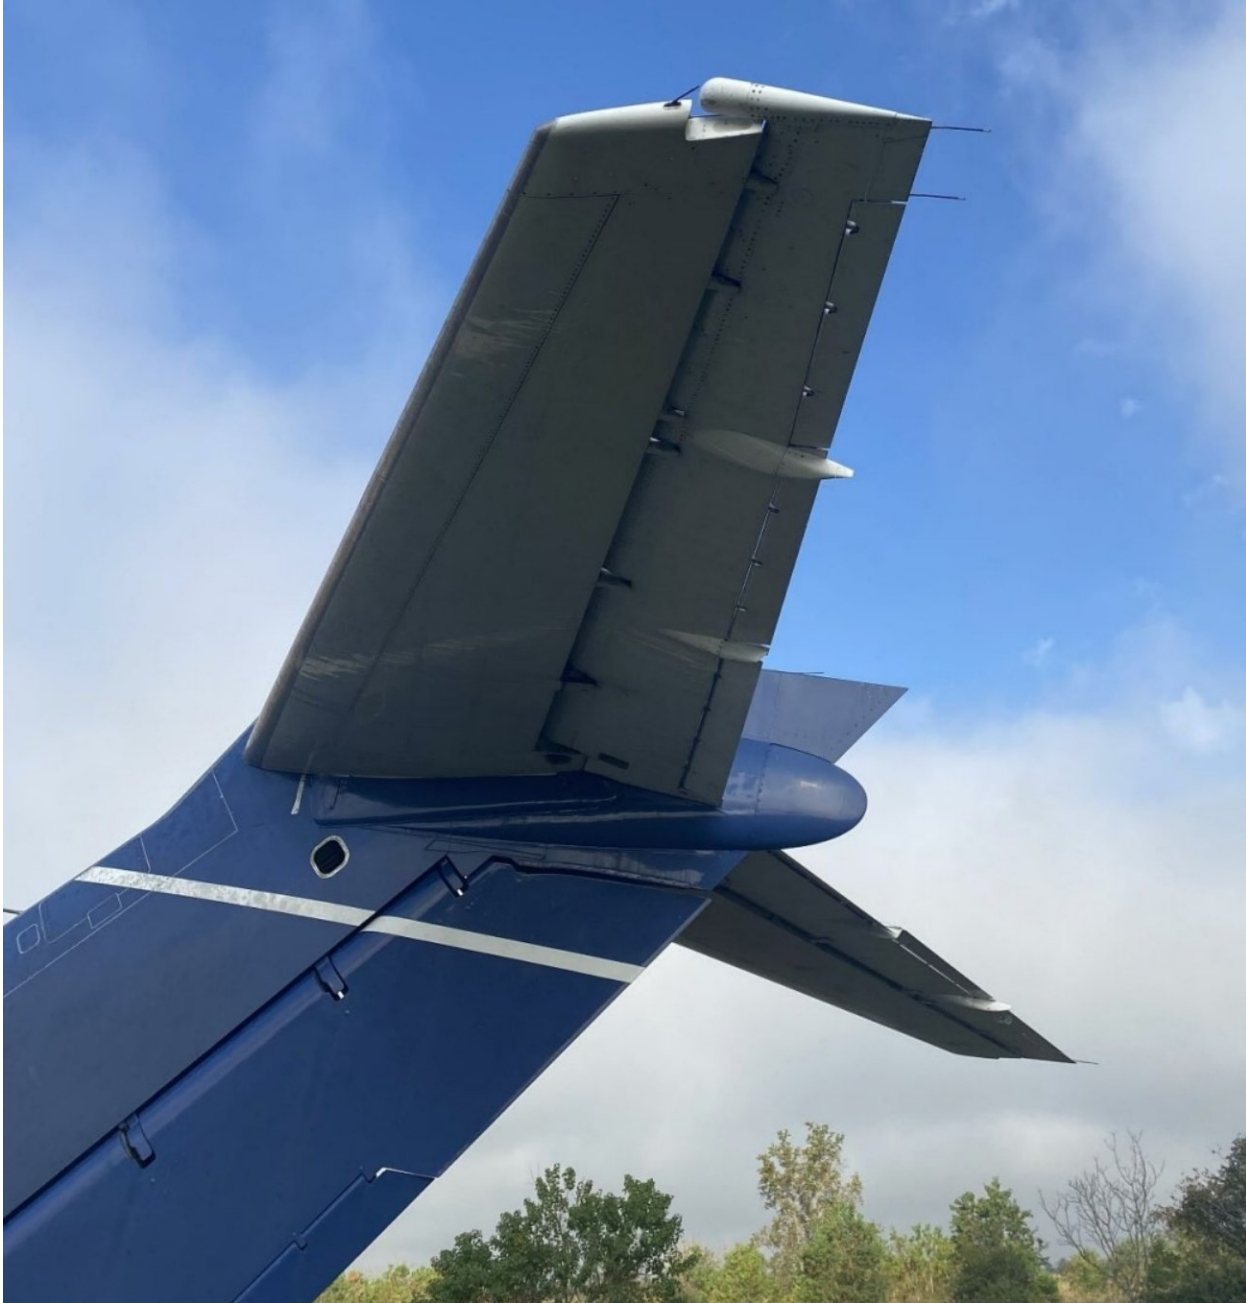
Postaccident examination found both elevators in a trailing-edge-down position, and attempts to move them upward (using hand pressure) were unsuccessful (see figure 4).

Figure 4. Both elevators as found in the trailing-edge down position.

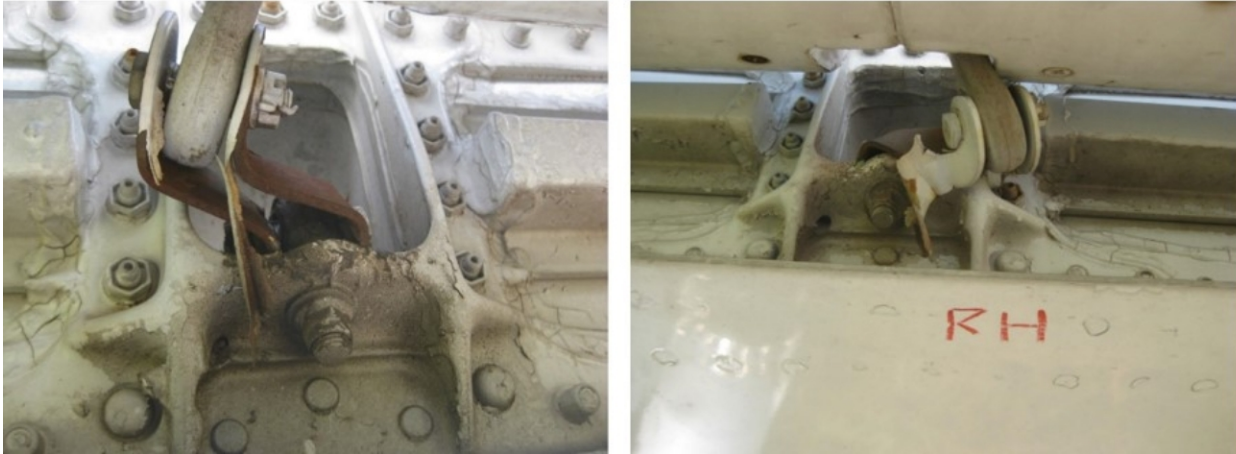
Examination found that the inboard actuating cranks for both elevators' geared tabs were bent, and their respective attachment linkages were bent outboard (see figure 5).

Figure 5. Left and right elevator inboard geared tab linkages (left and right, respectively), viewed from underneath each elevator. Each linkage is bent outboard.

The actuating crank and linkages were found locked overcenter beyond their normal range of travel. Once the actuating cranks were disconnected and the bent linkages removed, the elevators could be moved (using hand pressure) through their normal range of motion. No other elevator or pitch control system component anomalies were identified. Tests and examinations of the components removed from the system revealed no evidence of mechanical failures or damage, or any actions by the flight crew or maintenance personnel, that could have caused the overcenter condition.

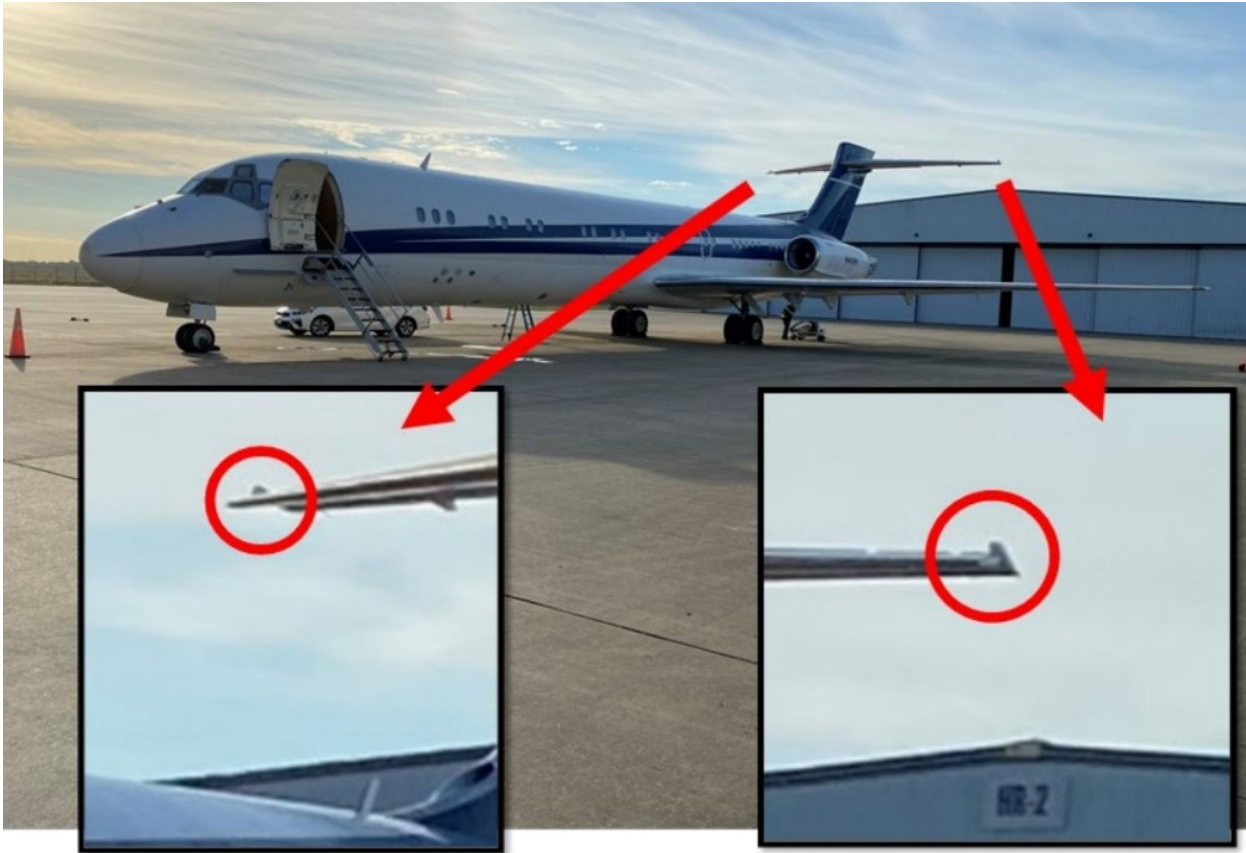
The first officer provided a photograph he took of the airplane on the morning of the accident, before the flight crew performed any manipulations of the cockpit flight controls. The photograph showed that the forward portion of each elevator's outboard balance weight was visible above the top surface of the horizontal stabilizer, consistent with both elevators in a trailing-edge-down position (see figure 6).

Figure 6. Accident airplane on the morning of the accident. Insets show the outboard balance weight for each elevator.
