Aviation Investigation Final Report

Location:	Folkston, Georgia	Accident Number:	ERA22LA031
Date & Time:	October 26, 2021, 23:23 UTC	Registration:	N525AT
Aircraft:	VANS AIRCRAFT INC RV-12	Aircraft Damage:	Destroyed
Defining Event:	Collision with terr/obj (non-CFIT)	Injuries:	1 Fatal
Flight Conducted Under:	Part 91: General aviation - Personal

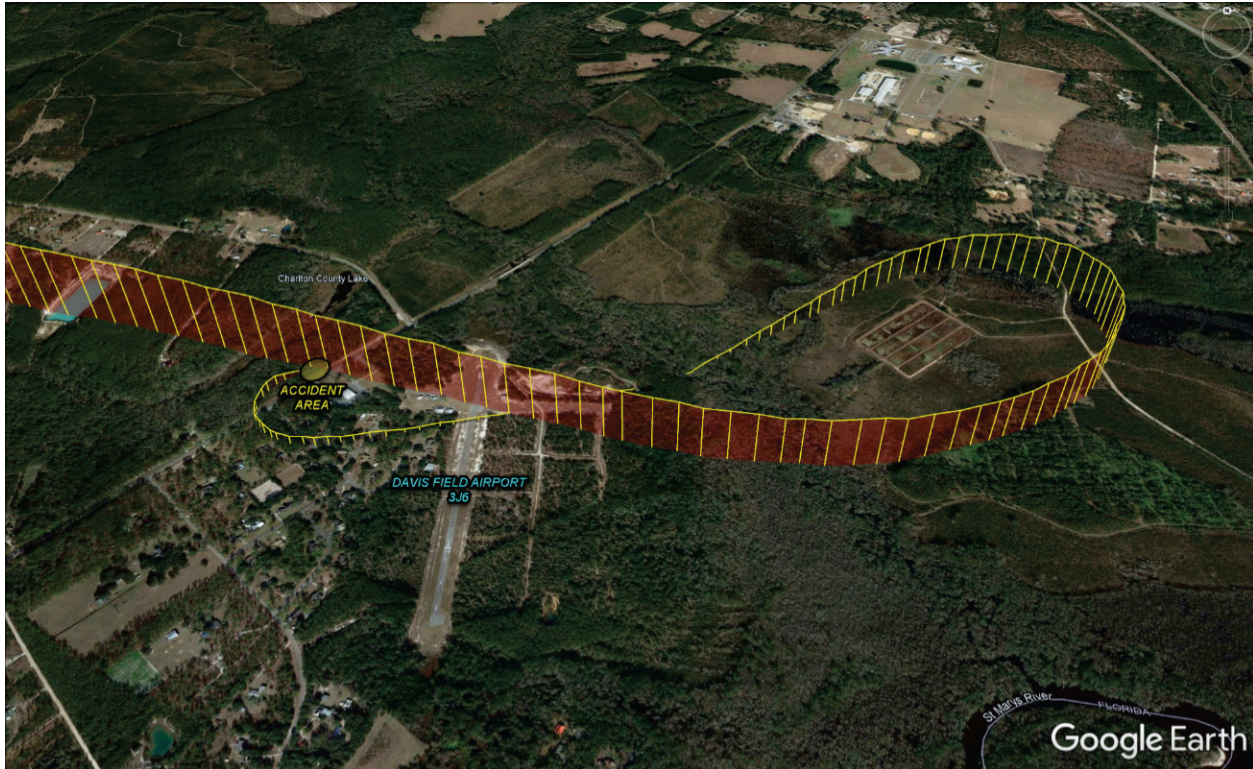
Flight track information indicated that, about 1 hour and 35 minutes after departure, in night conditions, the airplane was maneuvering in the vicinity of an airport. The pilot crossed over the runway twice while descending, maneuvered near a roadway, and the groundspeed decreased before the airplane contacted a utility pole beside the road and then impacted terrain.

According to automatic dependent surveillance-broadcast (ADS-B) data obtained from the Federal Aviation Administration (FAA), the airplane departed Winter Haven Regional Airport (GIF), Winter Haven, Florida, at 1725. About 1900, after about 1 hour and 35 minutes of flight on a generally northbound track, the airplane made a right turn toward Davis Field Airport (3J6), Folkston, Georgia. The airplane crossed over the middle of the runway at 3J6 at 575 ft above ground level (agl), then completed a descending left turn. The airplane again crossed over the runway, this time at 100 ft agl, and made a descending right turn, while the airspeed decreased from 76 knots to 47 knots. The airplane contacted a utility pole and came to rest next to a road. Figure 1 depicts the flight track as the airplane maneuvered in the vicinity of 36J.

Figure 1 – The airplane’s ADS-B-derived flight track while maneuvering near 3J6.
